# COMMERCIAL STRUCTURE INVESTIGATIONS

We have investigated a variety of commercial buildings and building types, a few of which are shown here.

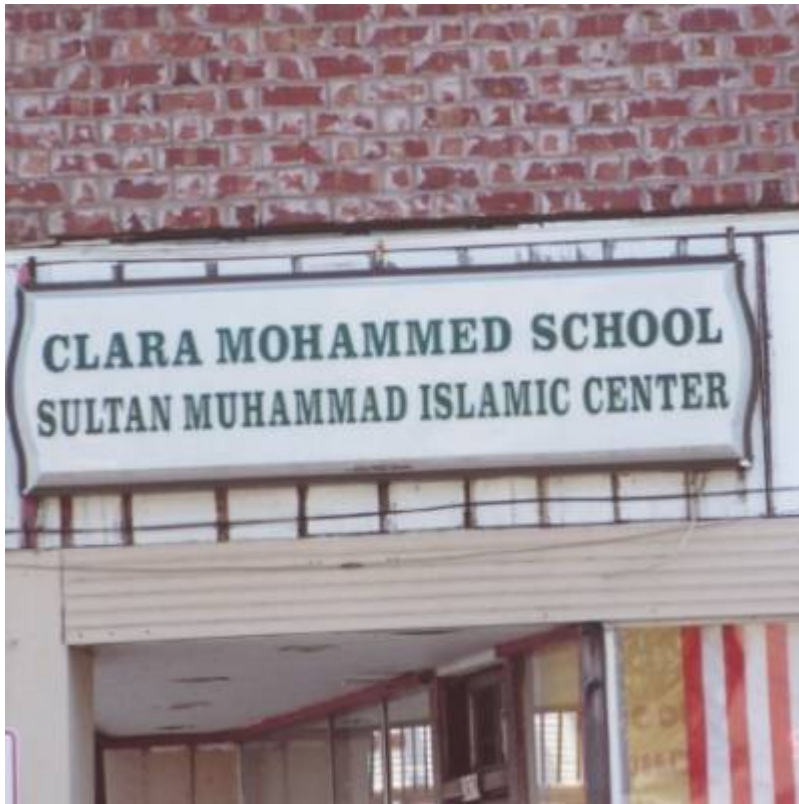
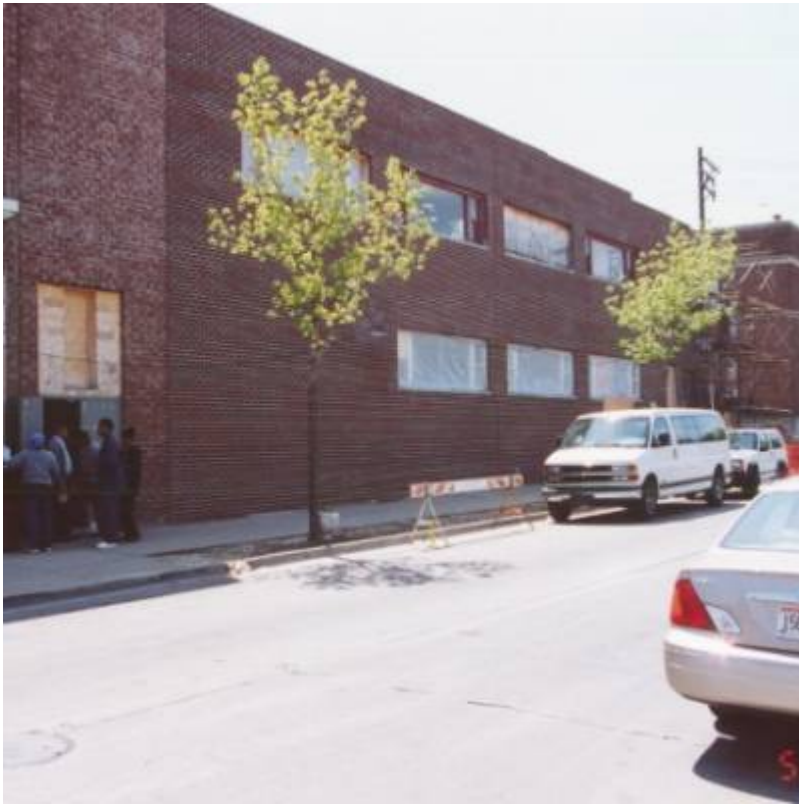
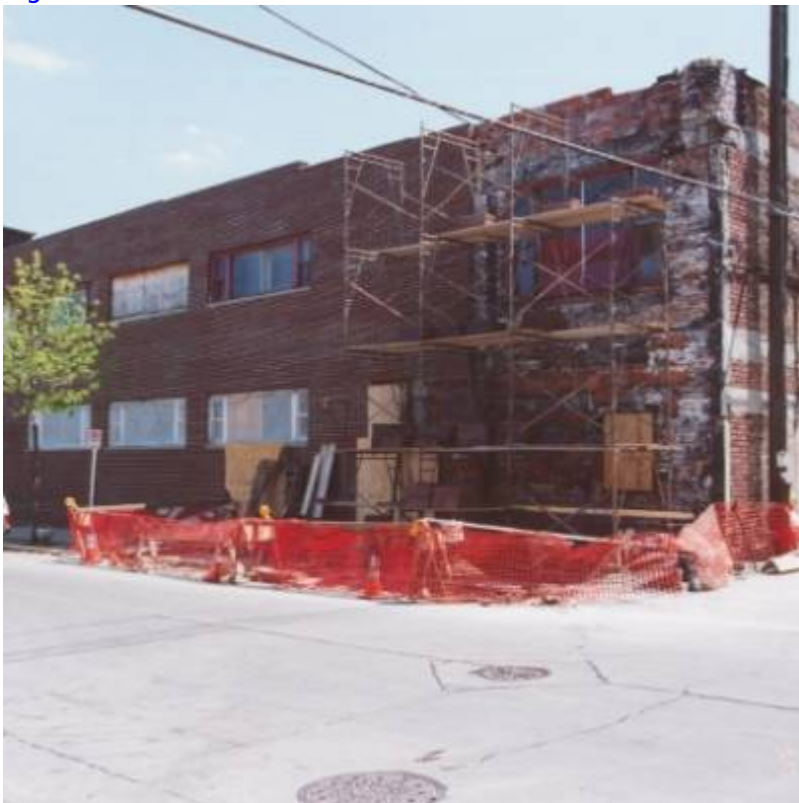
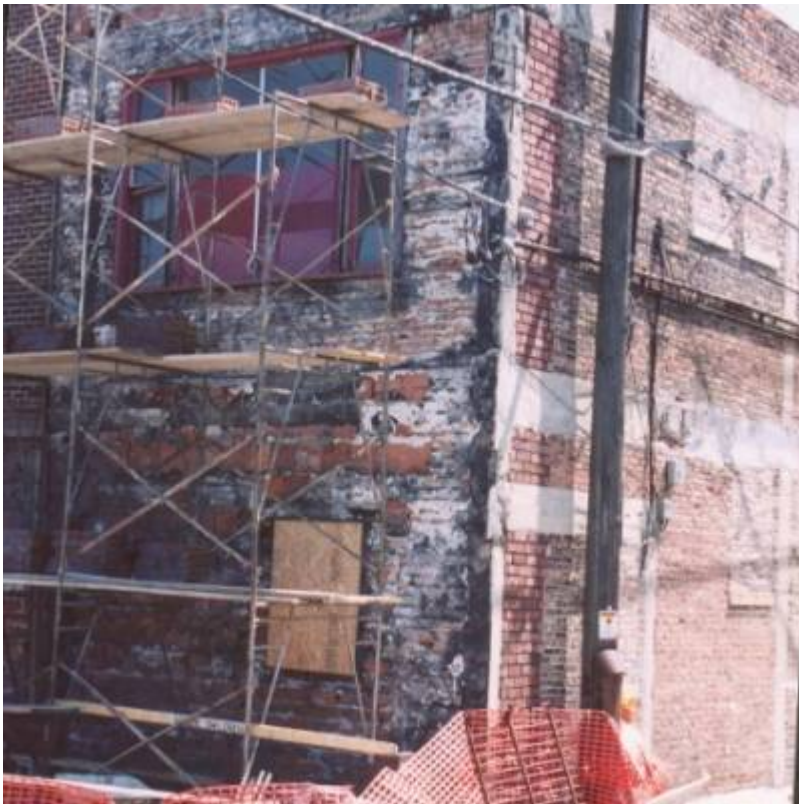
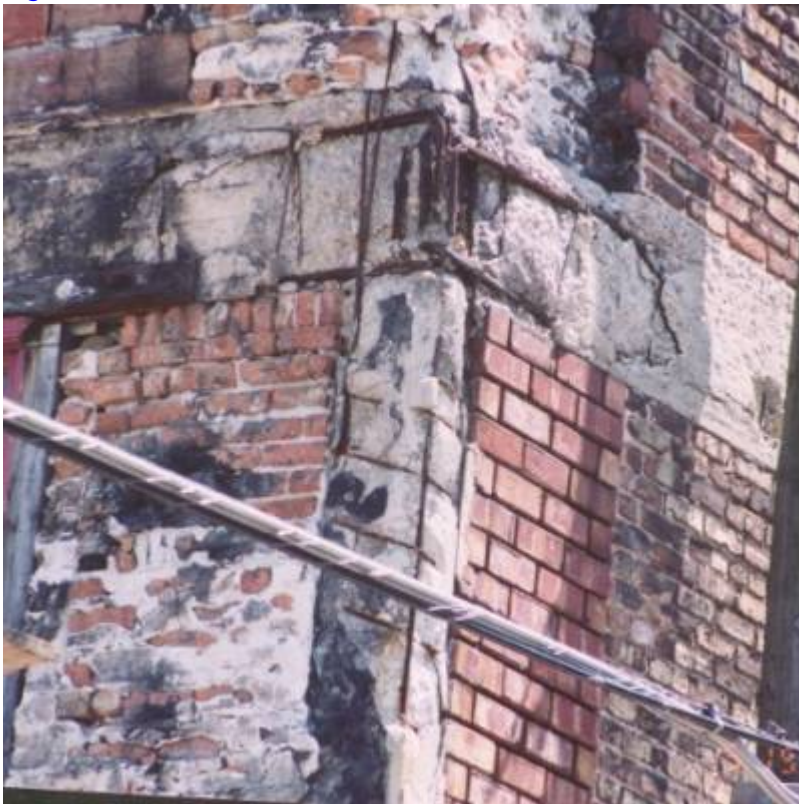
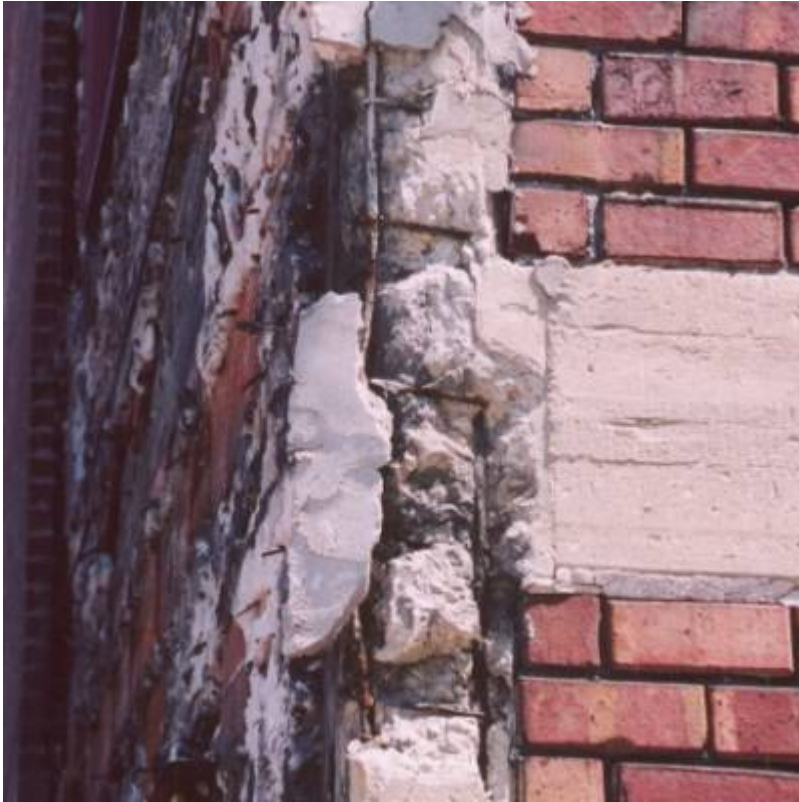
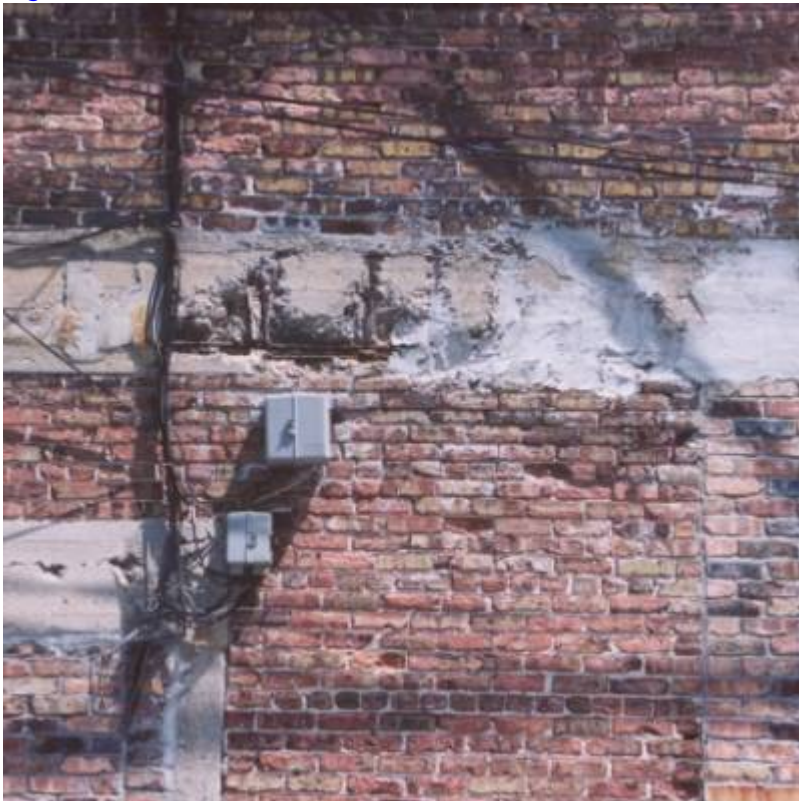
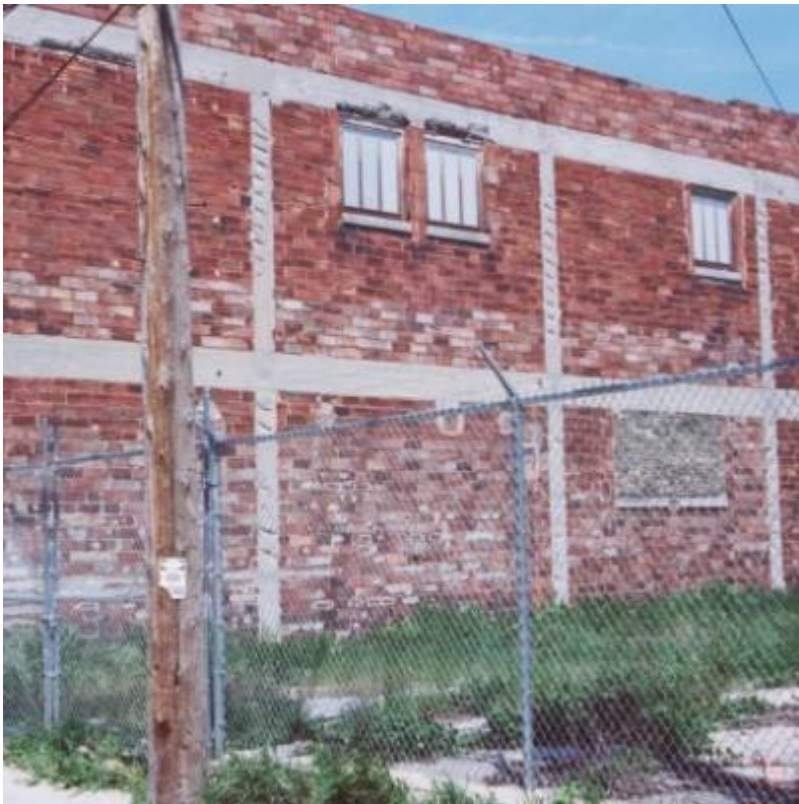
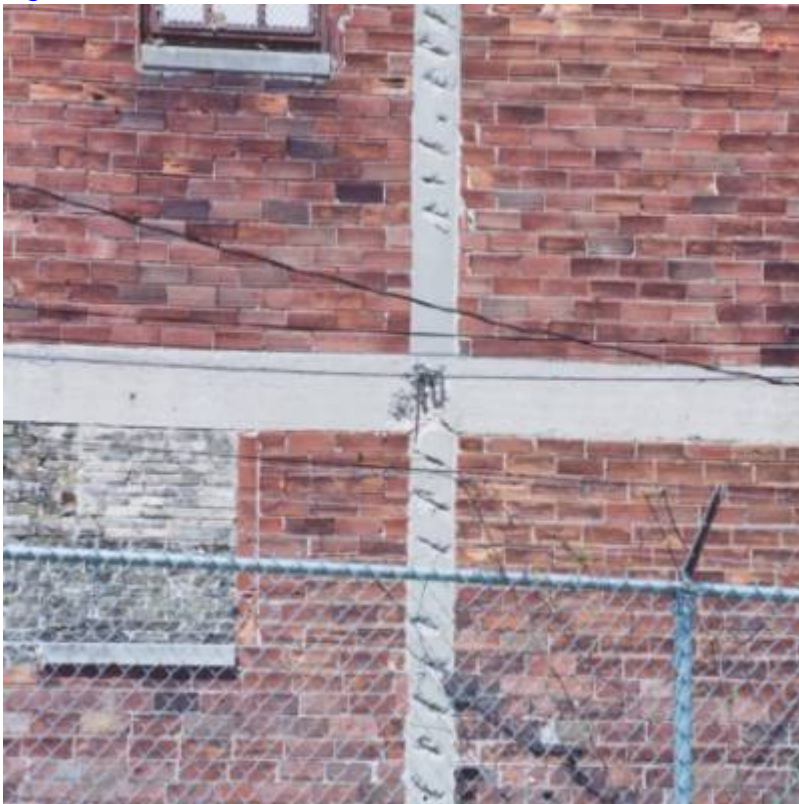
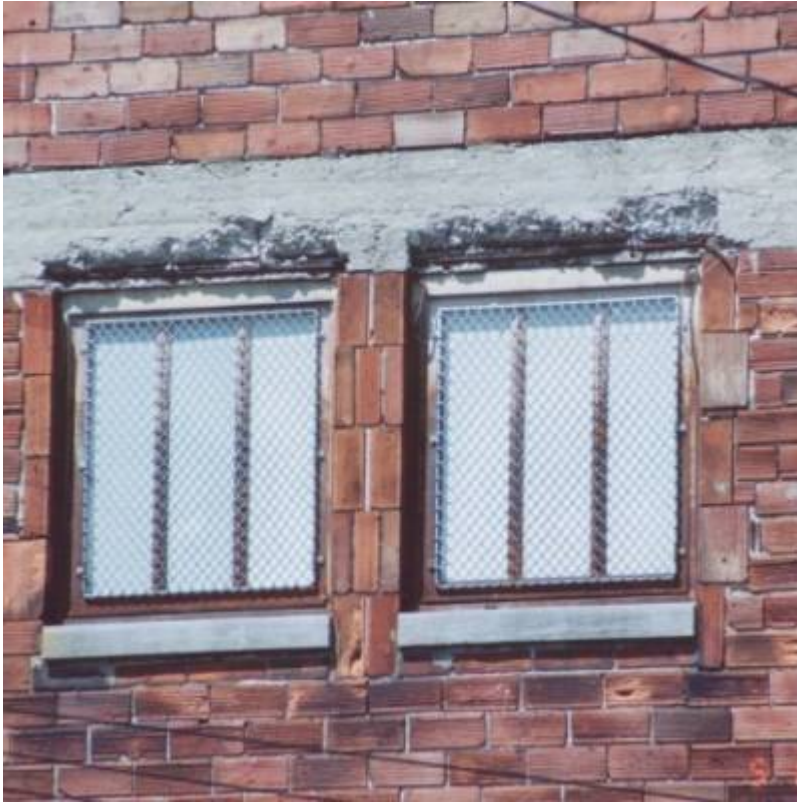
A one-hundred plus year-old former factory now used as a school has seen severe deterioration of its concrete frame over the years. Two sides of the structural frame have been totally exposed to the elements and the remaining two sides had a brick veneer over it. Corrosion of the reinforcement and subsequent cracking and delamination of the concrete was evident in numerous places. Water penetration through cracks and holes in the masonry and corrosion of reinforcement placed too close to the surface contributed to the deterioration.

A program of restoration was recommended. It is important to maintain a building to keep structural deterioration in check.

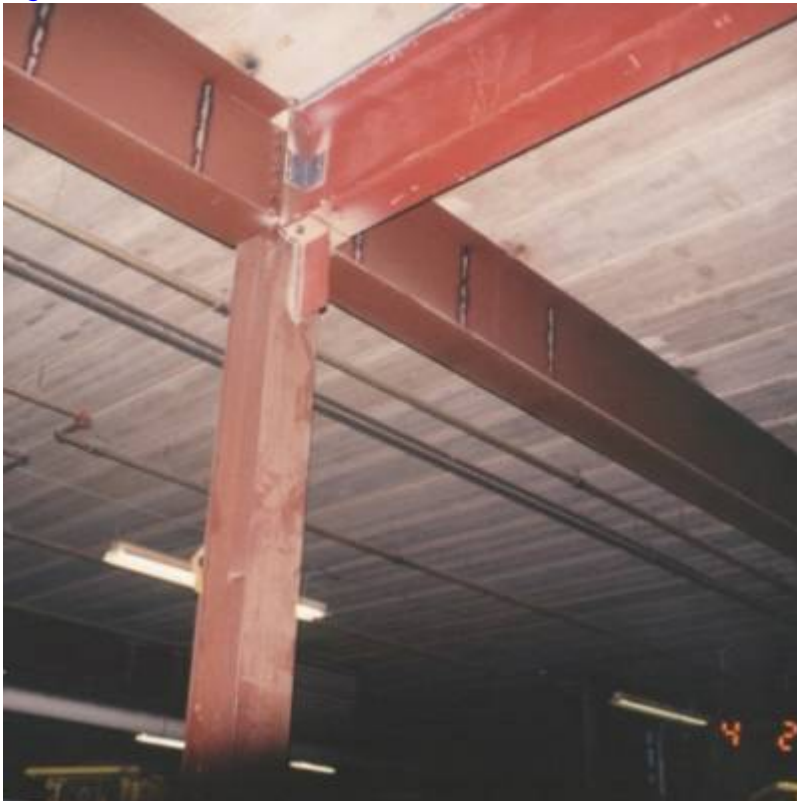
Fig. 4. Future Foam.

This industrial building's structural framing system was comprised of a pre-engineered steel frame and precast concrete floor slab. The owner, which recycles foam, wished to determine whether the second floor had any additional capacity for the companies operation. Well, not only did it not have any additional capacity, it's second floor beams were under-sized. As shown in Figure 4 stiffener plates were

added to these beams to bring their capacity up to the original prescribed design load of 100 psf.

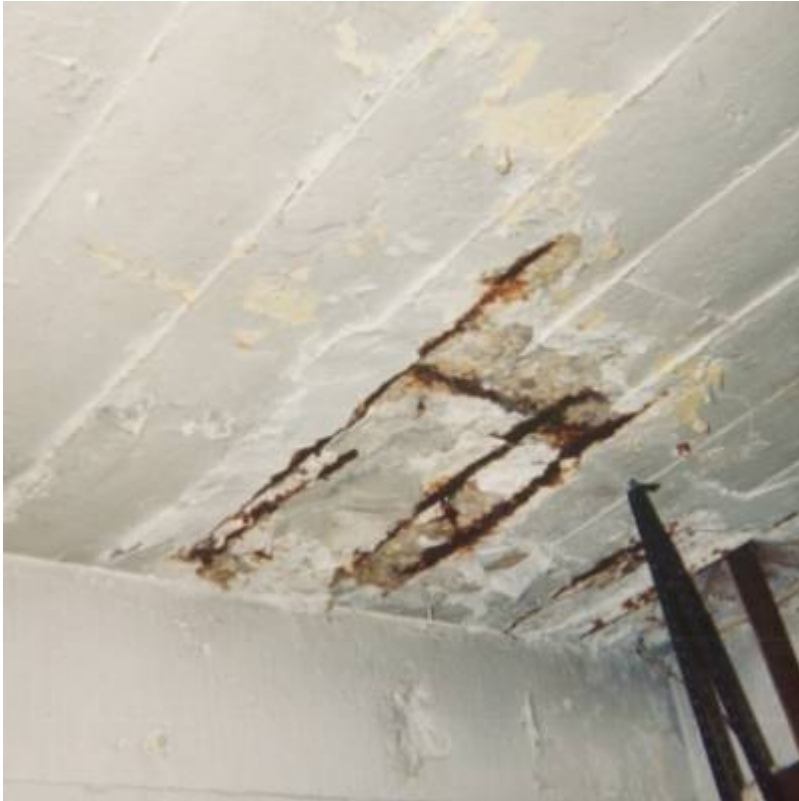
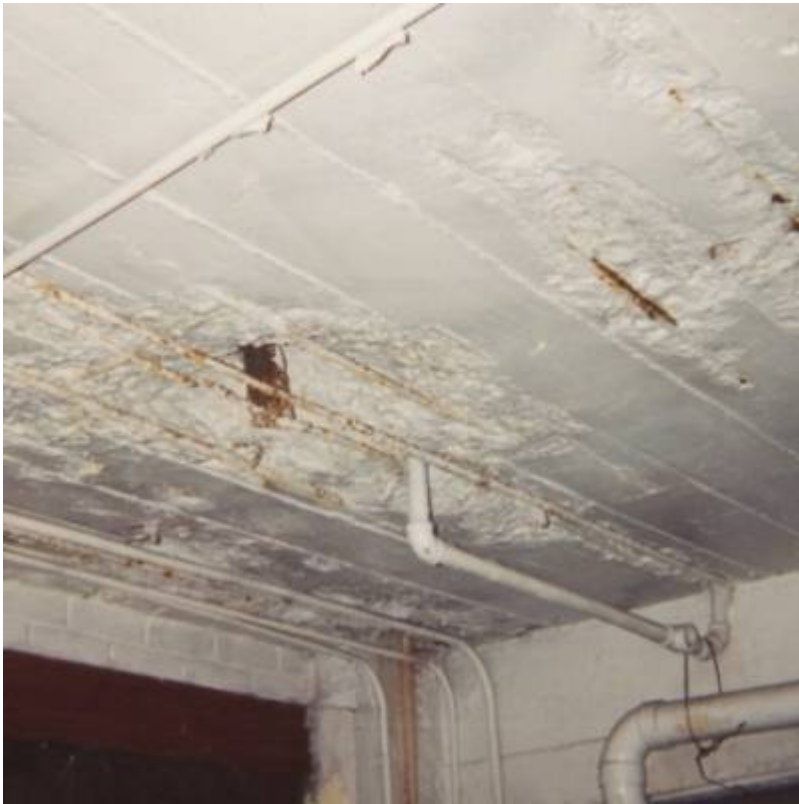
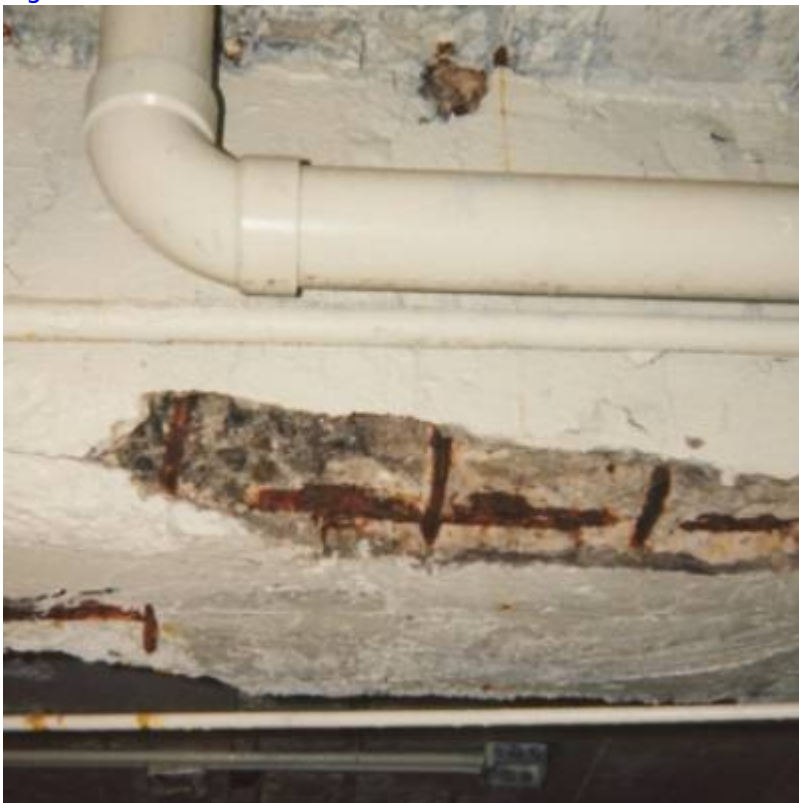
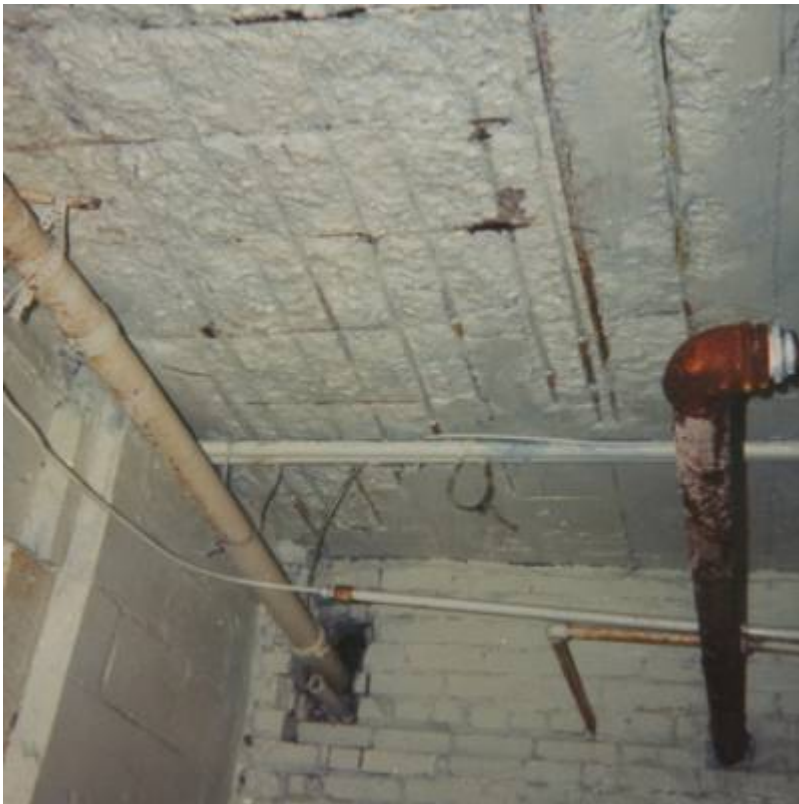
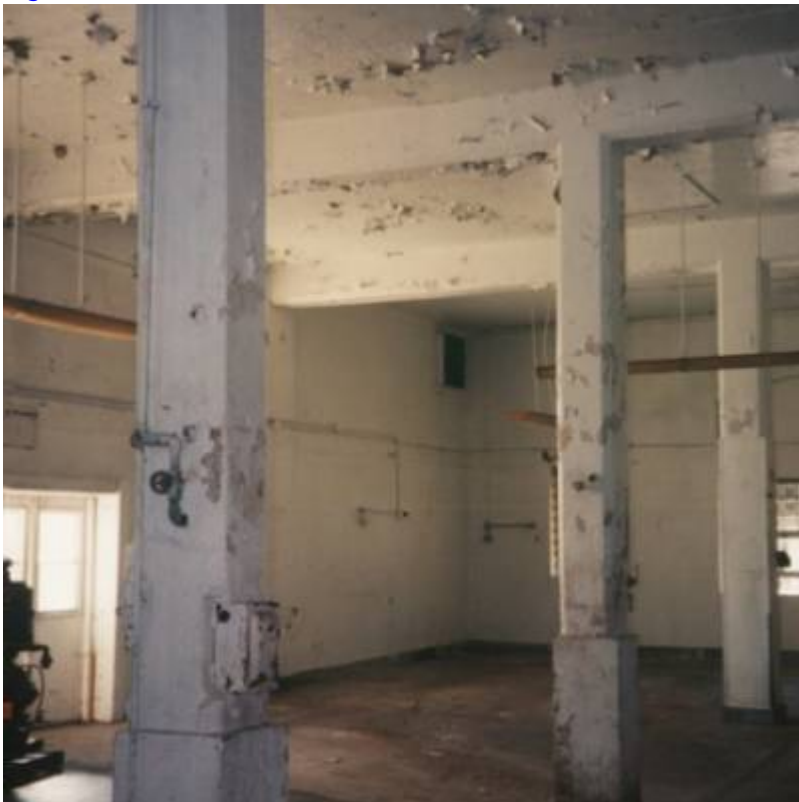
The first floor slab of this former dairy building showed extensive corrosion damage once all the insulation was removed from the ceiling below it. It was quite a shock to the new owners who wished to turn it into a brew pub. The solution for this project was to abandon the deteriorated floor slab, repair and

strengthen the floor beams and span between them with a concrete topped metal deck.

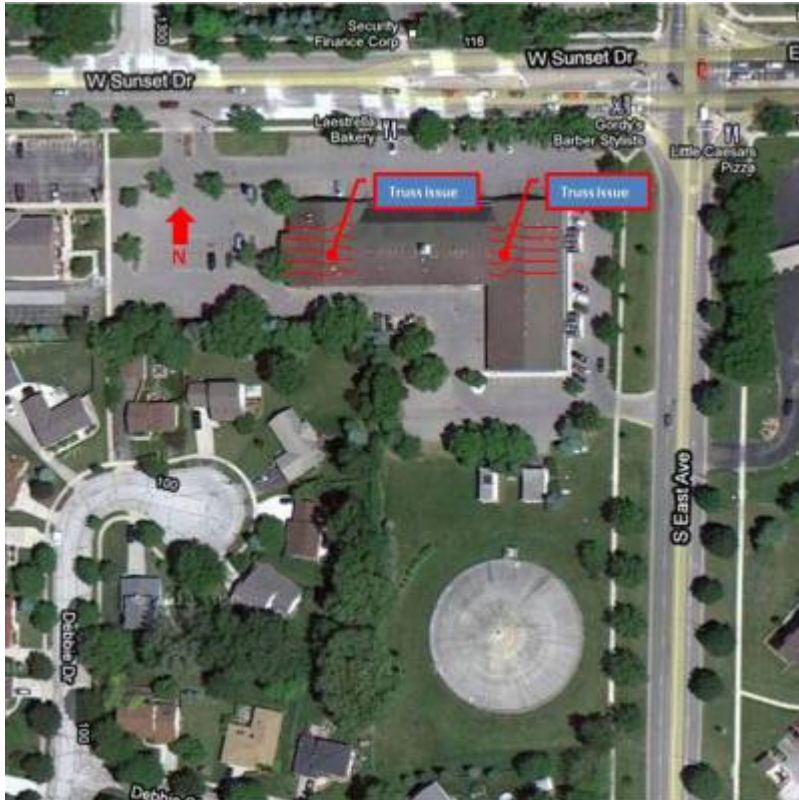
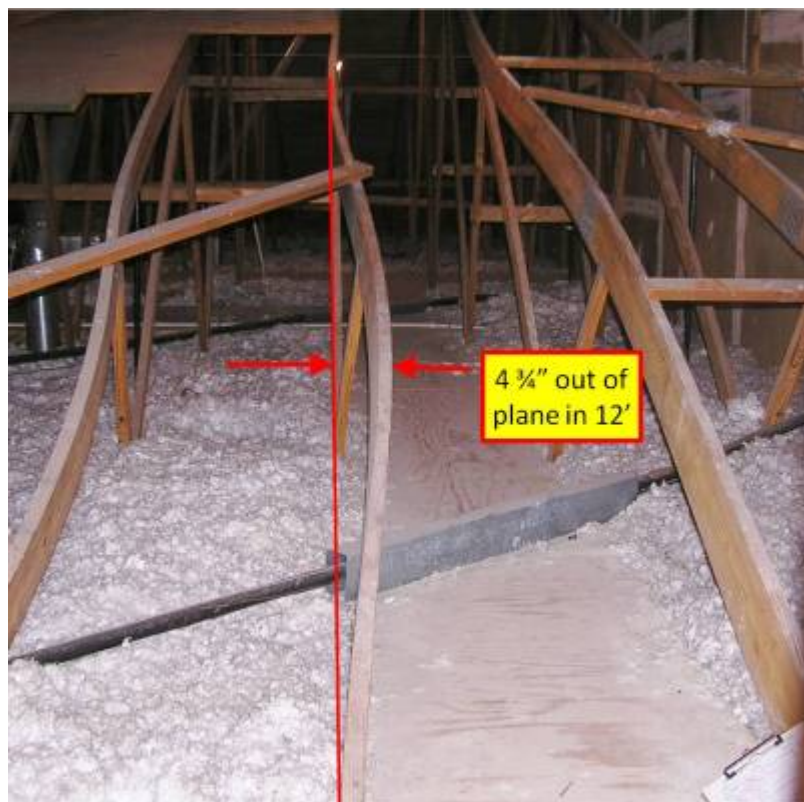
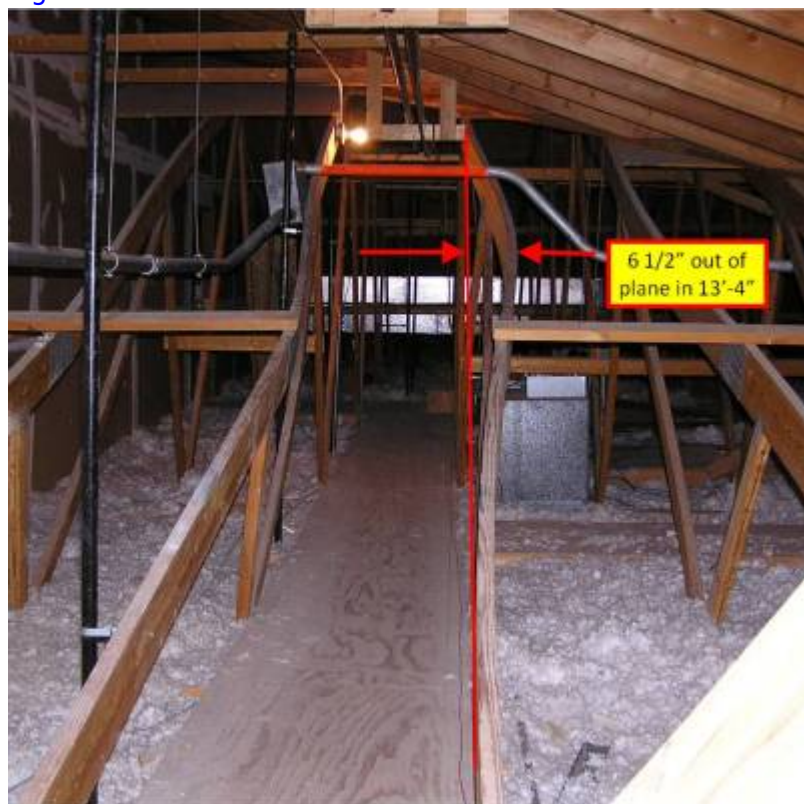
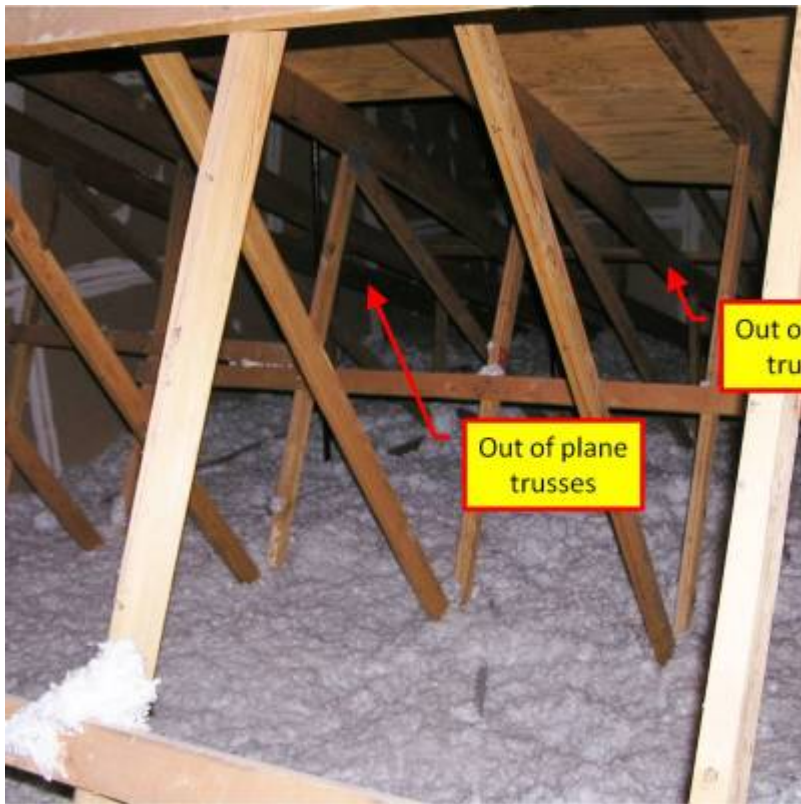
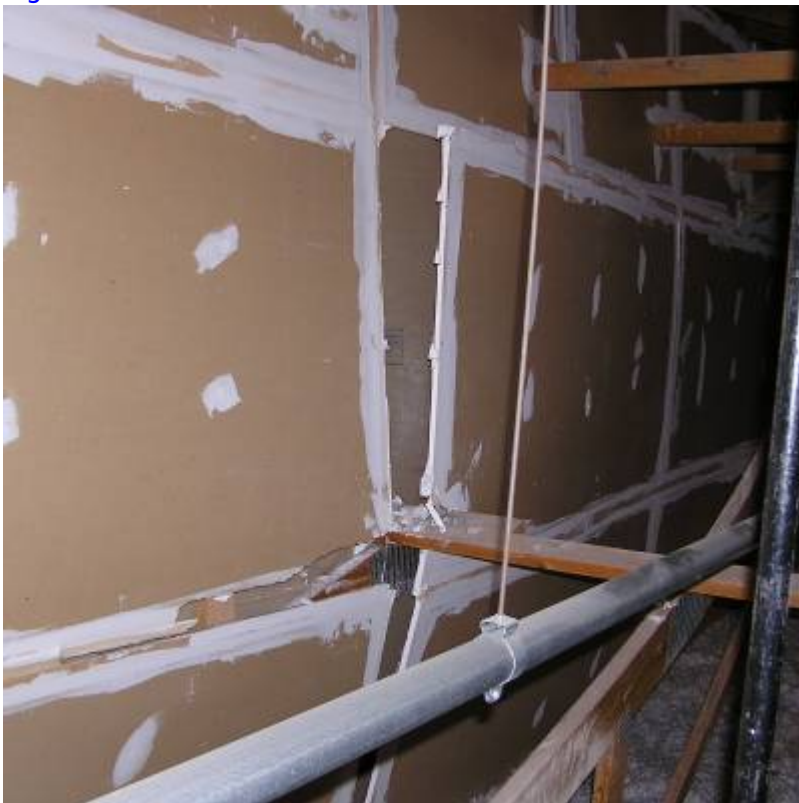
While investigating this strip mall's roof capacity for mechanical equipment added by a restaurant tenant an alarming discovery was made. It was discovered that errors made during construction by not providing the required permanent bracing in certain areas for the roof trusses caused them to deflect out-of-line. Over the years the top chords of these trusses, which should remain in a straight line had

deflected severely out-of-line.

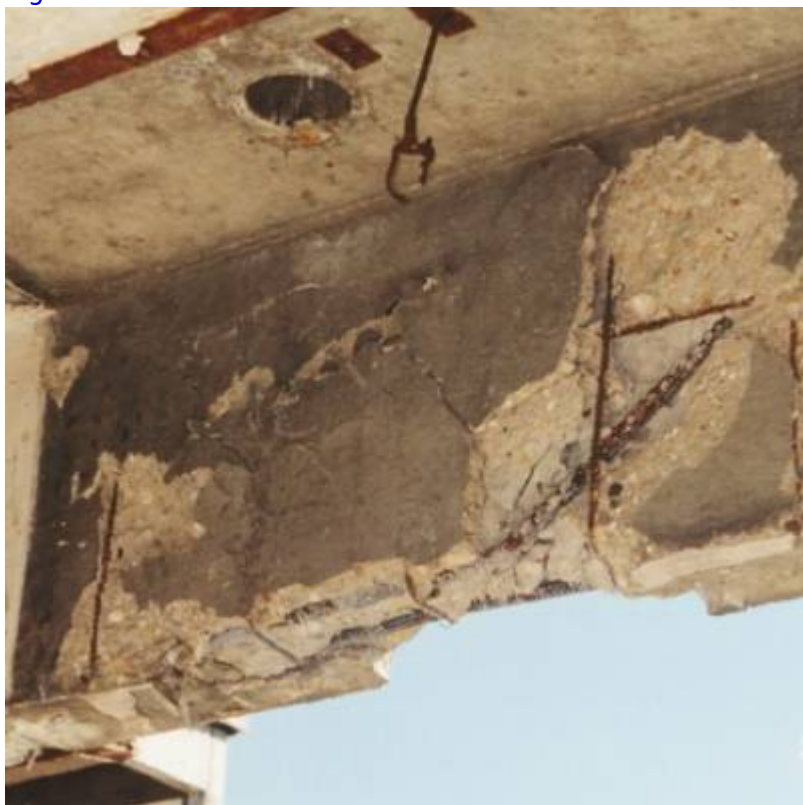
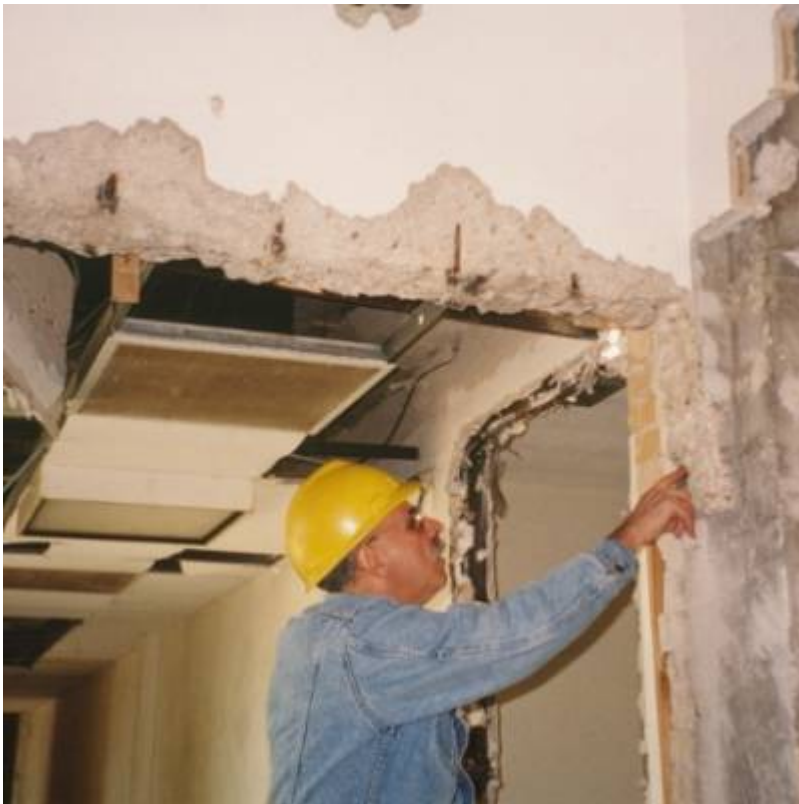
Damage to the concrete frame as a result of deterioration, previous remodeling projects or accidents during demolition may occur. Restoration of these elements helps ensure the continued "health" of the structure (Figures 6 and 7).
