# COMMERCIAL STRUCTURE INVESTIGATIONS

A number of structural system investigations shown in the galleries below are of buildings framed using concrete. Damage to the concrete frame and slab system may be the result of a corrosive interior or exterior environment, poor workmanship, previous remodeling projects or structural failure.

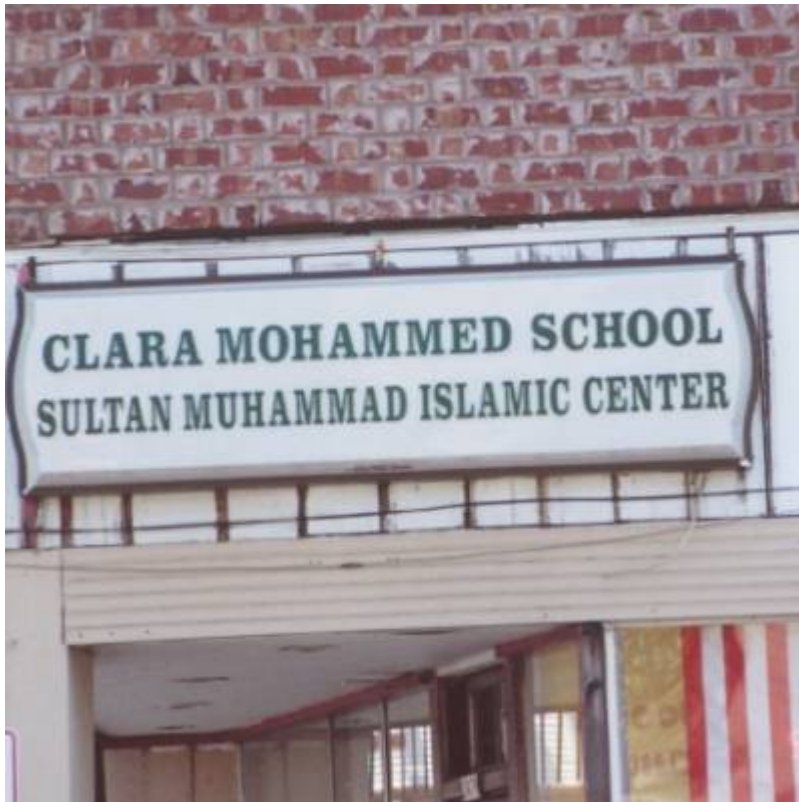
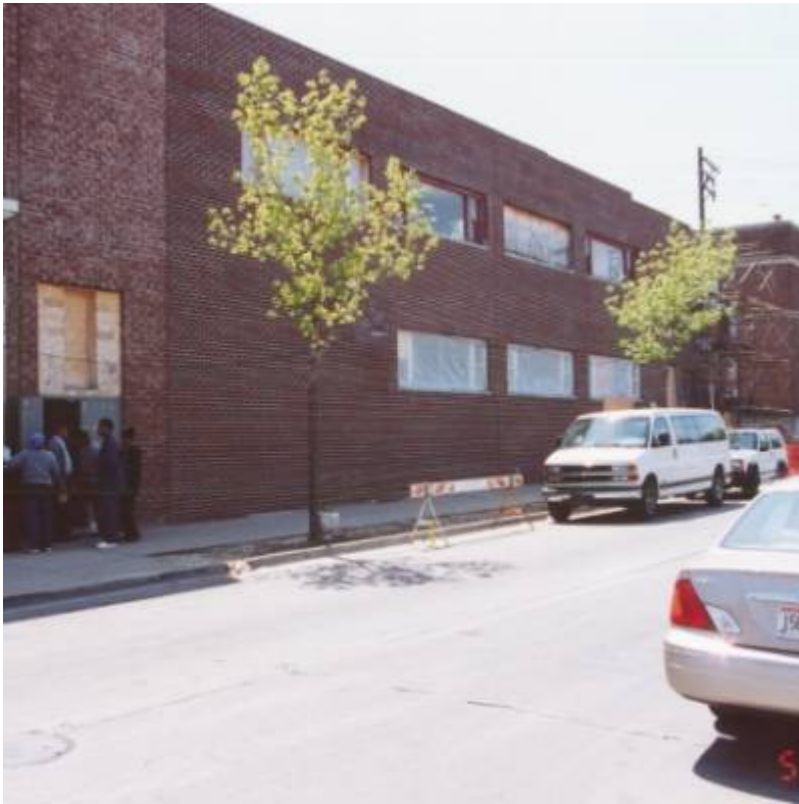
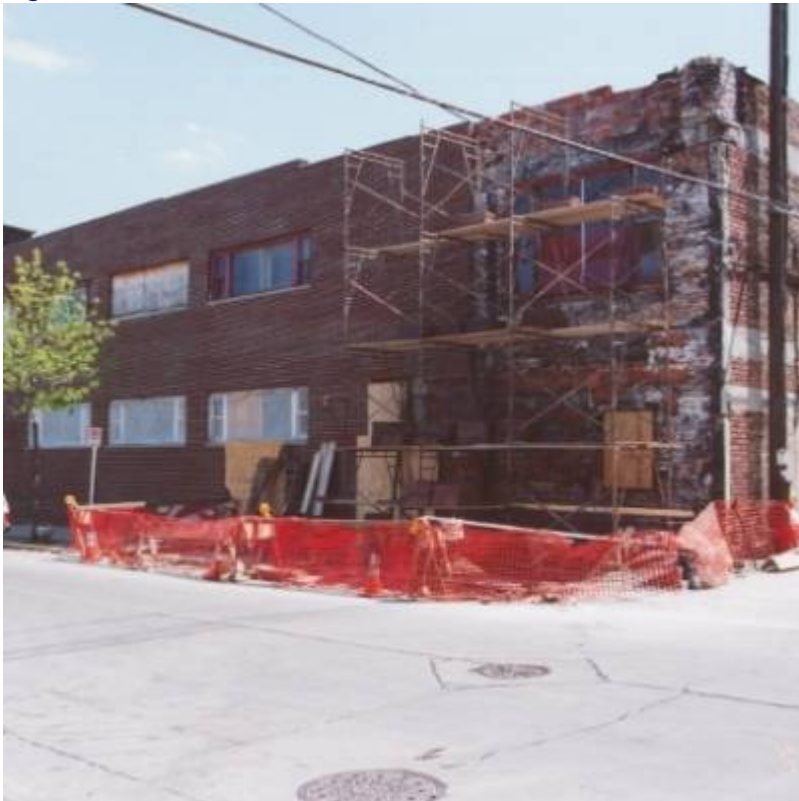
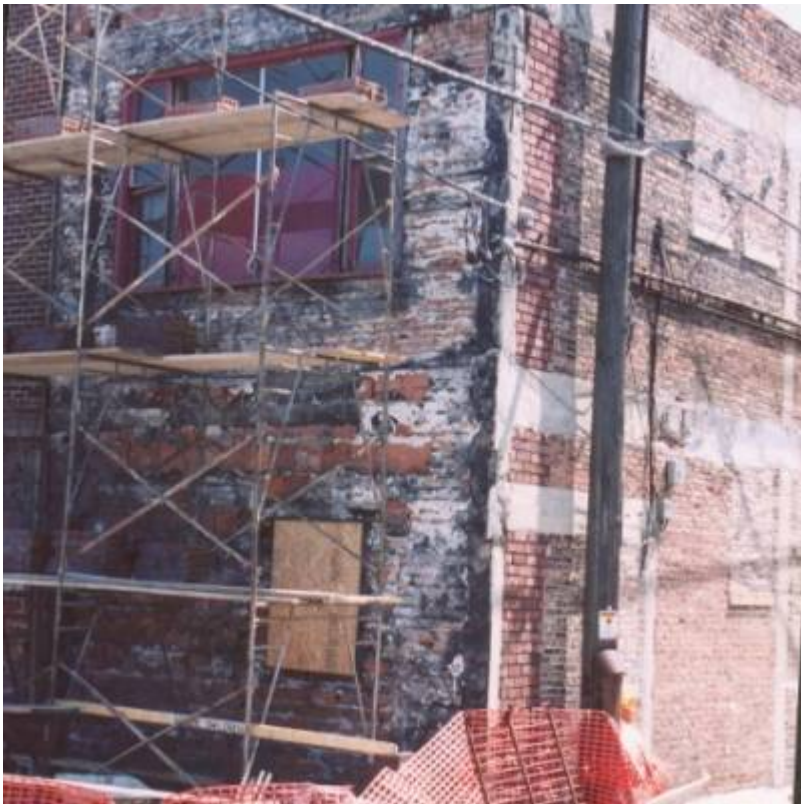
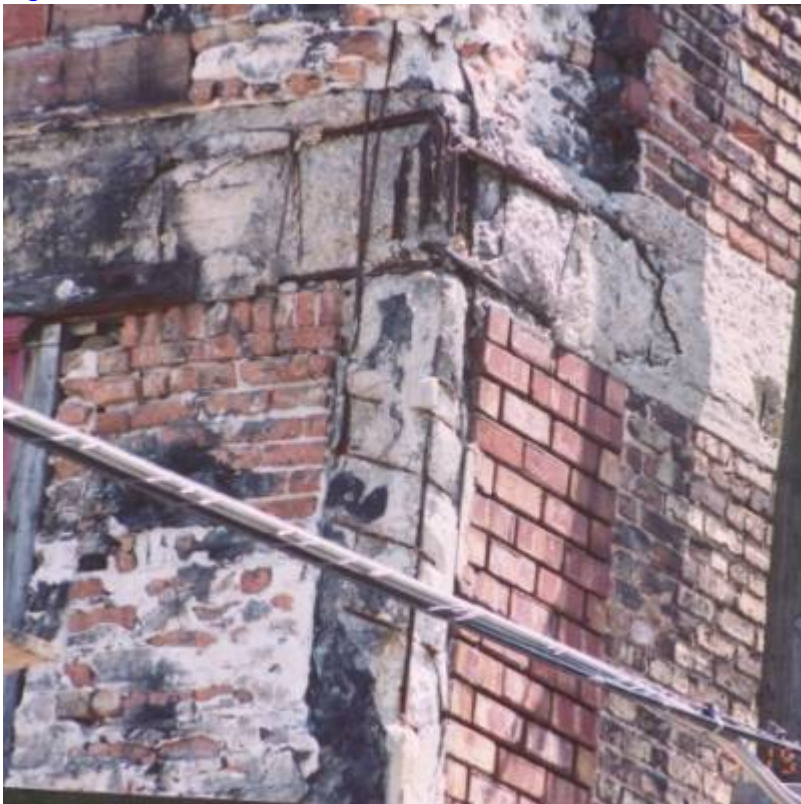
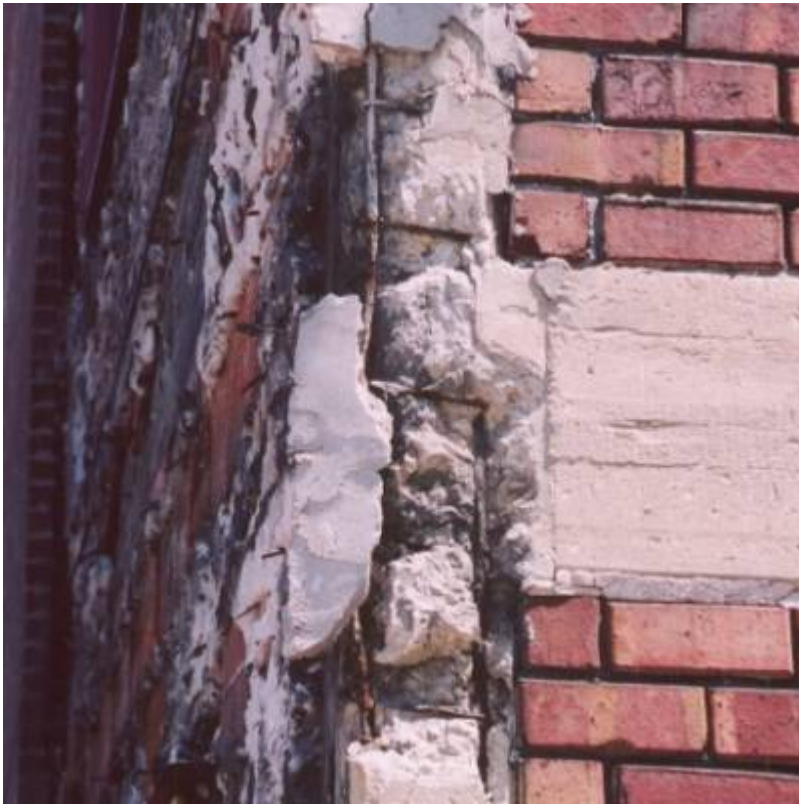
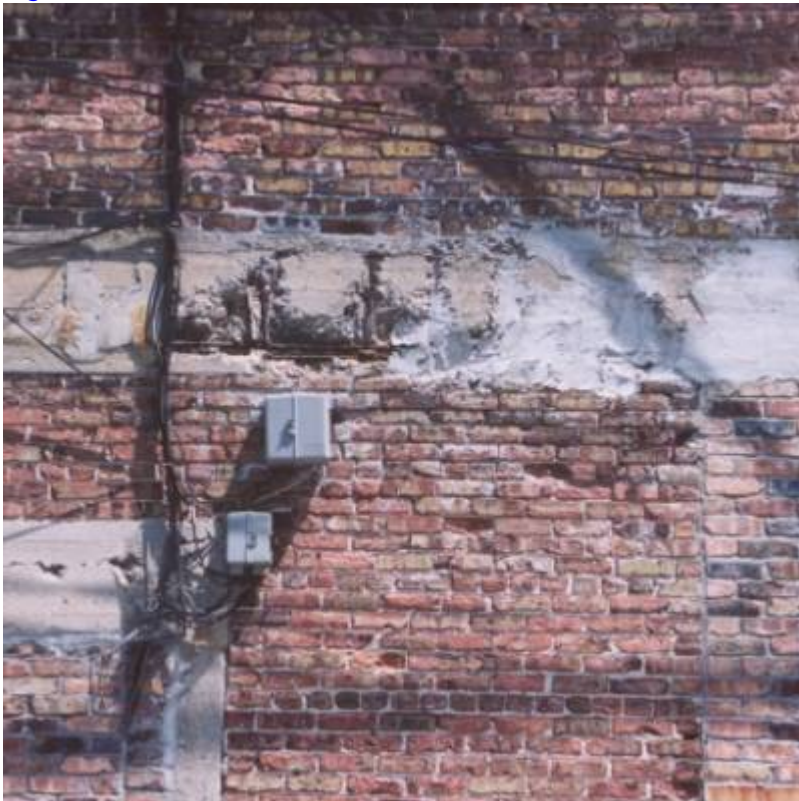
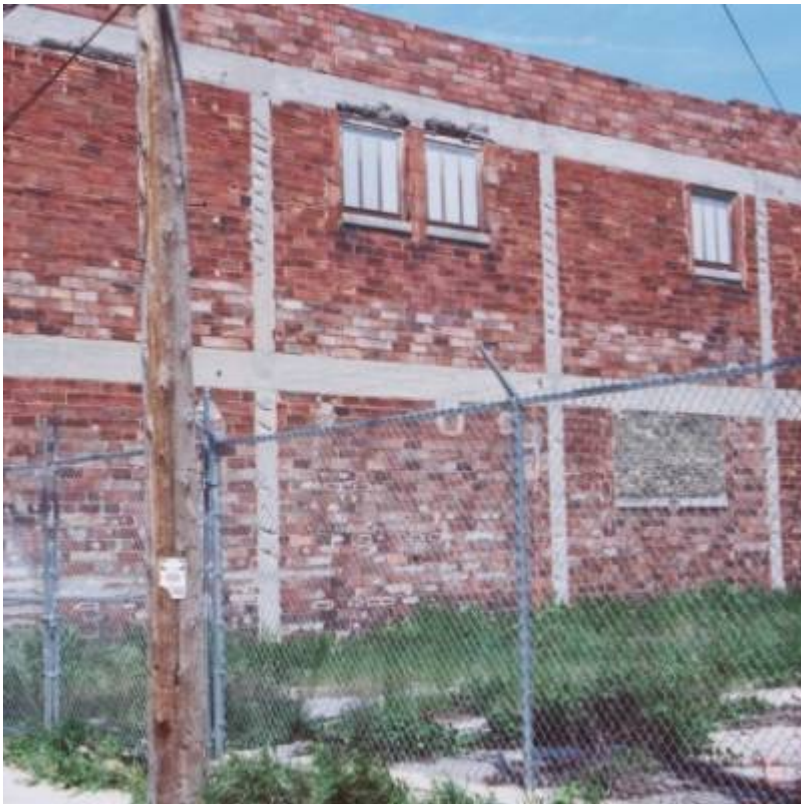
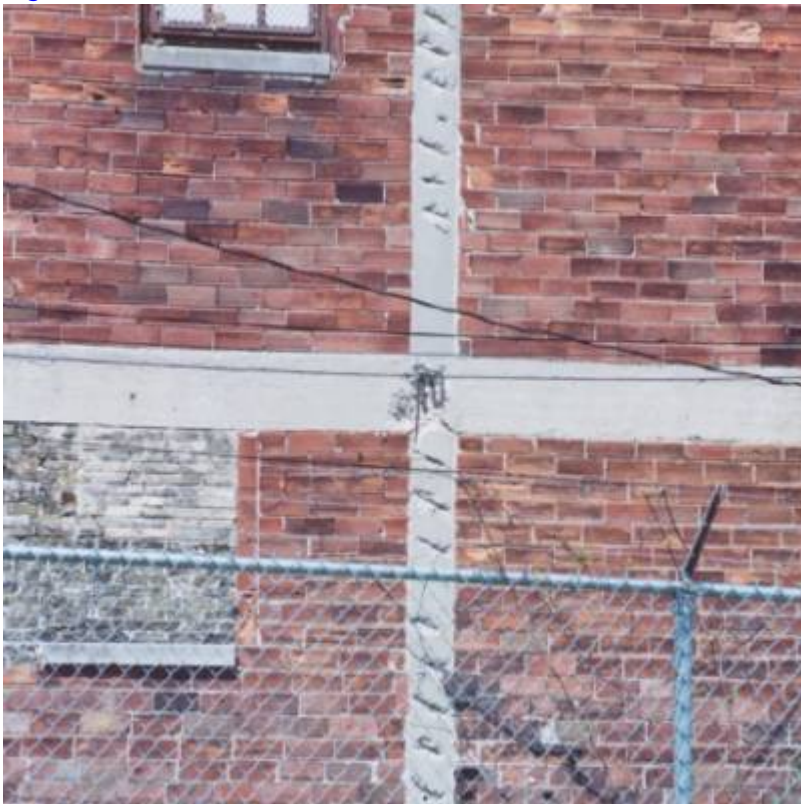
A one-hundred plus year-old former factory now used as a school has seen severe deterioration of its concrete frame over the years. Two sides of the structural frame have been totally exposed to the elements and the remaining two sides had a brick veneer over it. Corrosion of the reinforcement and subsequent cracking and delamination of the concrete was evident in numerous places. Water penetration through cracks and holes in the masonry and corrosion of reinforcement placed too close to the surface contributed to the deterioration.

Once a concrete frame has undergone such severe deterioration its strength can be greatly impaired. A program of investigation, documentation, field observations, testing, evaluation and reporting followed by rehabilitation becomes imperative. Several recommended repair details are shown below.

A program of restoration was recommended. It is important to maintain a building to keep structural deterioration in check.

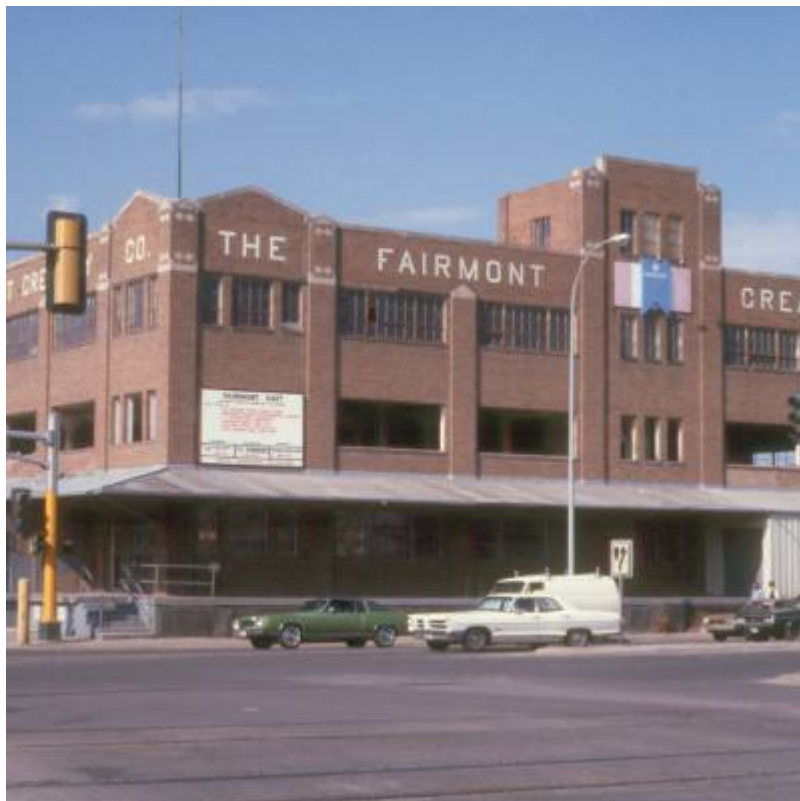
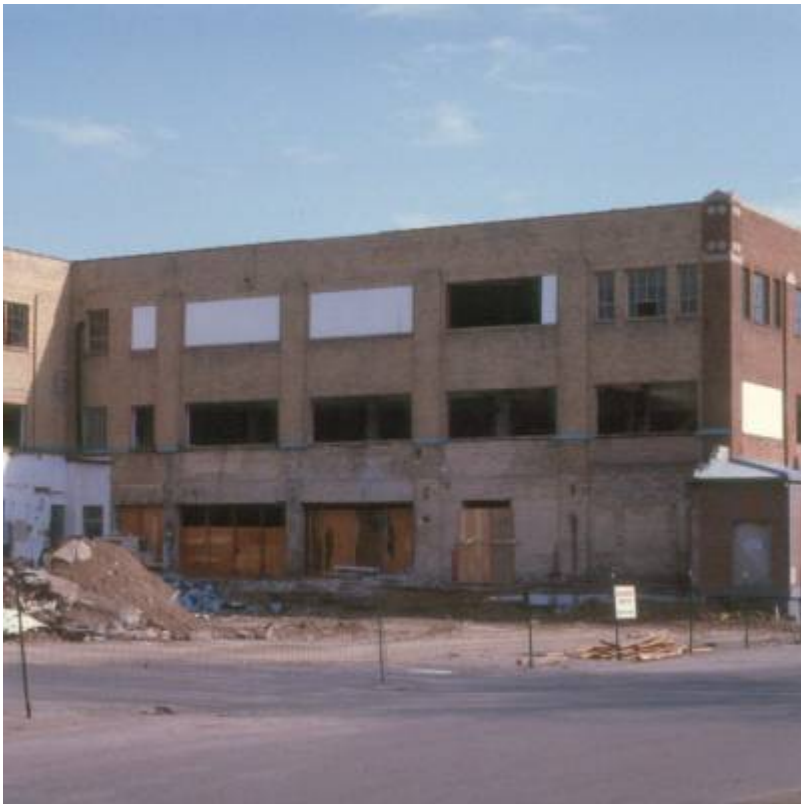
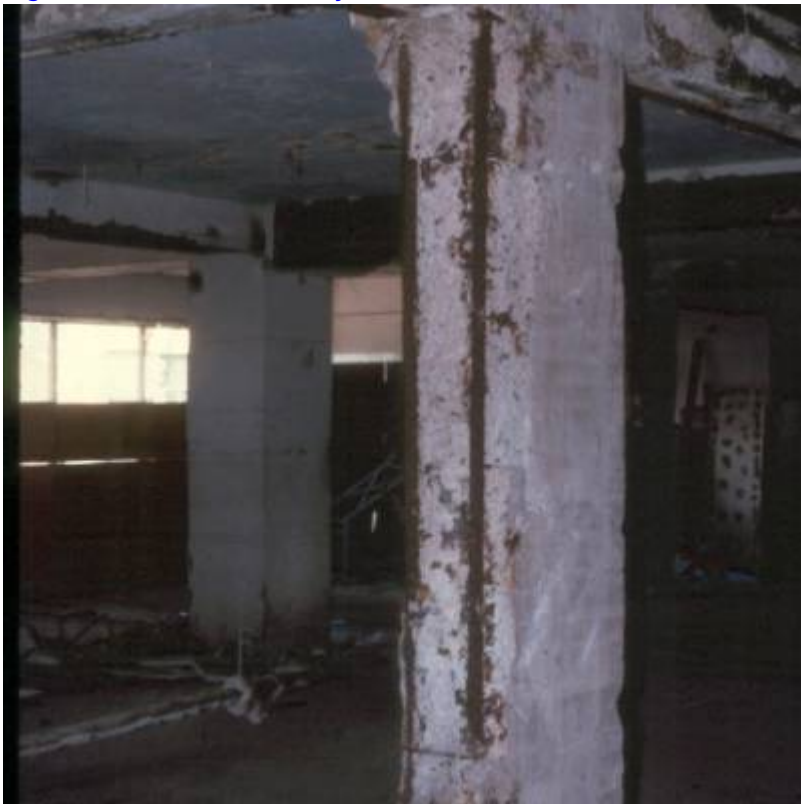
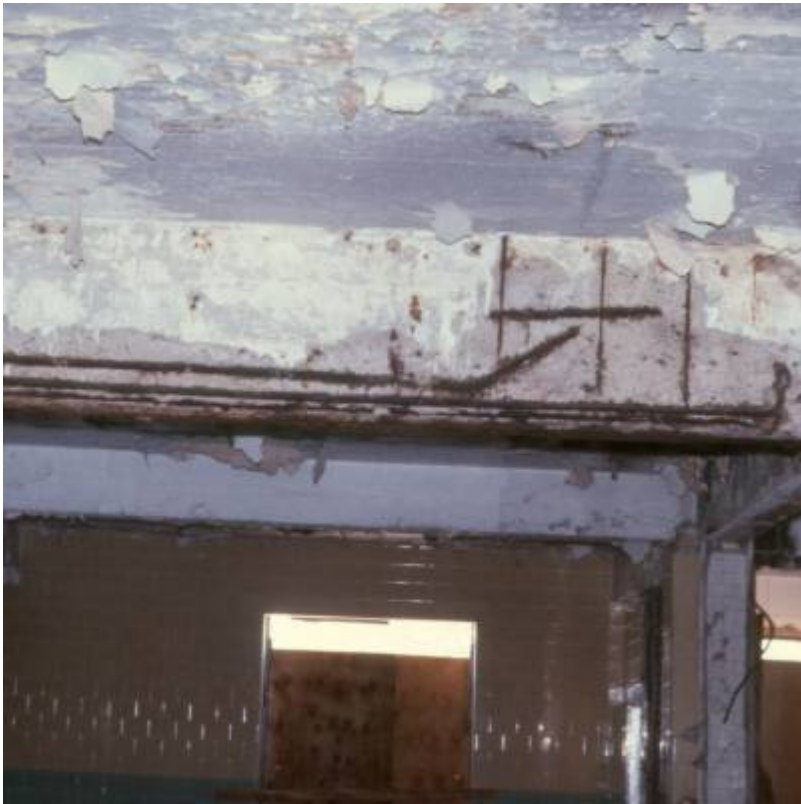
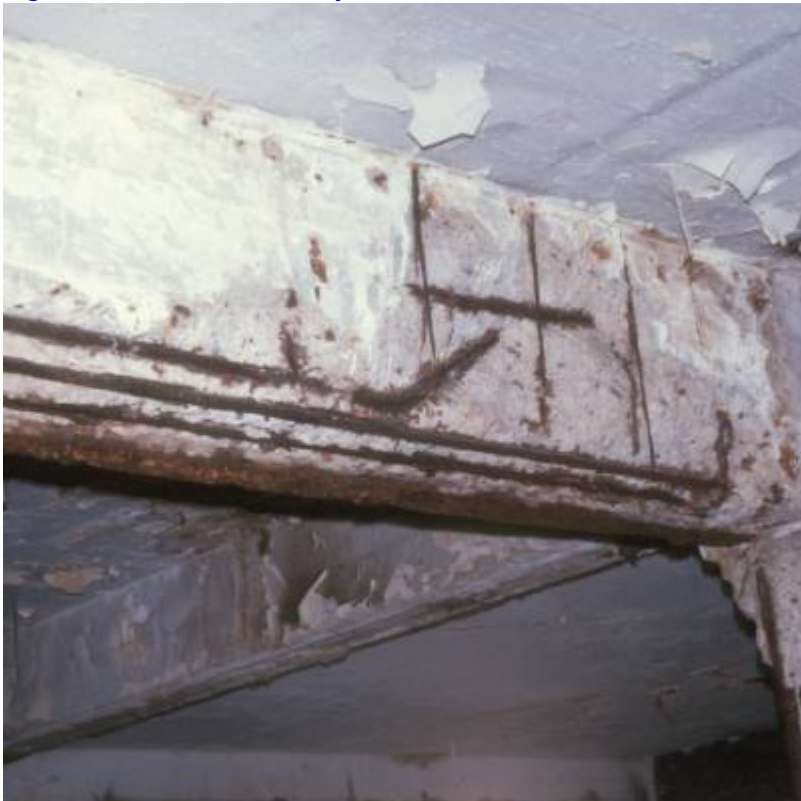
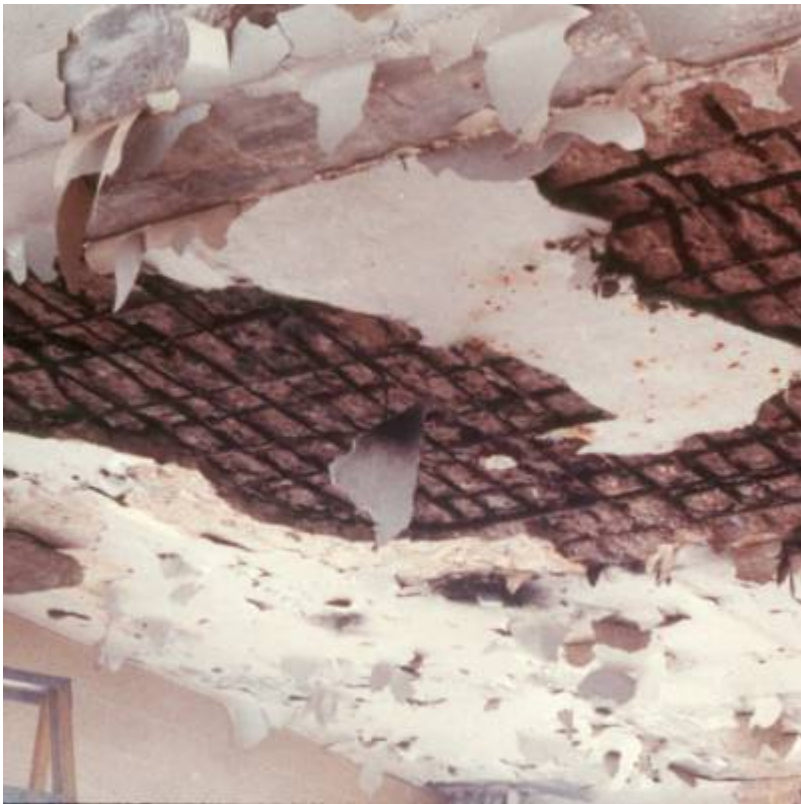
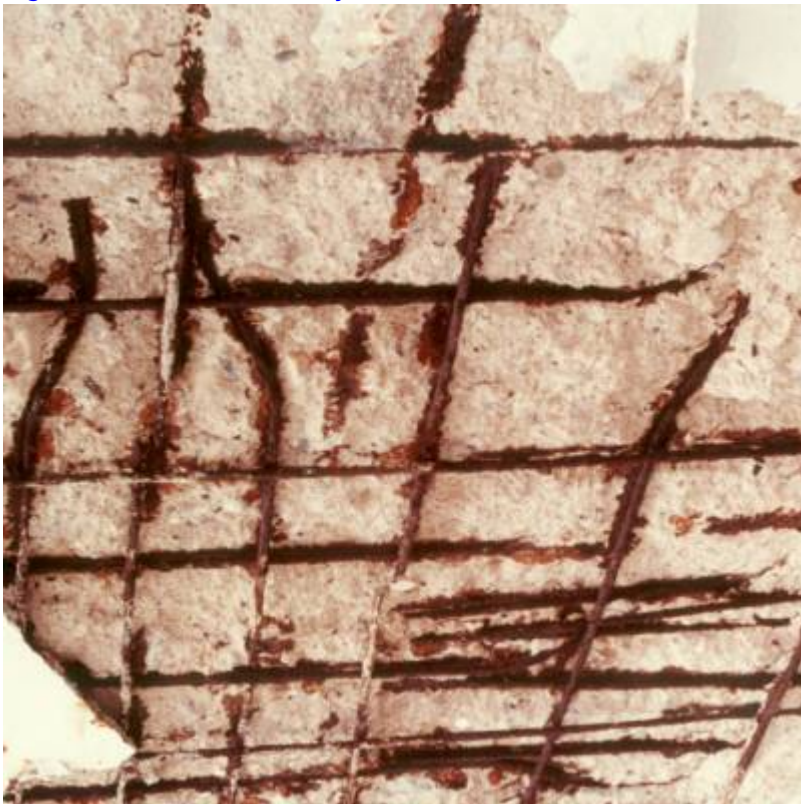
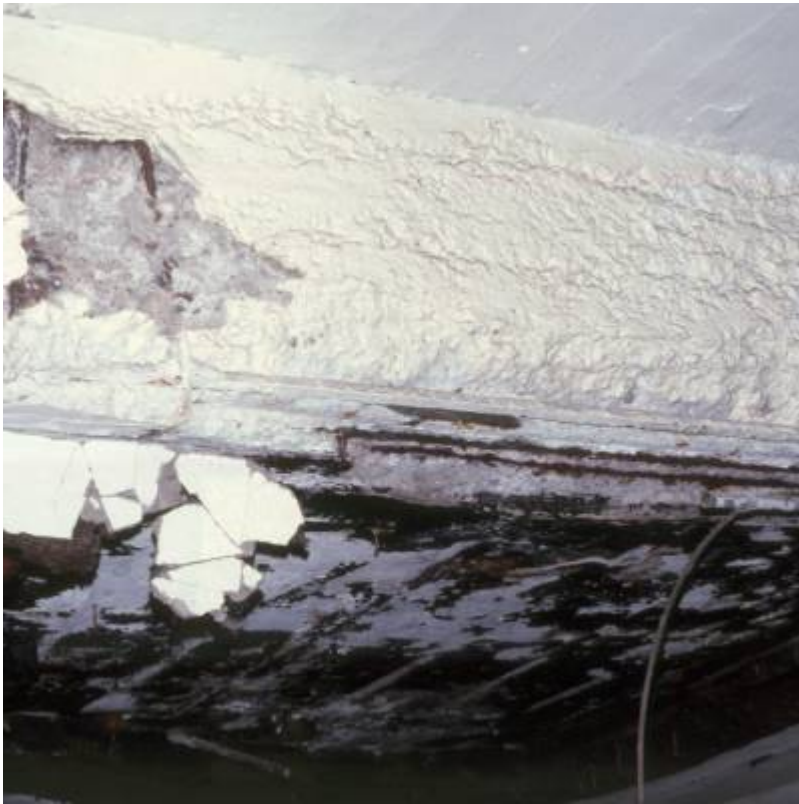
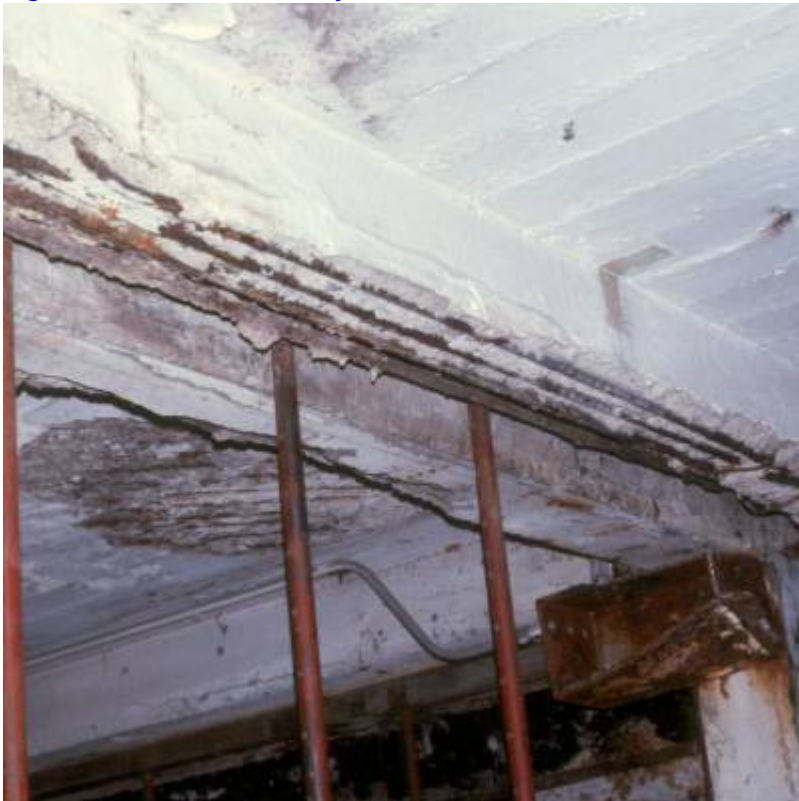
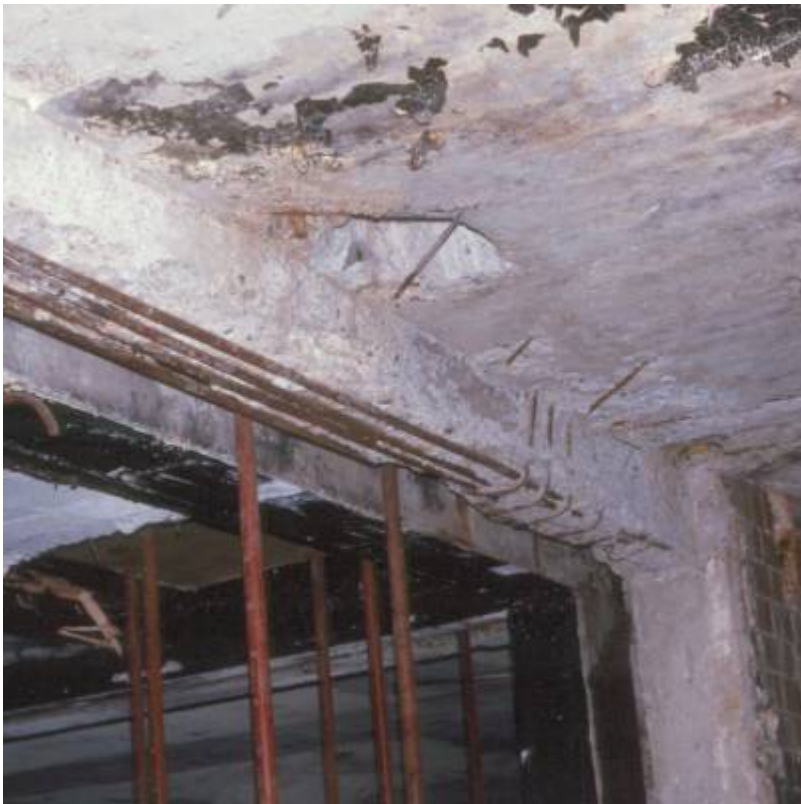
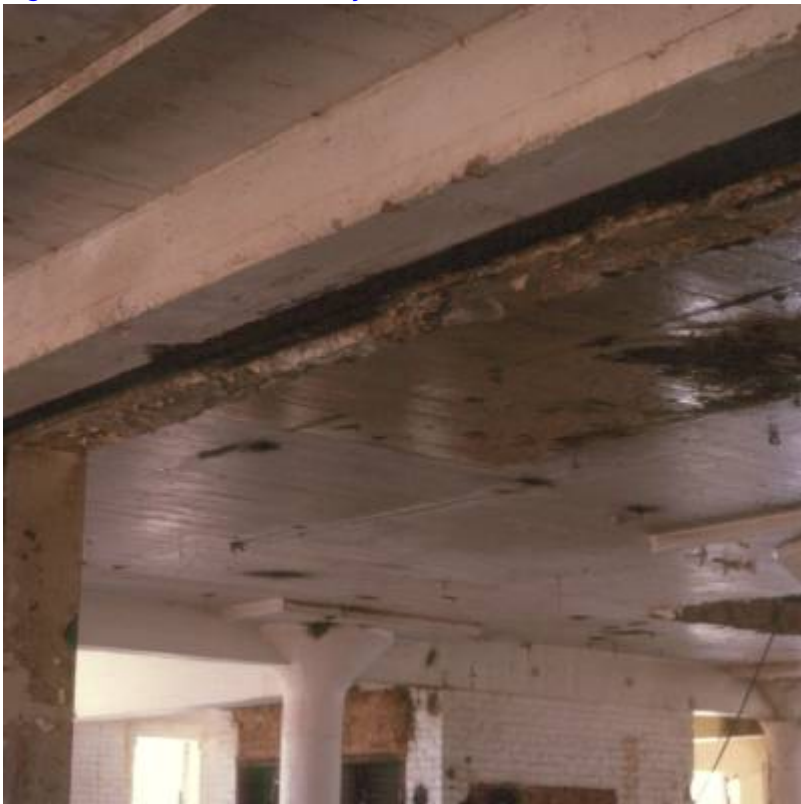
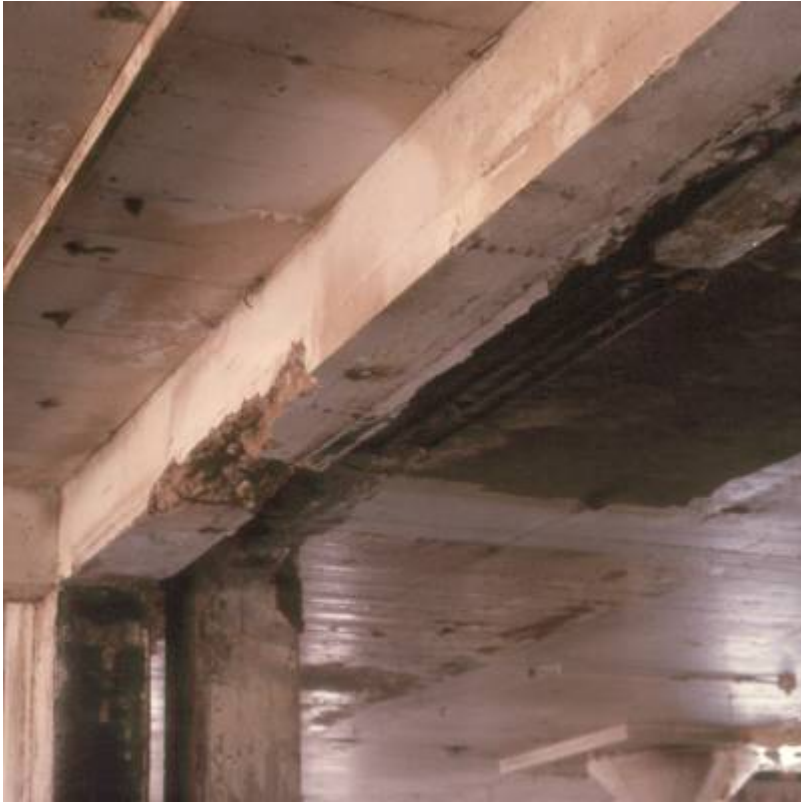
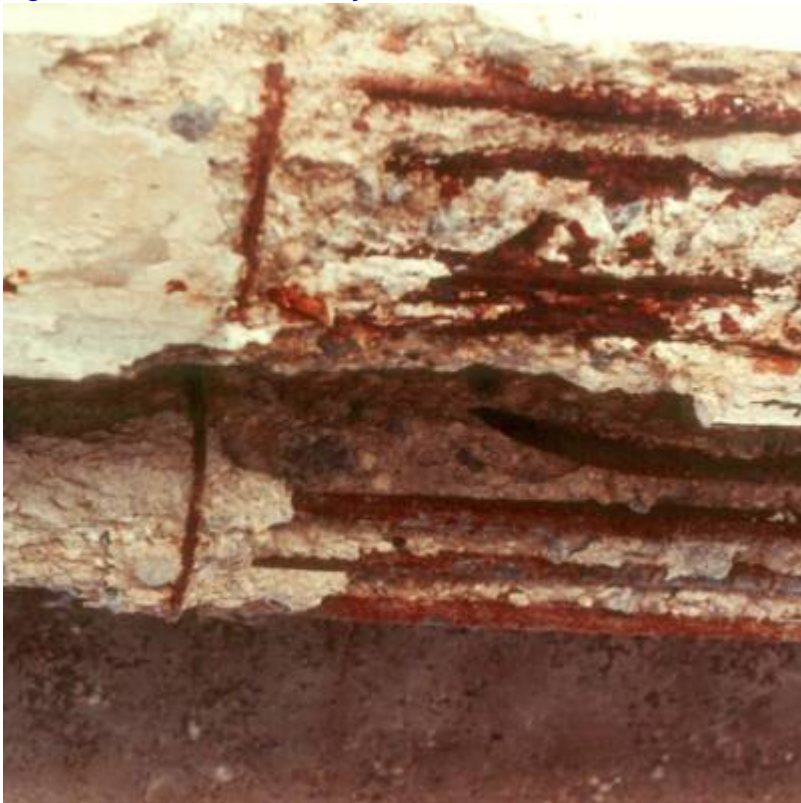
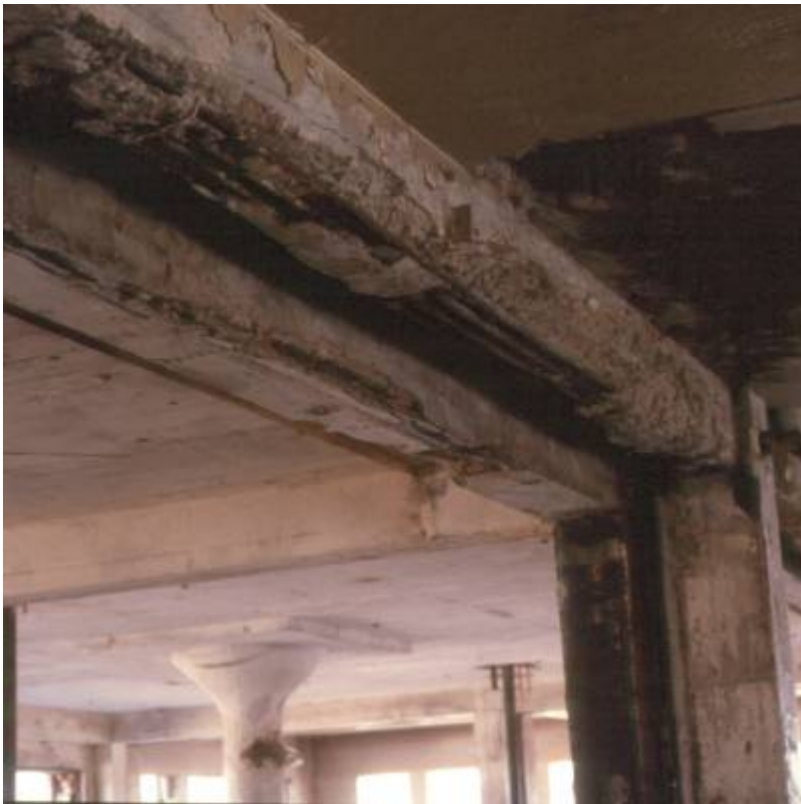
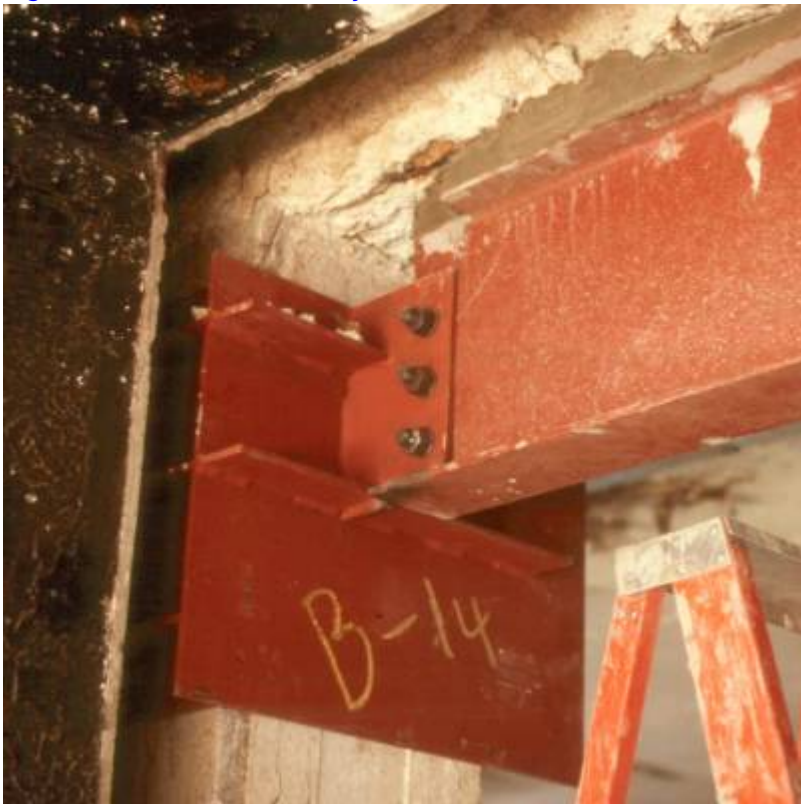
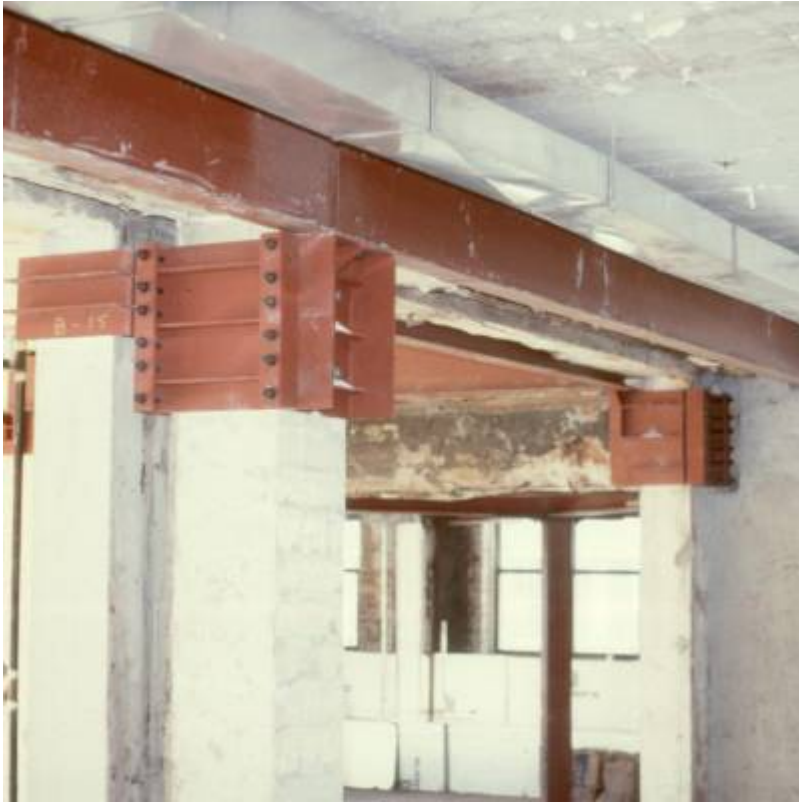
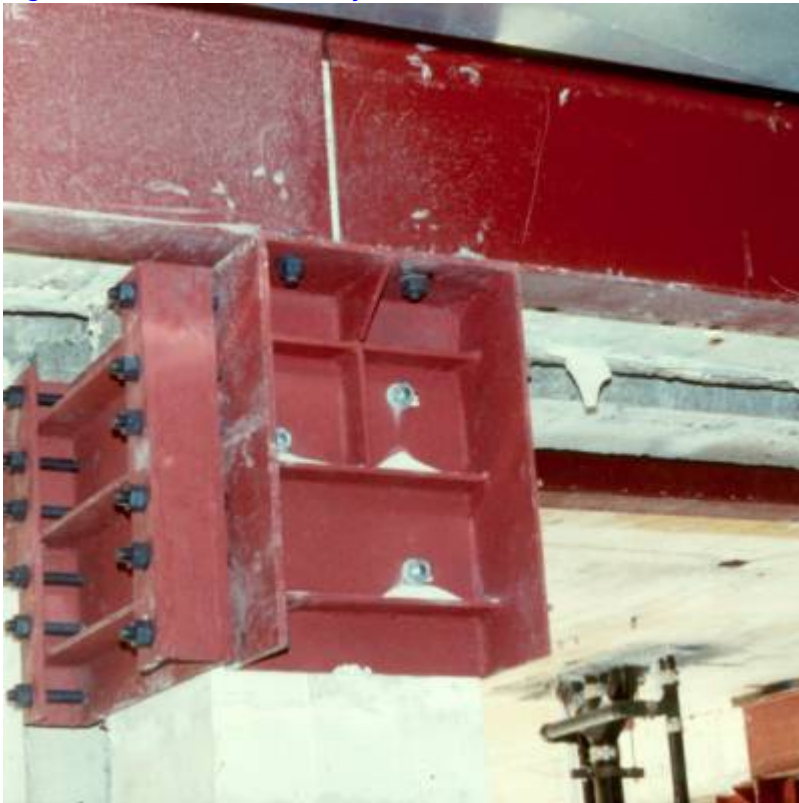
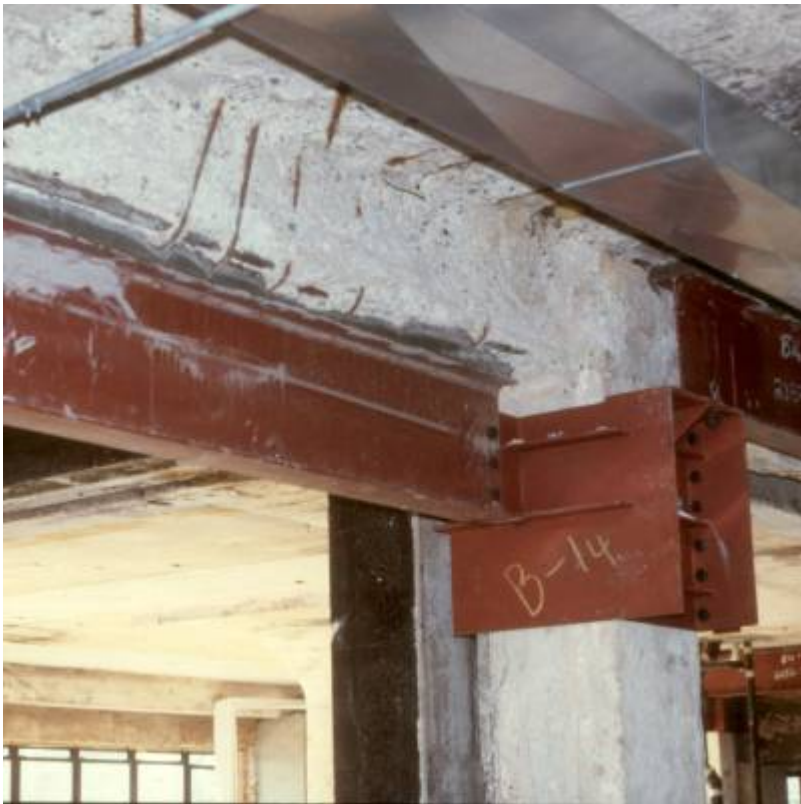
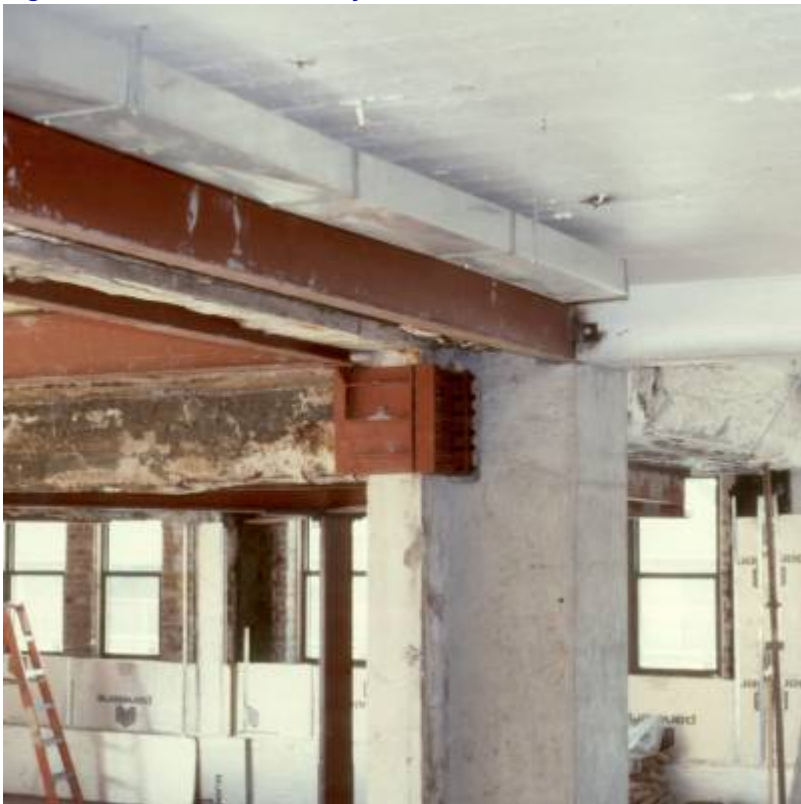
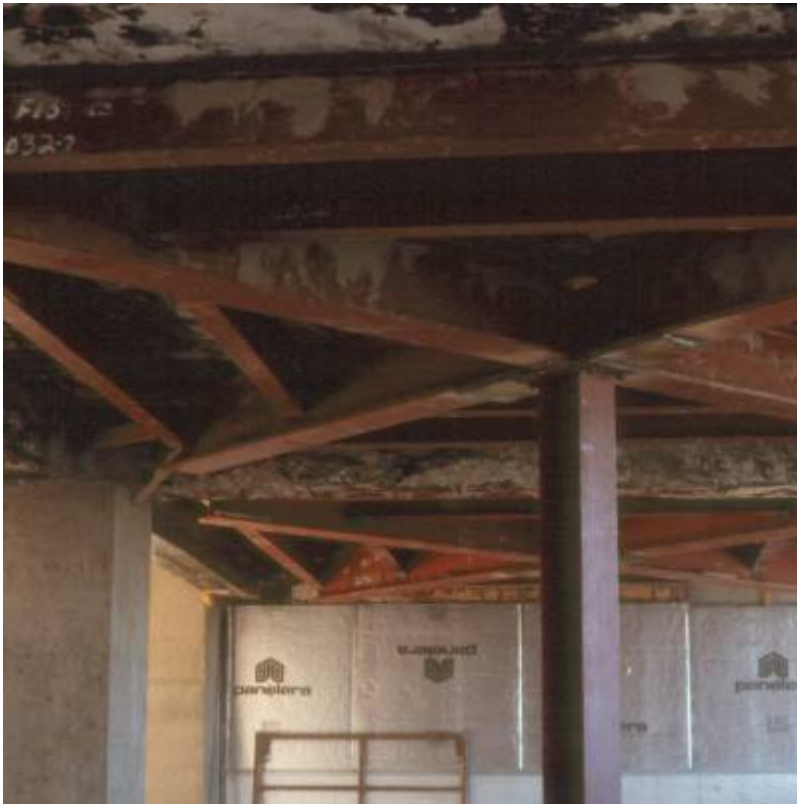
While employed with Hurst & Hendricks in Fargo, ND I had the opportunity to be involved with the restoration adaptive reuse of this historic 1923 brick industrial building now listed on the register of historic places. Many parts of this building's concrete structural frame and floor slabs had severe deterioration due to nature of the creameries' operations, a wet environment, coolers and freezers.

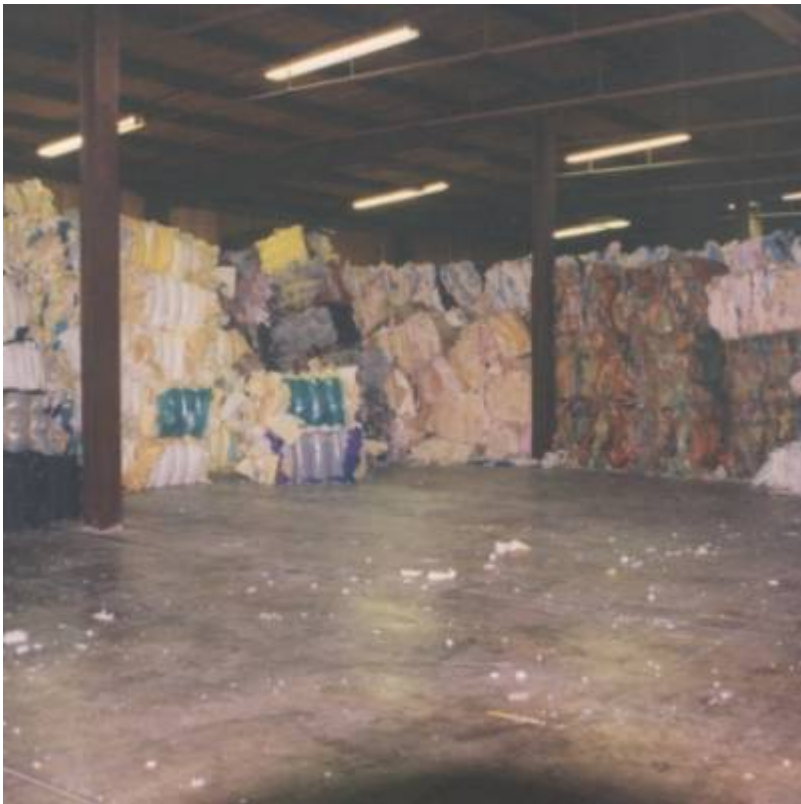
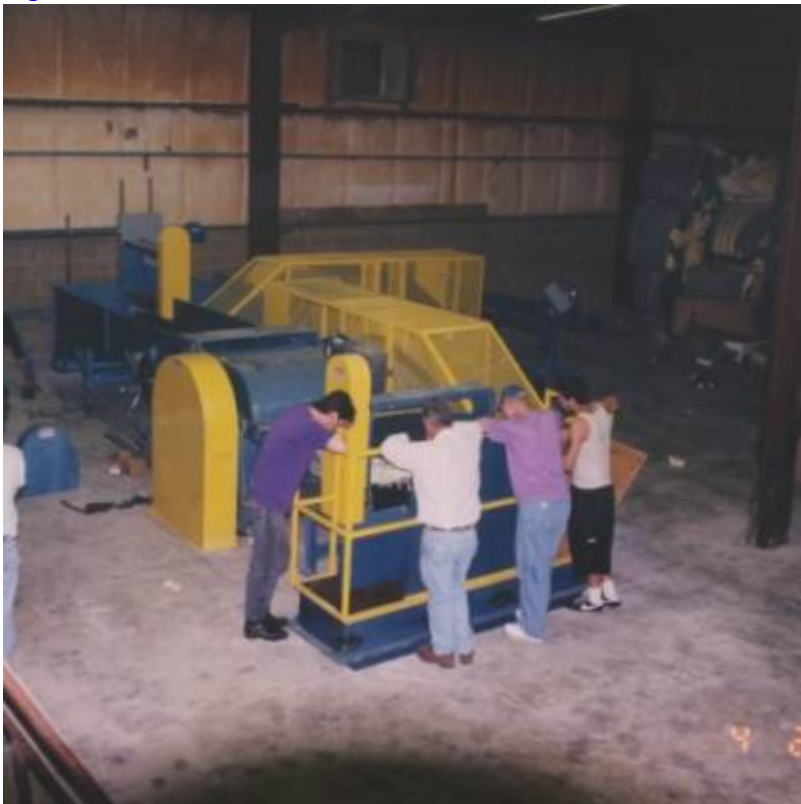
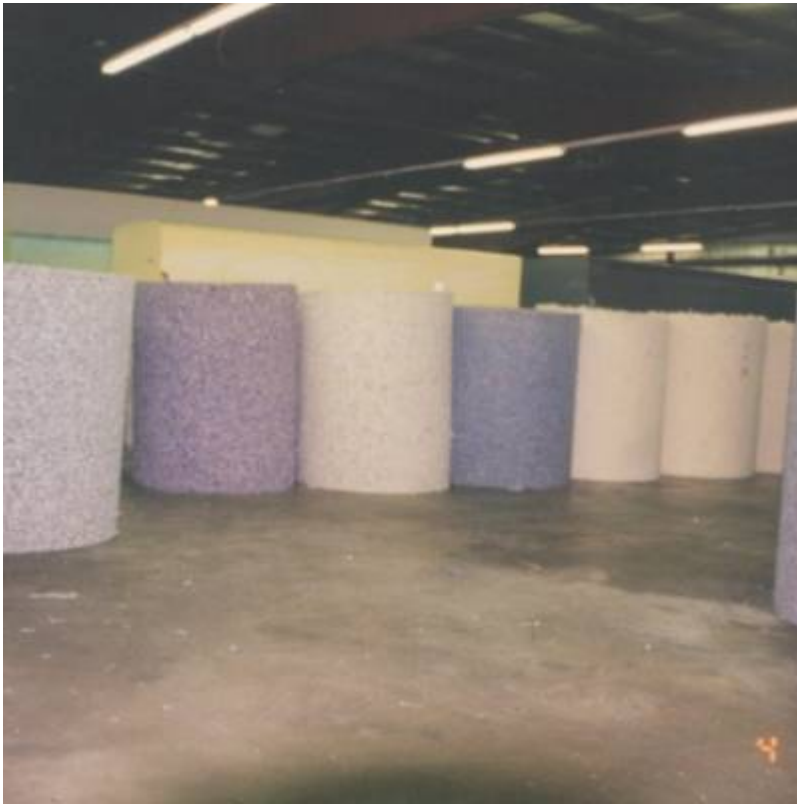
This industrial building's structural framing system was comprised of a pre-engineered steel frame and precast concrete floor slab. The owner, which recycles foam, wished to determine whether the second floor had any additional capacity for the companies operation. Well, not only did it not have any additional capacity, it's second floor beams were under-sized. As shown in Figure 4 stiffener plates were

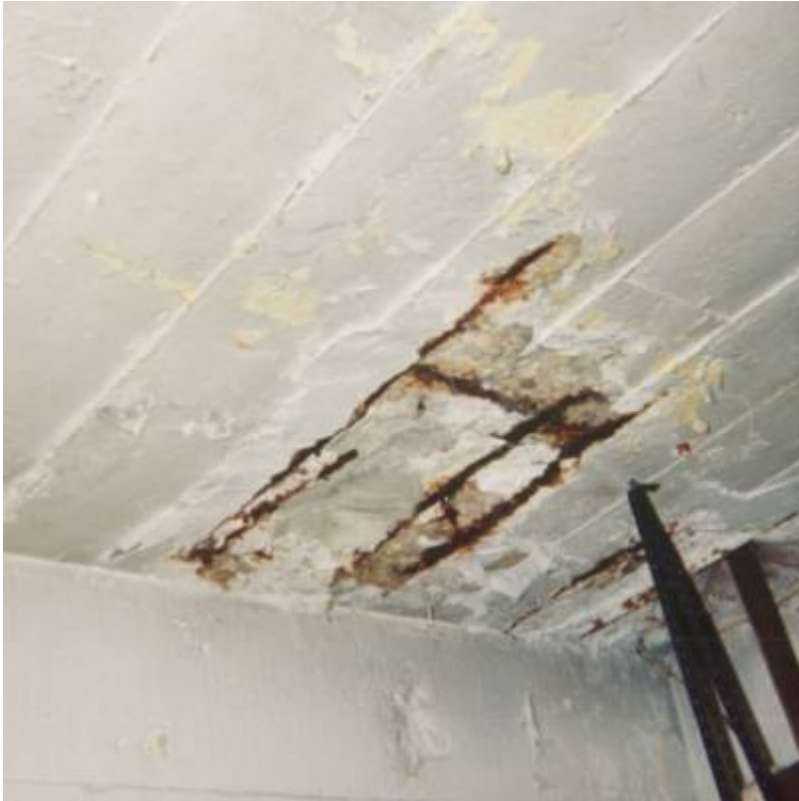
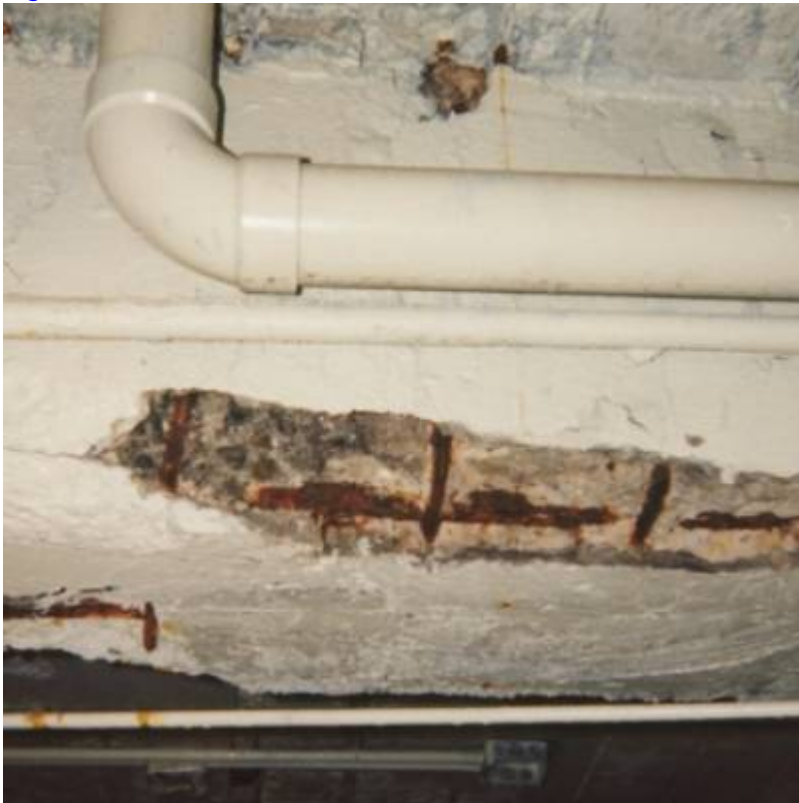
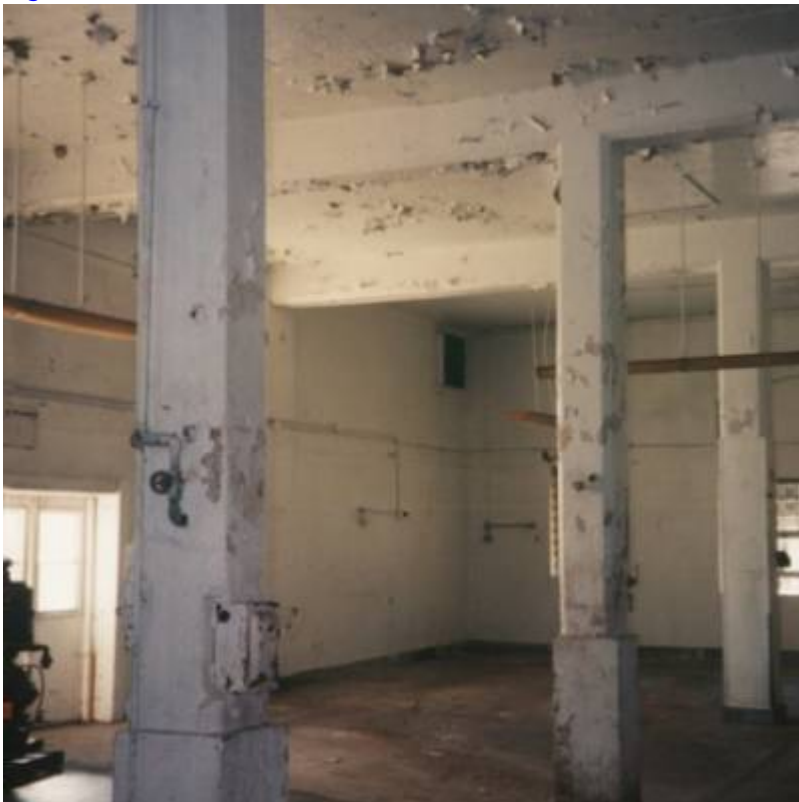
The first floor slab of this former dairy building showed extensive corrosion damage once all the insulation was removed from the ceiling below it. It was quite a shock to the new owners who wished to turn it into a brew pub. The solution for this project was to abandon the deteriorated floor slab, repair and

strengthen the floor beams and span between them with a concrete topped metal deck.
