# COMMERCIAL STRUCTURE INVESTIGATIONS

A number of structural system investigations shown in the galleries below are of buildings framed using concrete. Damage to the concrete frame and slab system may be the result of a corrosive interior or exterior environment, poor workmanship, previous remodeling projects or structural failure.

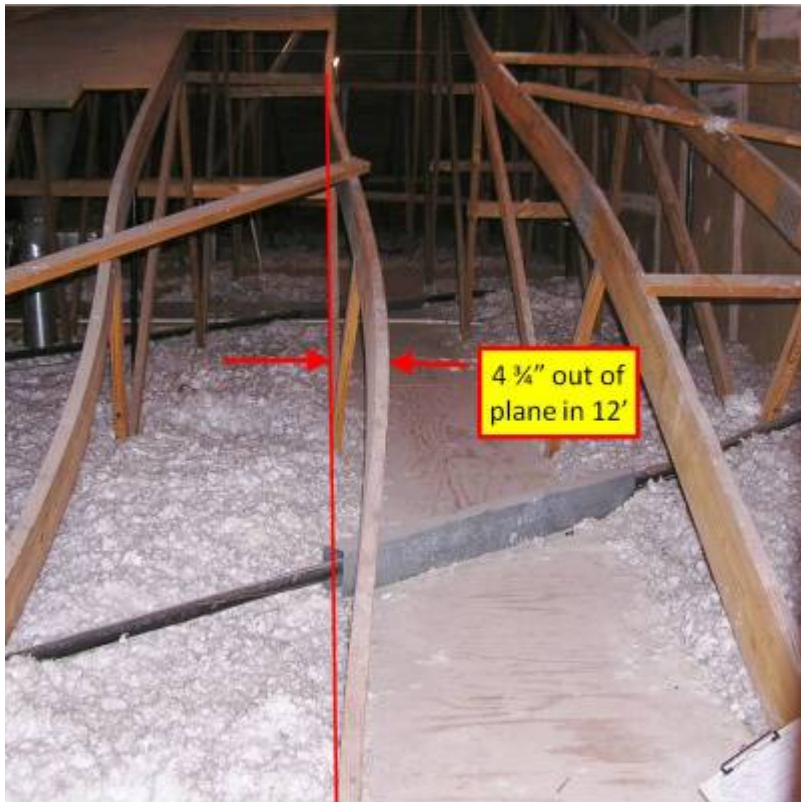
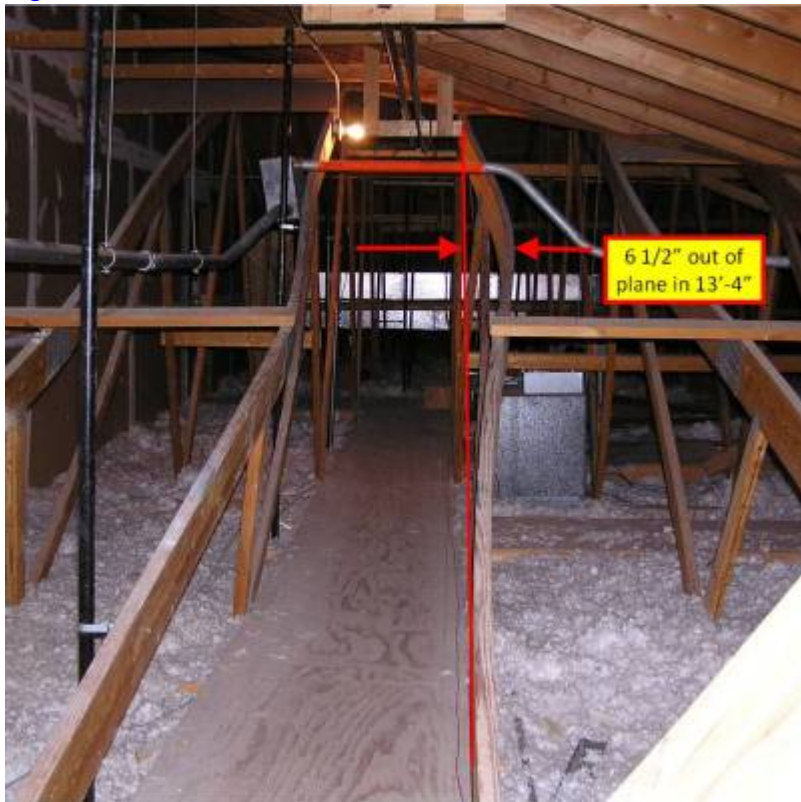
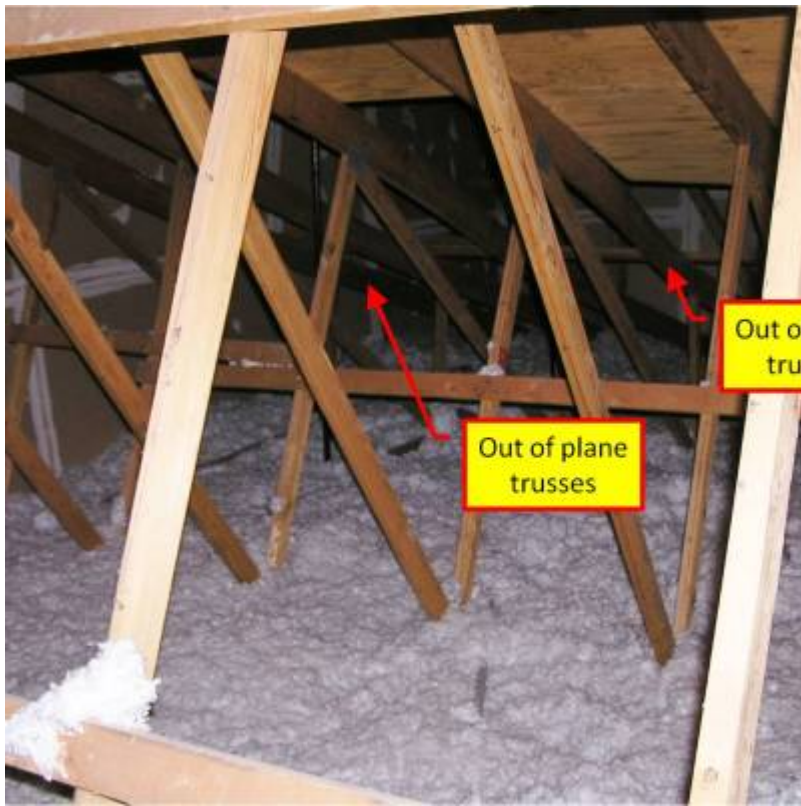
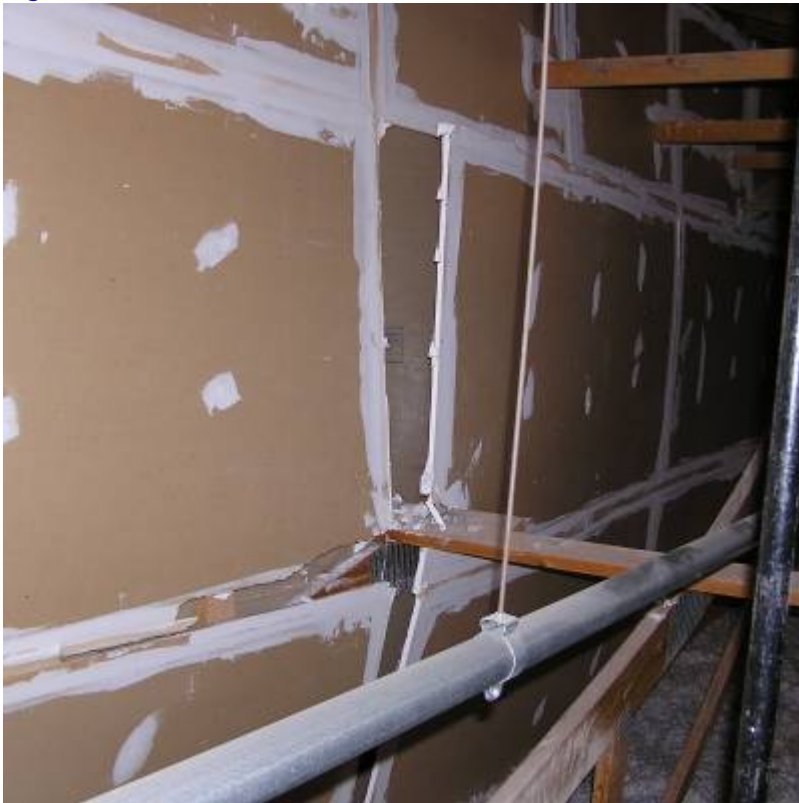
While investigating this strip mall's roof capacity for mechanical equipment added by a restaurant tenant an alarming discovery was made. It was discovered that errors made during construction by not providing the required permanent bracing in certain areas for the roof trusses caused them to deflect out-of-line. Over the years the top chords of these trusses, which should remain in a straight line had

deflected severely out-of-line.

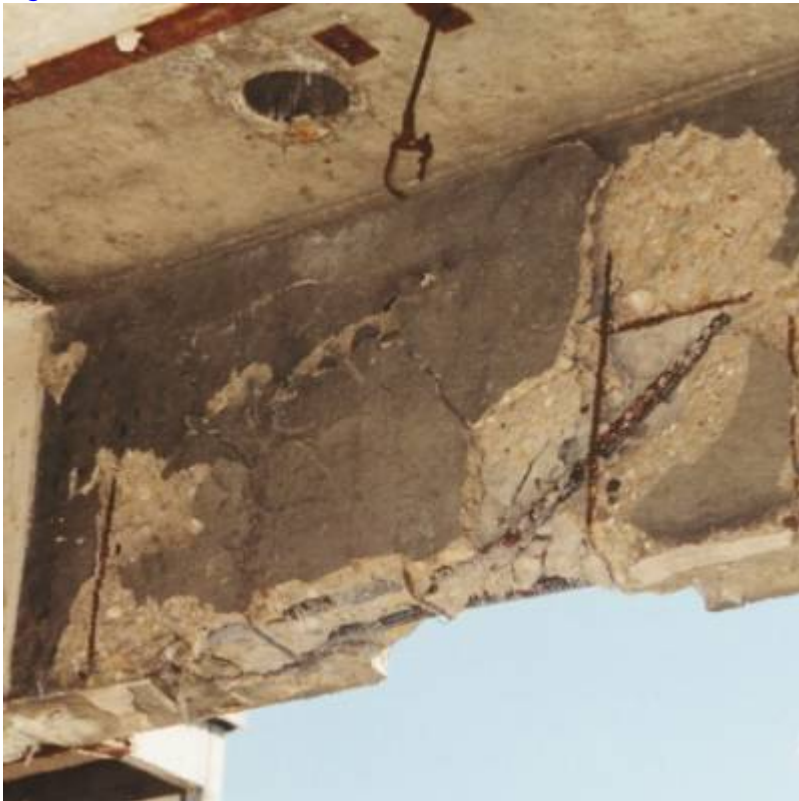
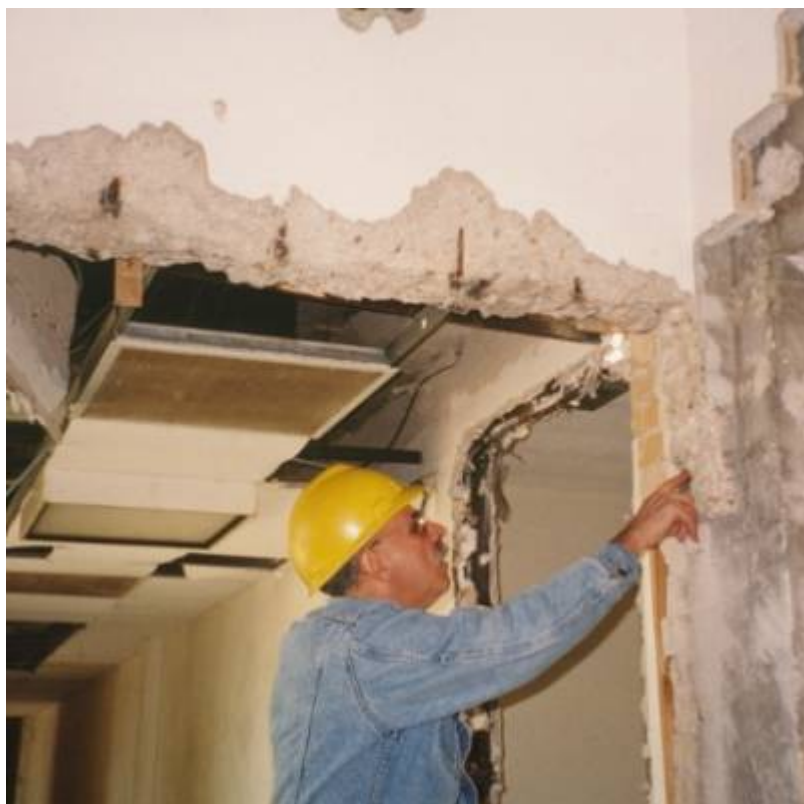
Damage to the concrete frame as a result of deterioration, previous remodeling projects or accidents during demolition may occur. Restoration of these elements helps ensure the continued "health" of the structure (Figures 6 and 7).
