UTILITY/FOUNDATIONS

CUNA MUTUAL - Dual Generator Installation

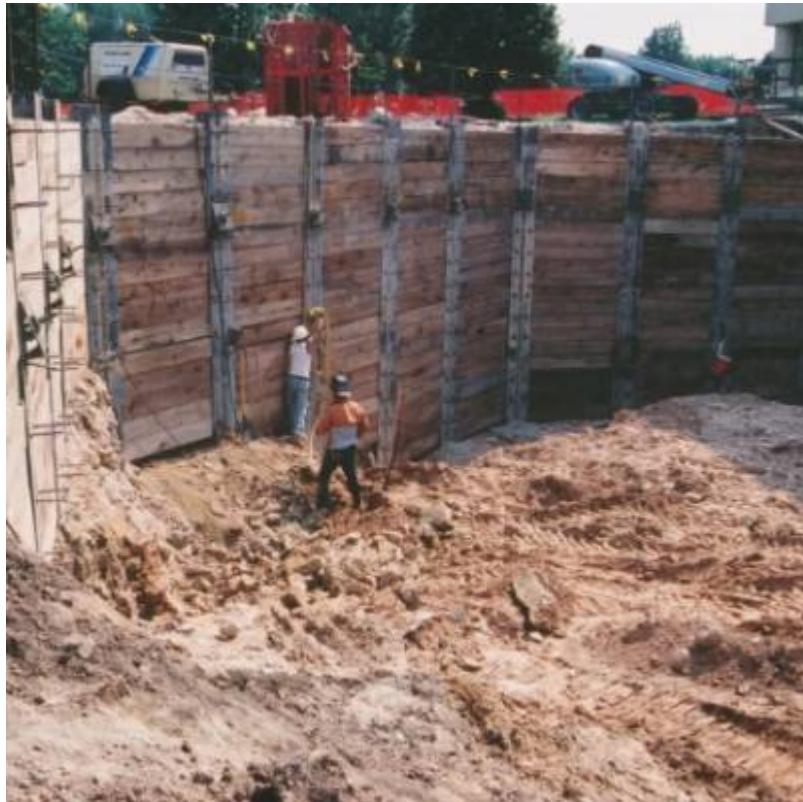
Fig. 1. Excavation and soldier beam earth retention system.

Photos in Figures 1-9 show a commercial earth retention project. The project was originally designed as a modified counterfort retaining wall system. The modification to the system was to anchor the counterforts and stem walls into bedrock, which occurred at the required bearing elevations.

Unfortunately, timing for the installation, the owner's desire to have these emergency generators available as soon as possible and also minimize the amount of excavation the system was changed to a tied-back soldier beam system during the bidding phase. The soldier beam earth retention system was still an effective and workable system.

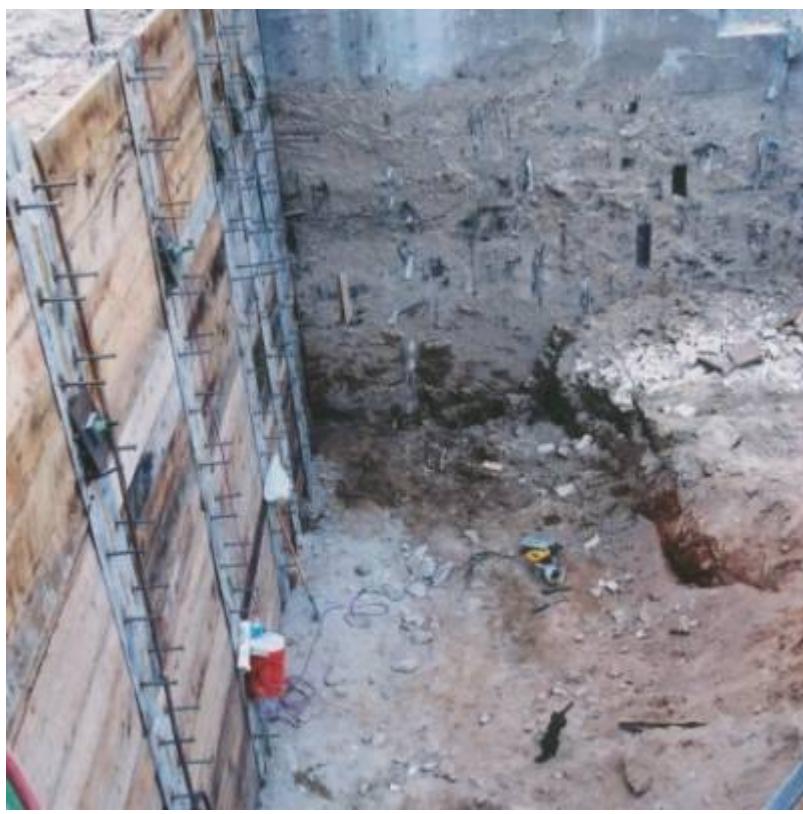
Fig. 2. Excavation and soldier beam earth retention system.

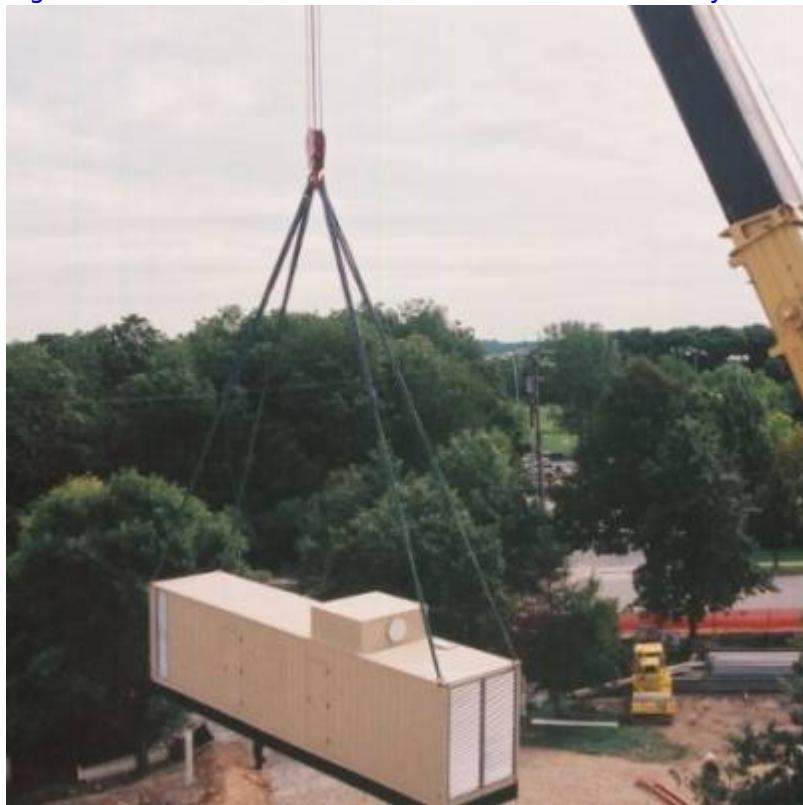
Fig. 3. Setting generators.

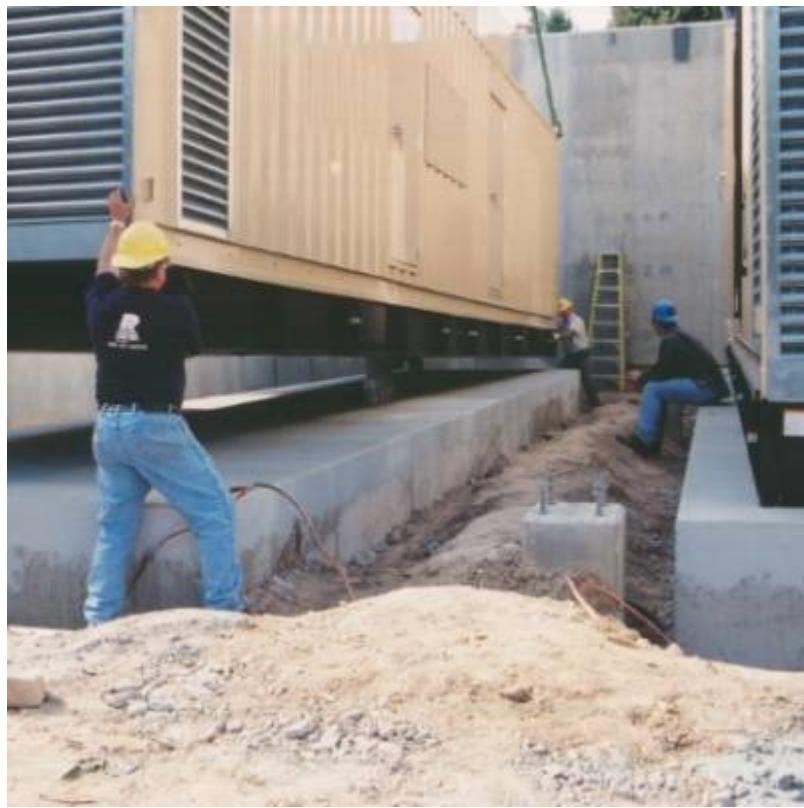
Fig. 4. Setting generators.

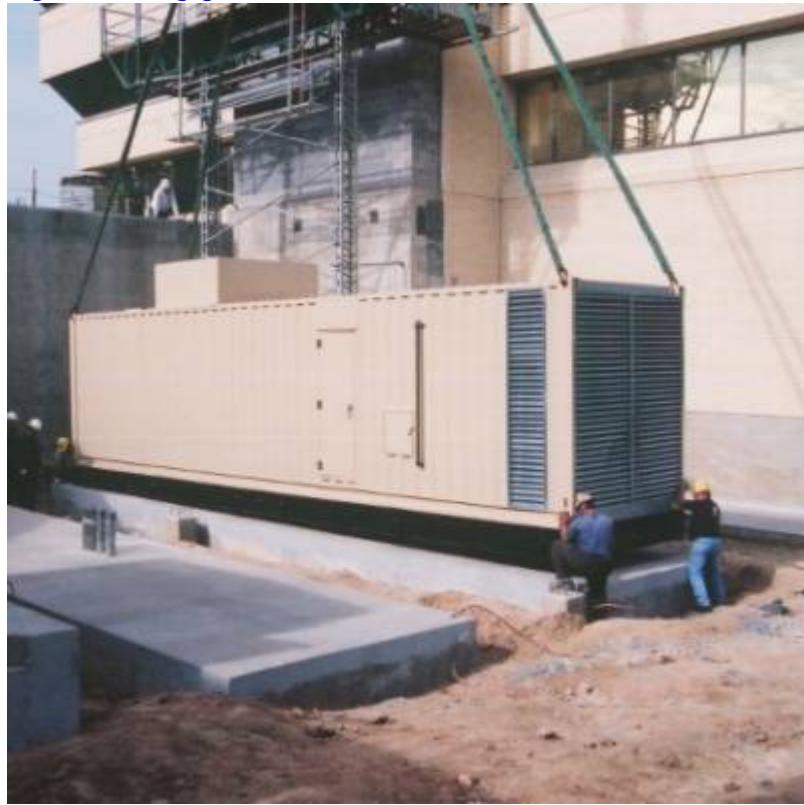
Fig. 5. Setting generators.

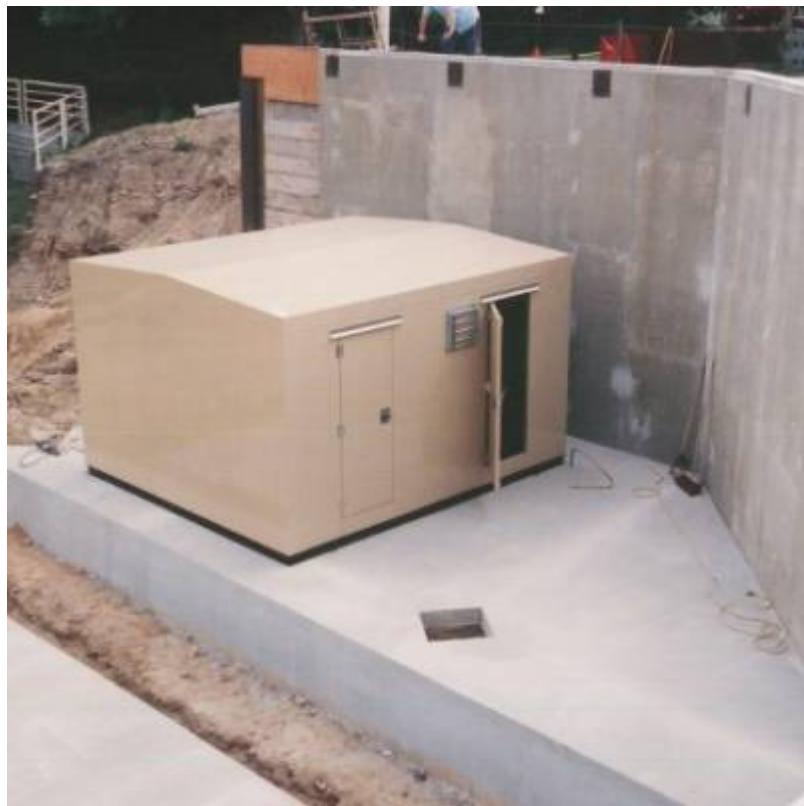
Fig. 6. Generator equipment room.

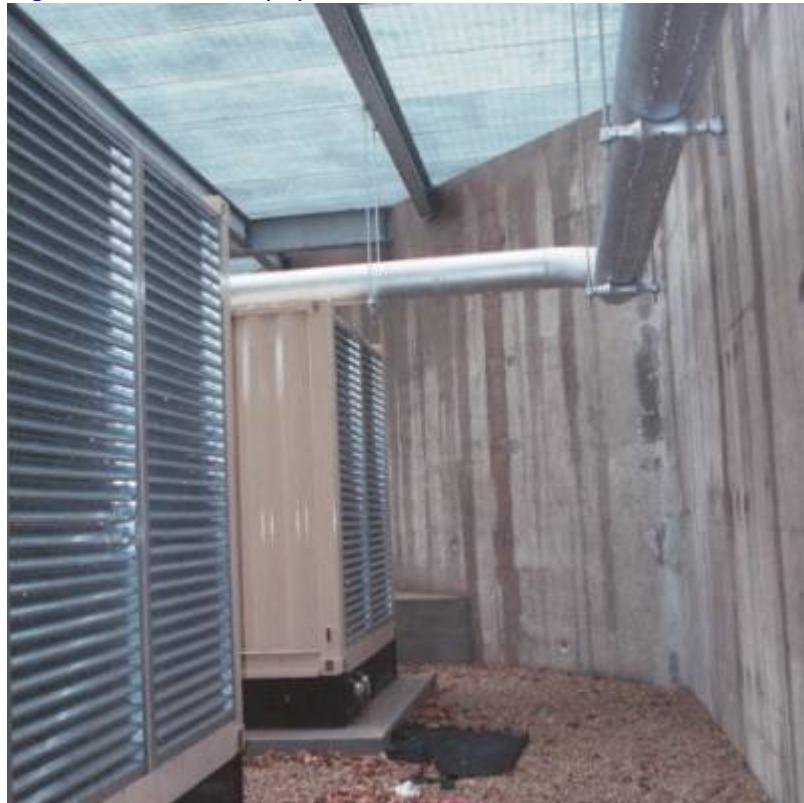
Fig. 7. Generators installed.

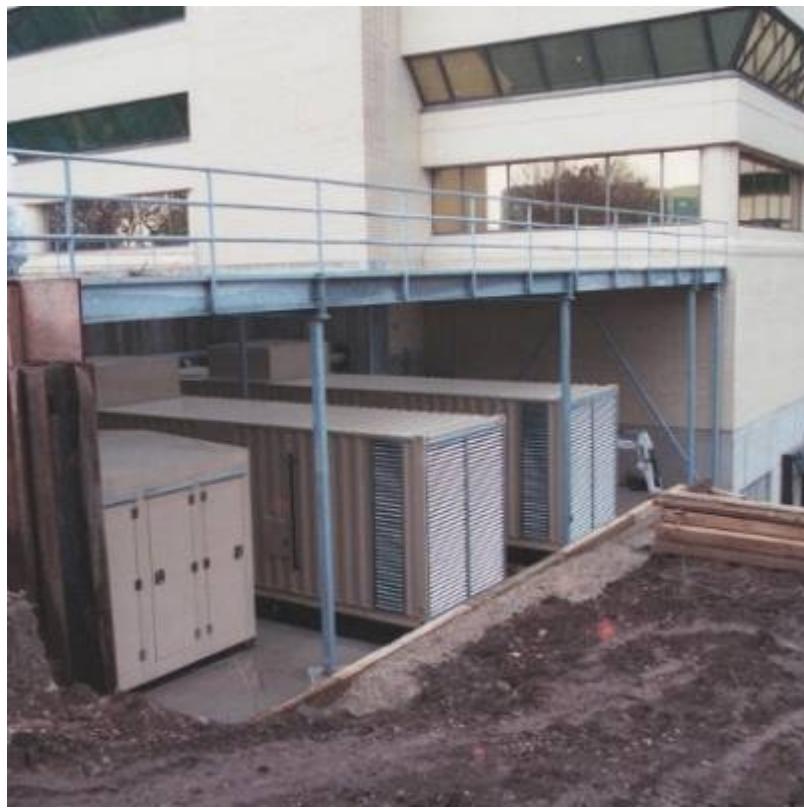
Fig. 8. Generators installed

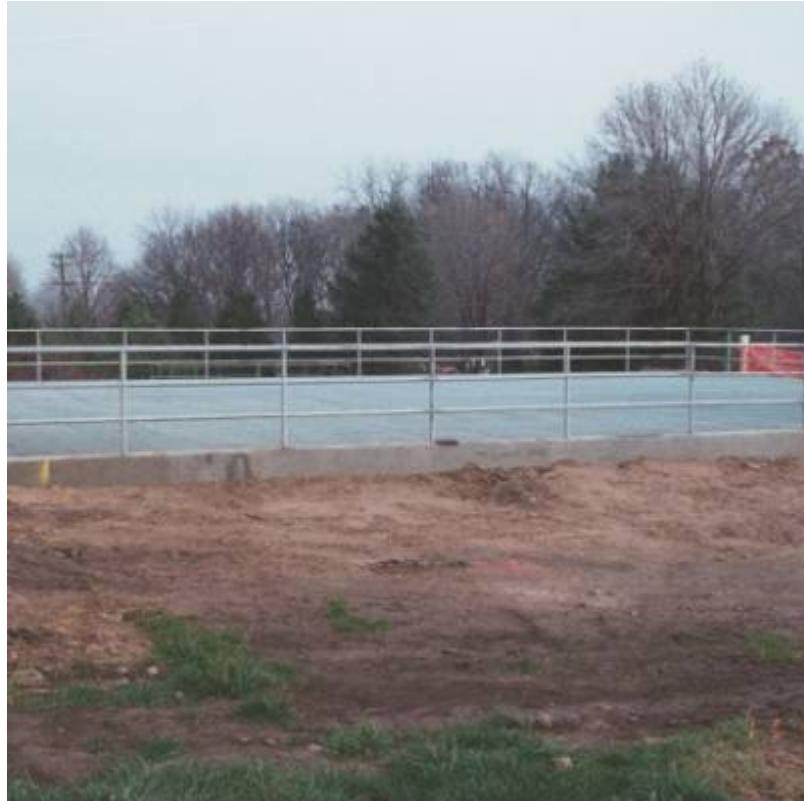
Fig. 9. Grated roof over generator installation.

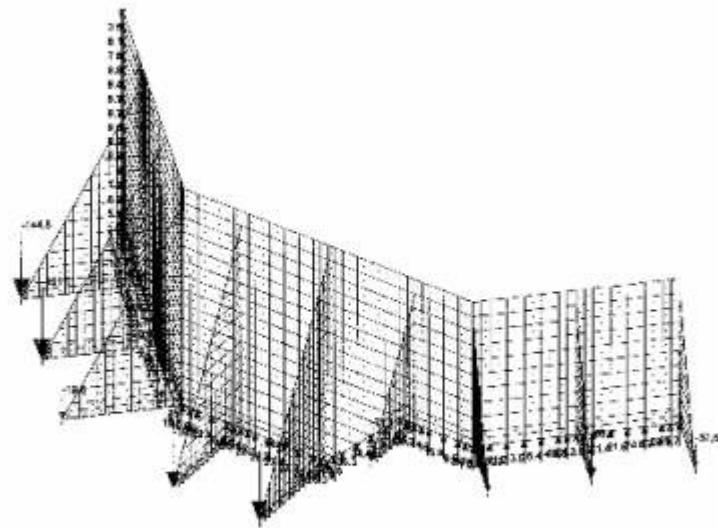
Fig. 10. Finite element model.

As a consultant for KJWW Engineering Consultants engineered the counterforts and stem wall utilizing RISA 3D finite elements. Extensive finite element analysis was performed as shown in Figure 10 and 11 to obtain the most efficient system.

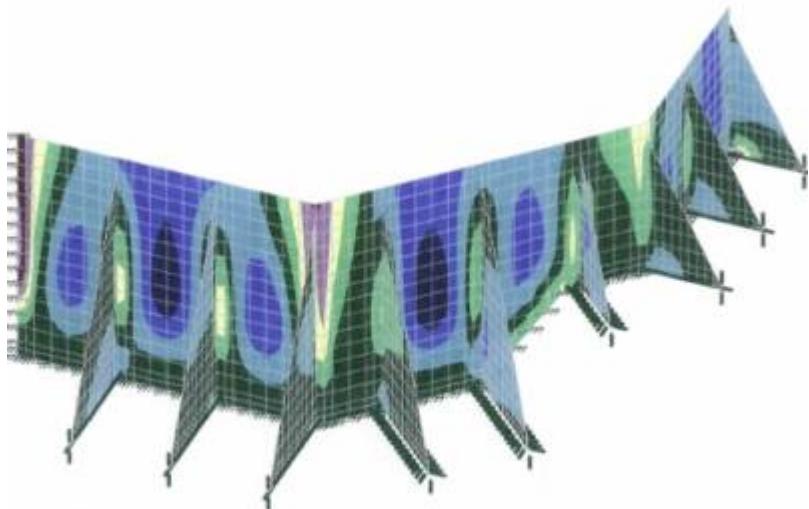
Fig. 11. Finite element model showing stresses.

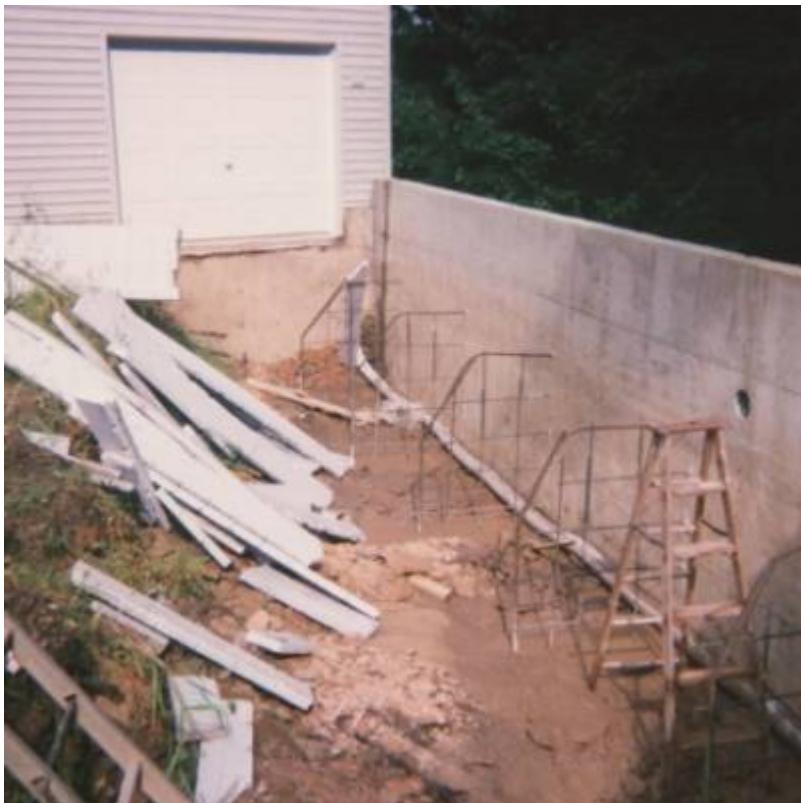
Retaining Wall Repair

The above photo shows the repair of a tipping retaining wall. The wall was stabilized by employing a counterfort retaining wall system and epoxy anchoring rebar into the sandstone ledge.

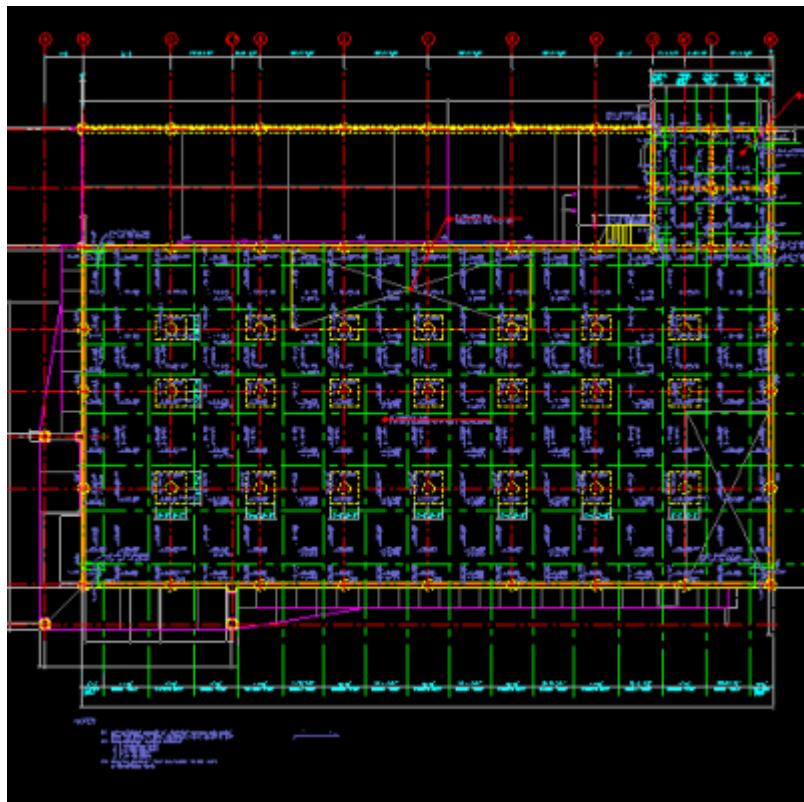
Alsip Aldi

The above Figure shows the two-way structural slab-on-grade plan for a proposed grocery store. The store was to be located in an area of poor soil bearing capacity and as a consequence the structural slab was supported by grade beams and drilled piers. As a consultant for KJWW Engineering Consultants engineered this structural support system.
