# COMMERCIAL STRUCTURE INVESTIGATIONS

A number of structural system investigations shown in the galleries below are of buildings framed using concrete. Damage to the concrete frame and slab system may be the result of a corrosive interior or exterior environment, poor workmanship, previous remodeling projects or structural failure.

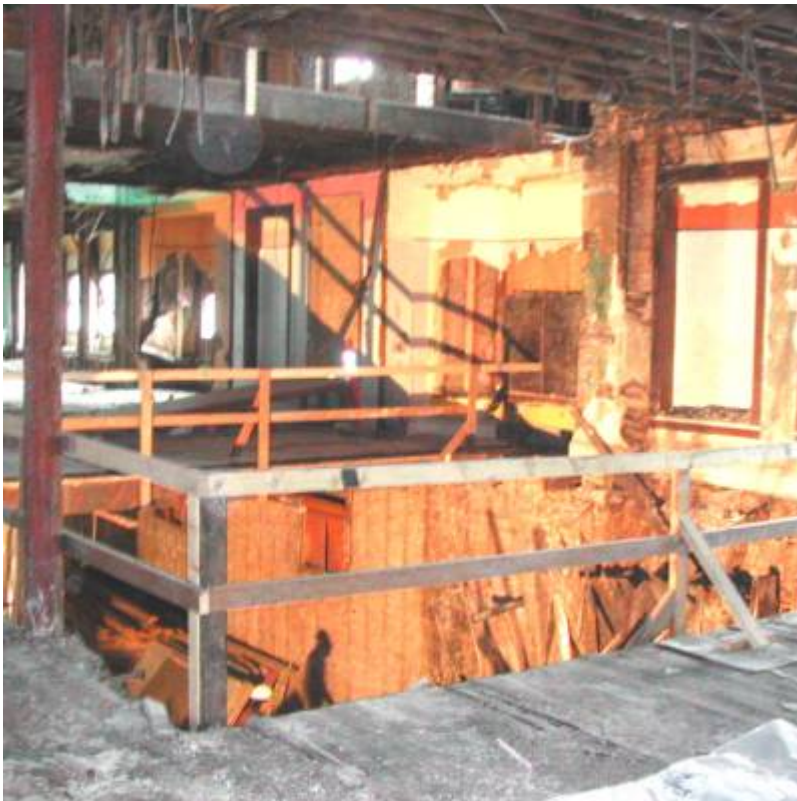
Fig. 1. Brewers Hill Apartments.

The renovation and rehabilitation of an apartment building one-hundred or more years old may involve dealing with posts made of cast iron, early iron or steel beams made of an unknown steel strength, timber without a grading stamp and most often no plans. The challenges can be numerous.

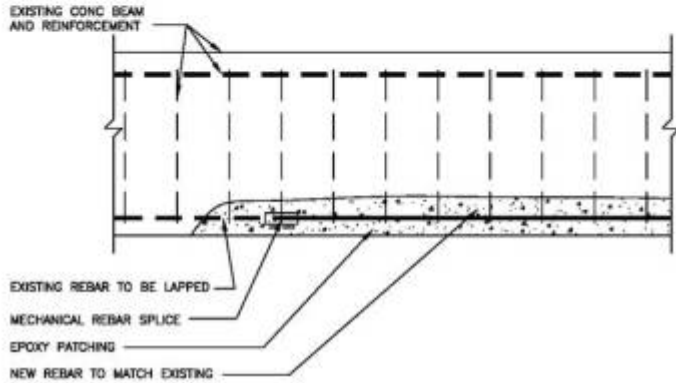
D-1 Model

**A** **DETAIL REBAR SPLICE**  
1"=1'-0"

Once a concrete frame has undergone such severe deterioration its strength can be greatly impaired. A program of investigation, documentation, field observations, testing, evaluation and reporting followed by rehabilitation becomes imperative. Several recommended repair details are shown below.

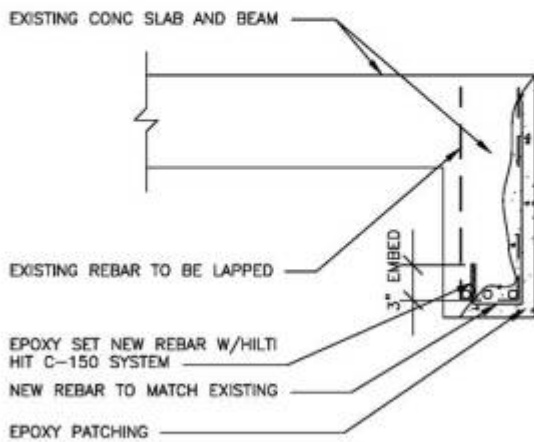
D-2 Model

**DETAIL STIRRUP REBAR SPLICE**

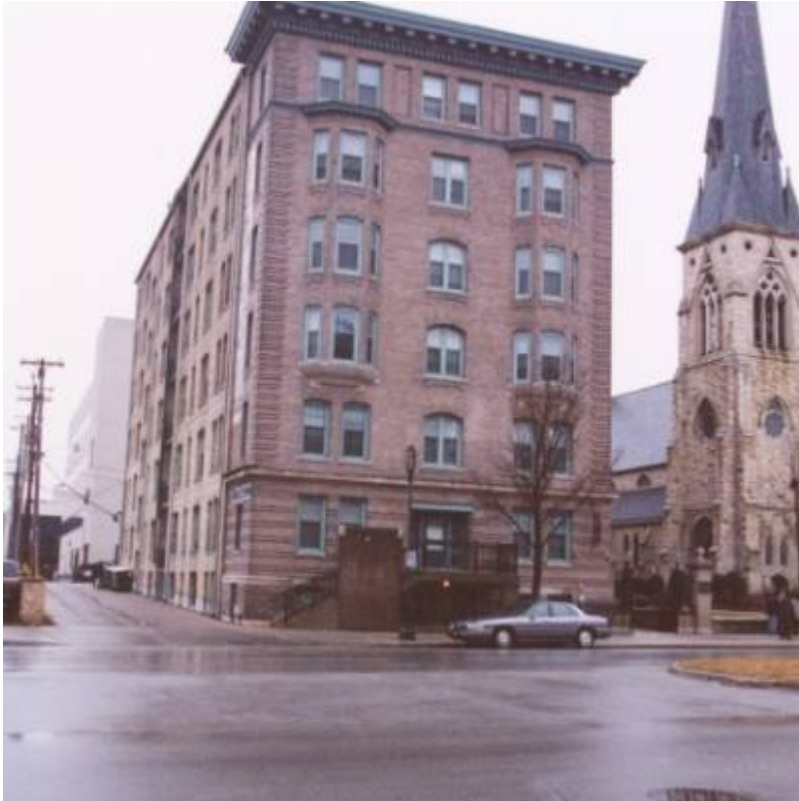
Fig. 1. Historic St. James Apartments.

The renovation and rehabilitation of an apartment building one-hundred or more years old may involve dealing with posts made of cast iron, early iron or steel columns and beams made of an unknown steel strength, concrete floor systems of unknown capacity and most often no plans. The challenges can be numerous. This project involved the review of existing steel framing which supported an elevator that owner wished to upgrade.
