# COMMERCIAL STRUCTURE INVESTIGATIONS

We have investigated a variety of commercial buildings and building types, a few of which are shown here.

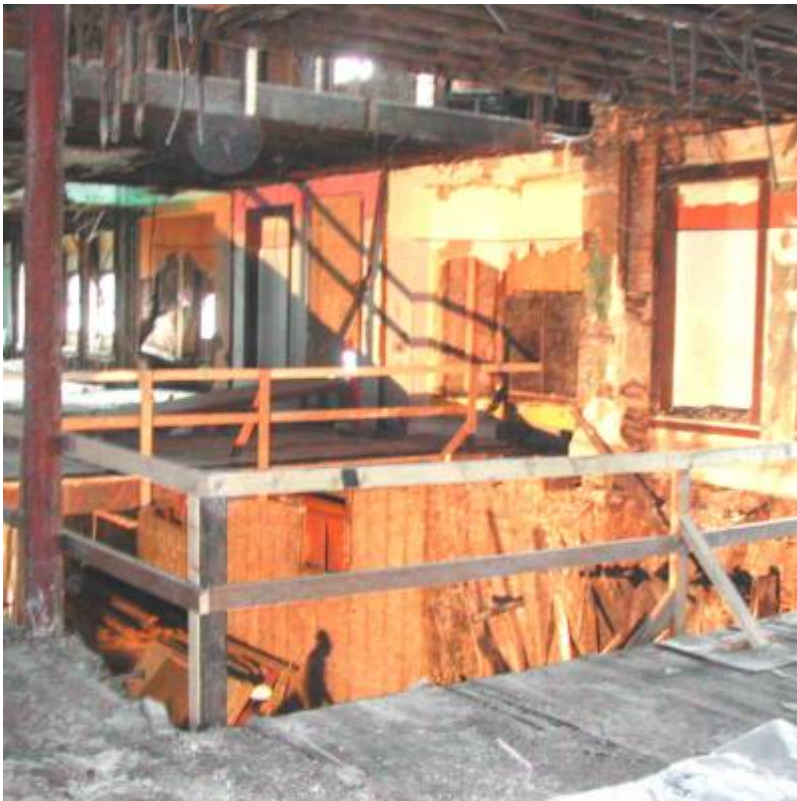
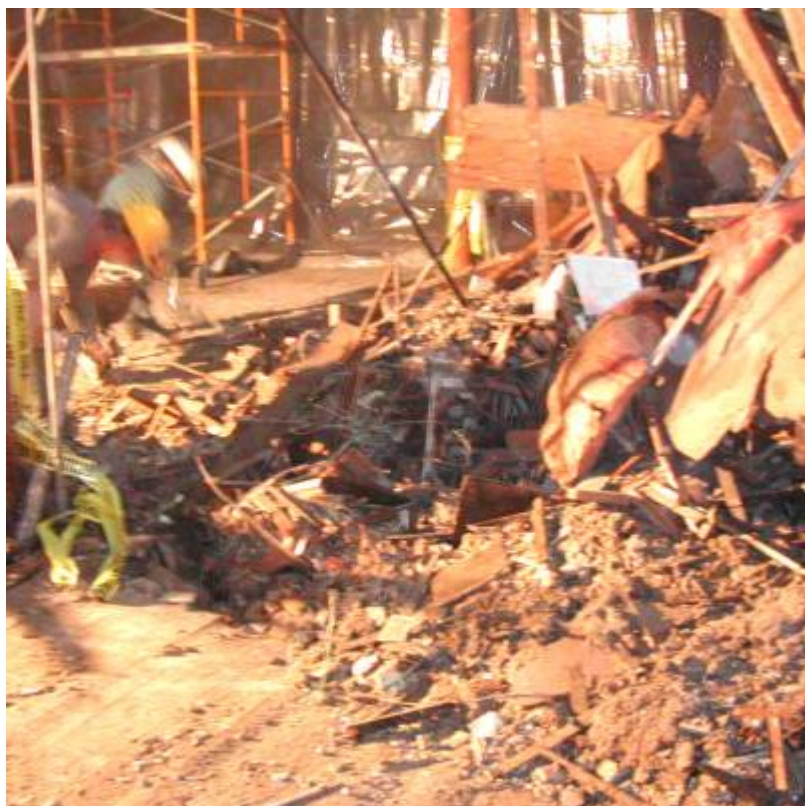
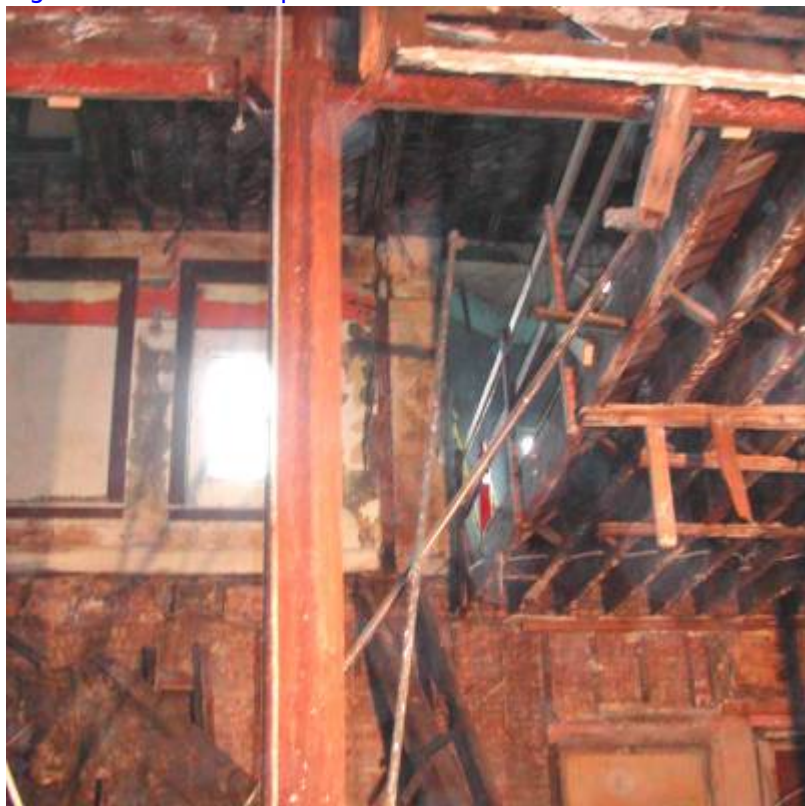
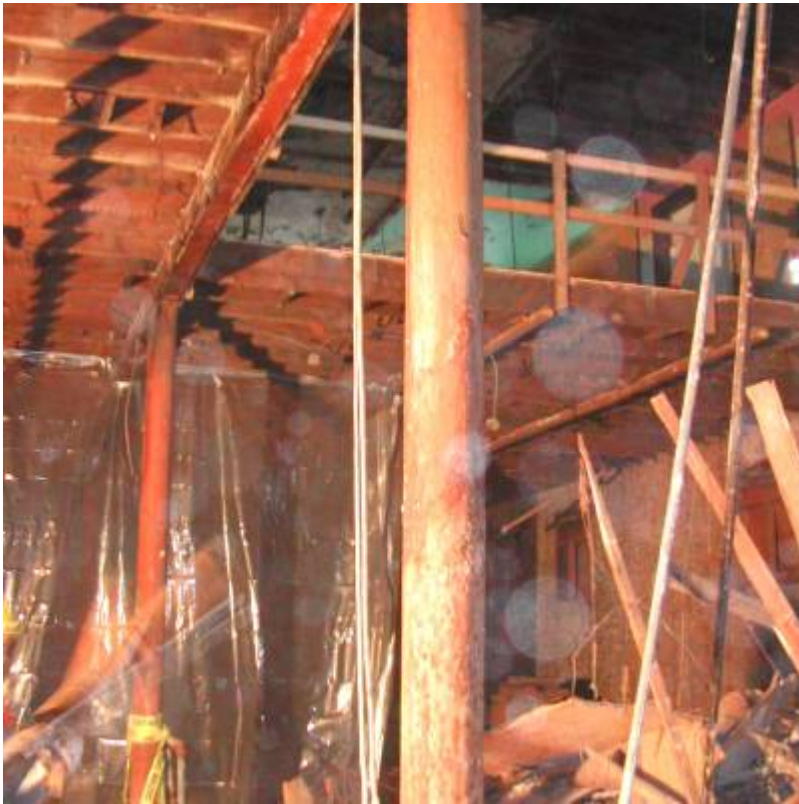
The renovation and rehabilitation of an apartment building one-hundred or more years old may involve dealing with posts made of cast iron, early iron or steel beams made of an unknown steel strength, timber without a grading stamp and most often no plans. The challenges can be numerous.

During the renovation process existing structural systems need careful evaluation for new loading conditions and for compliance with current building codes. Material properties may need to be determined to ensure compatibility with restoration materials.

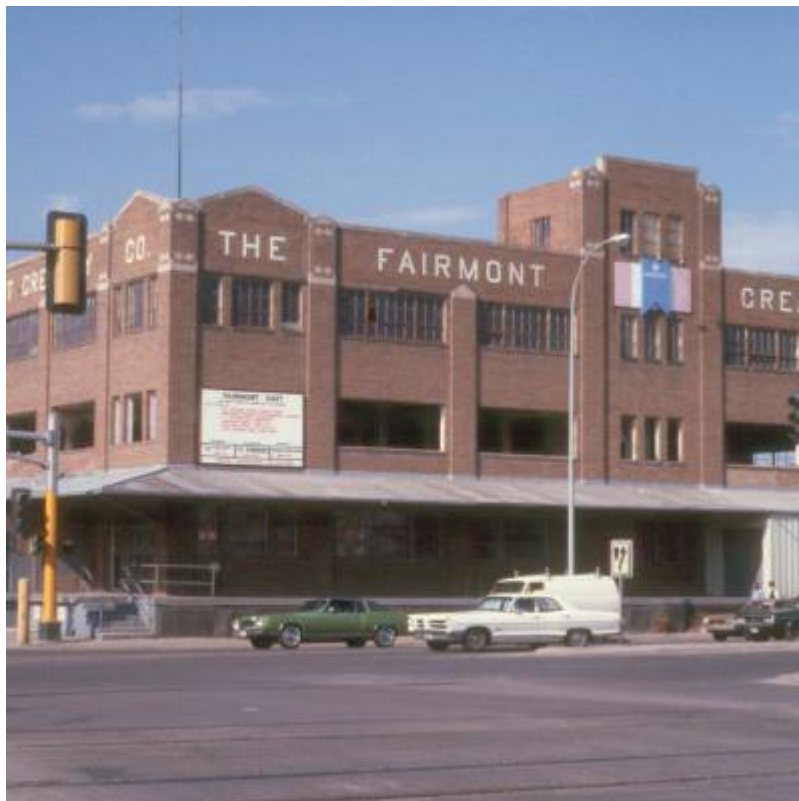
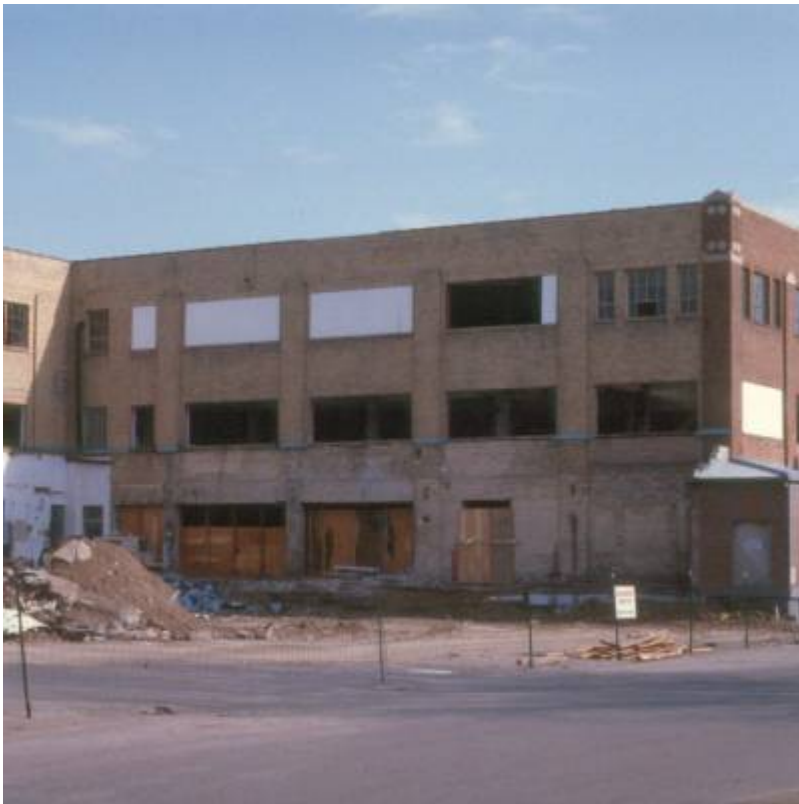
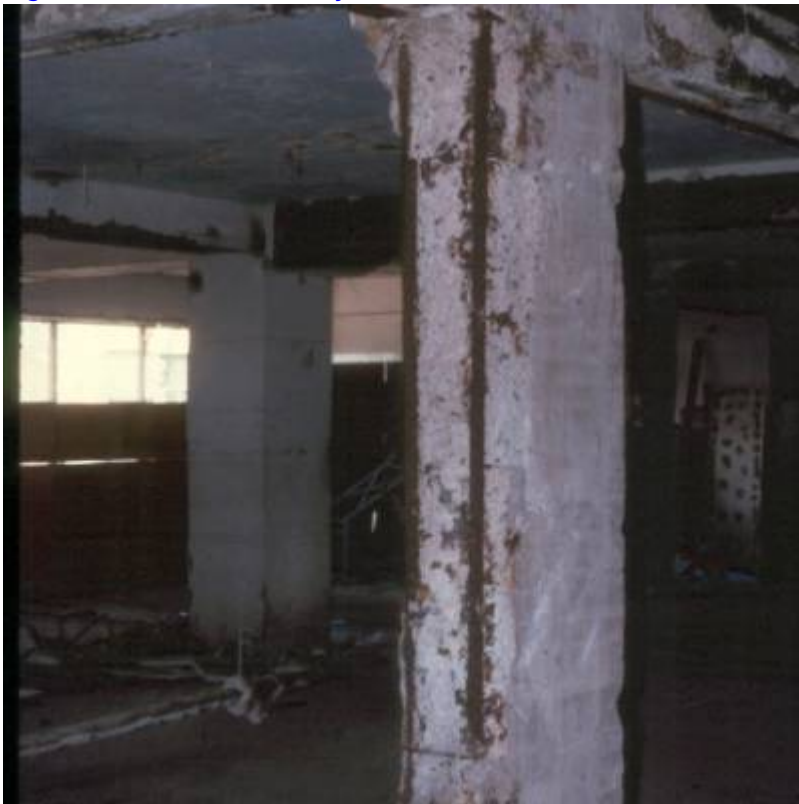
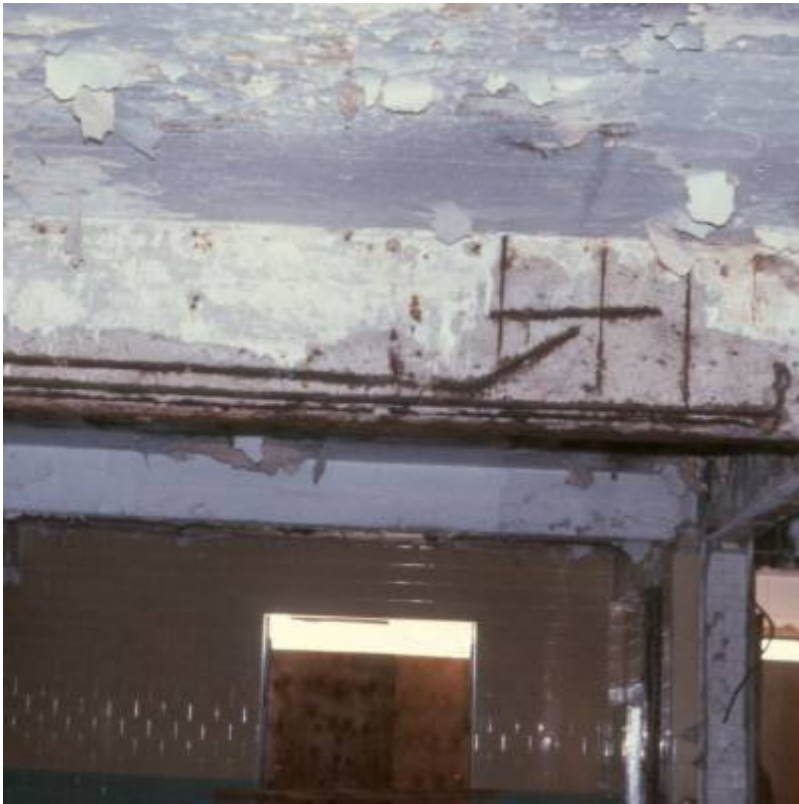
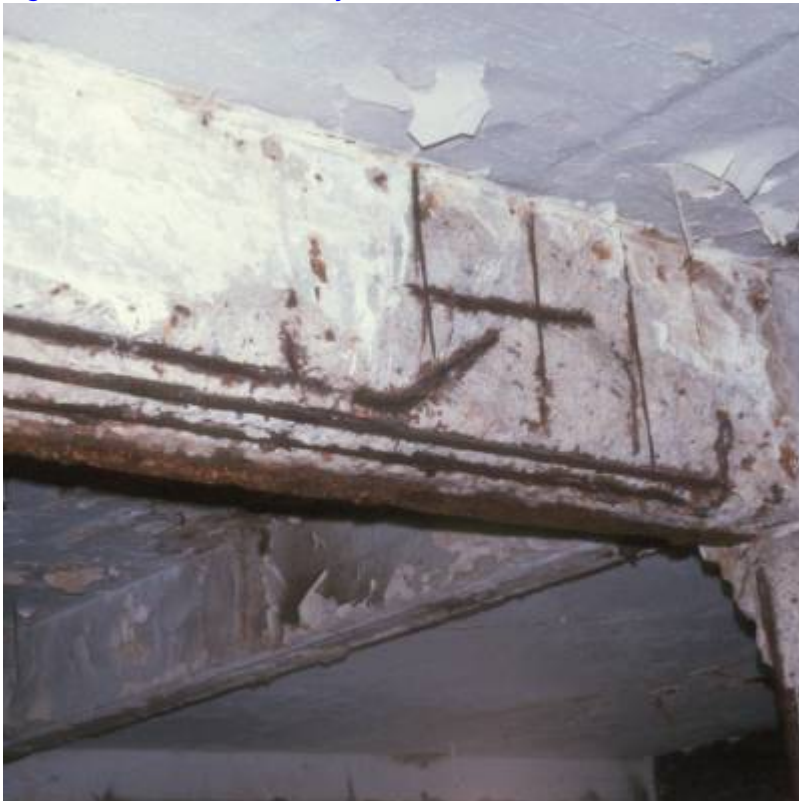
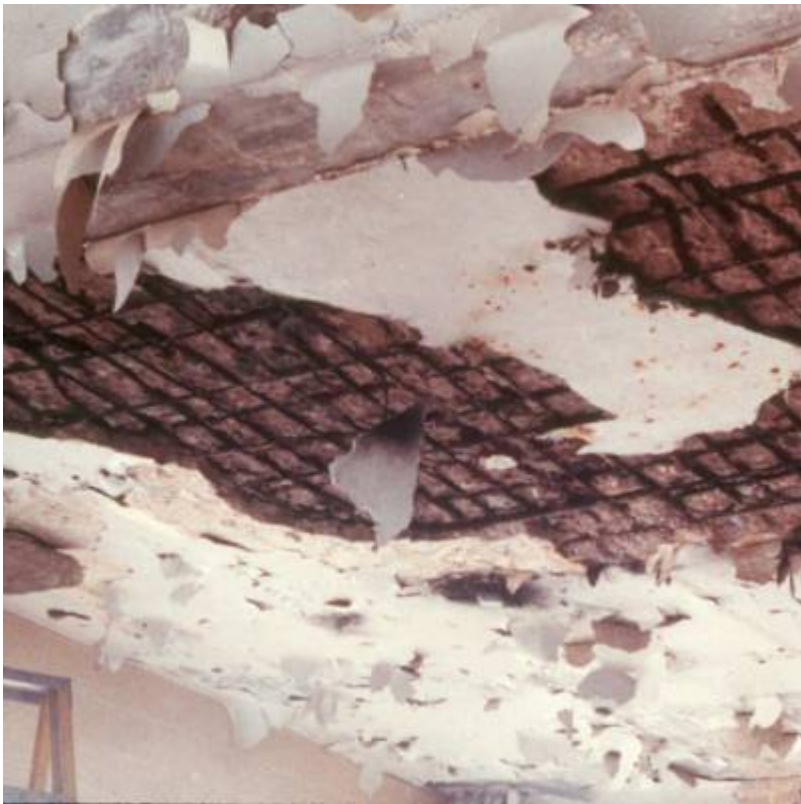
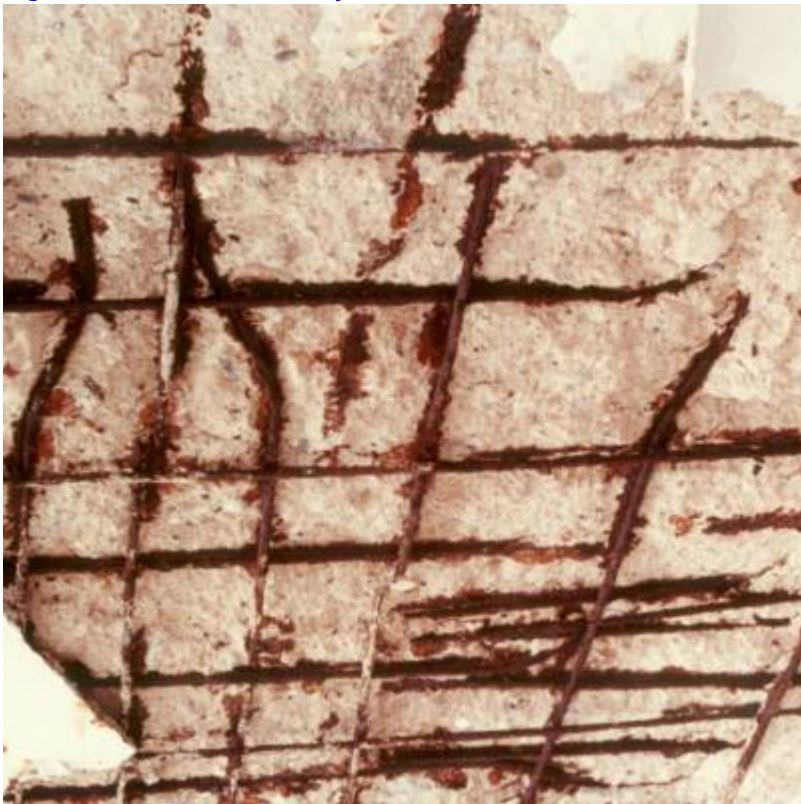
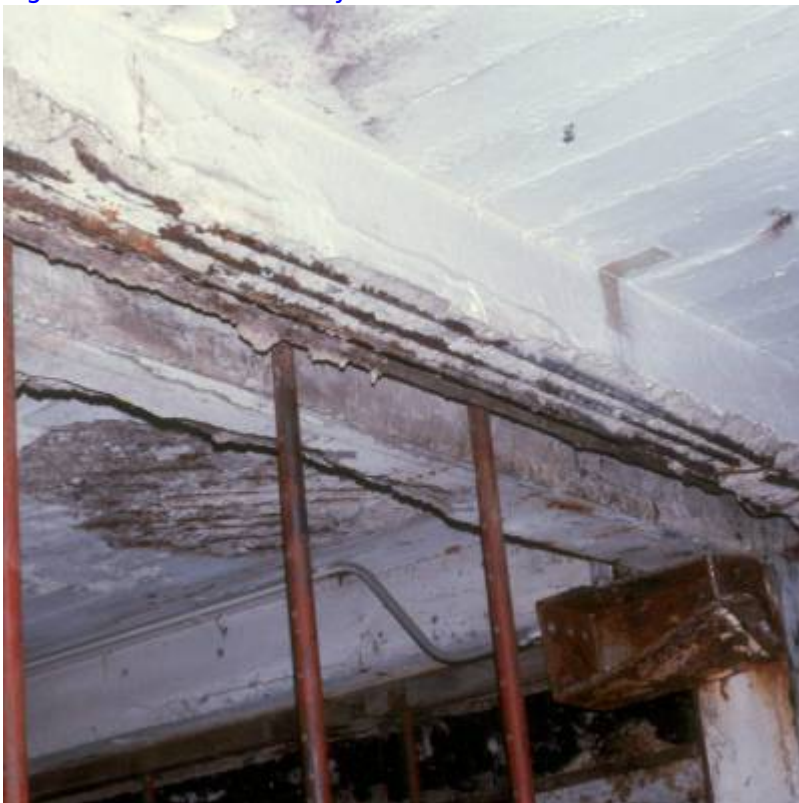
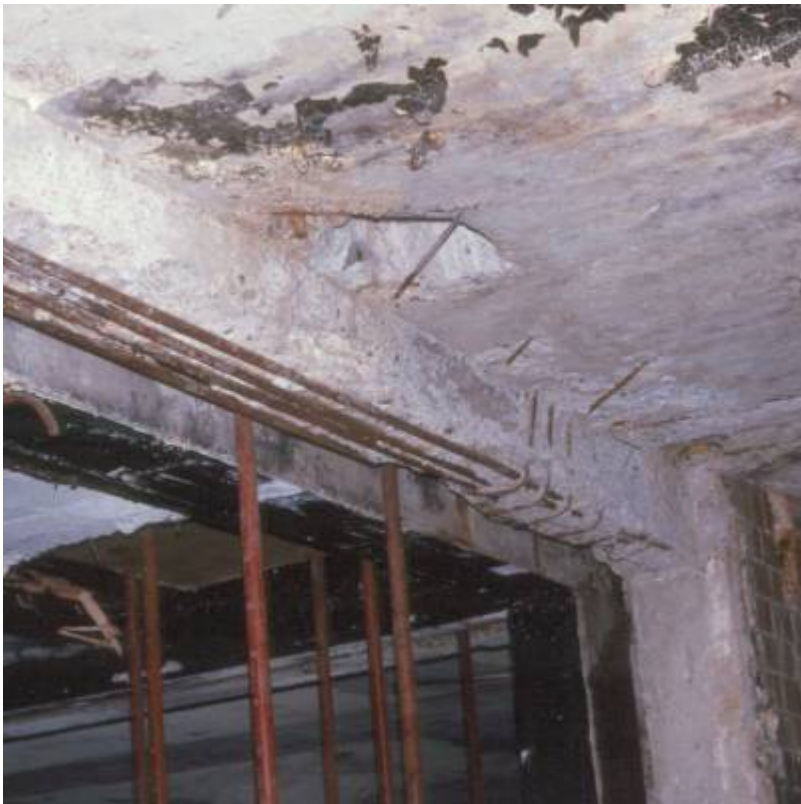
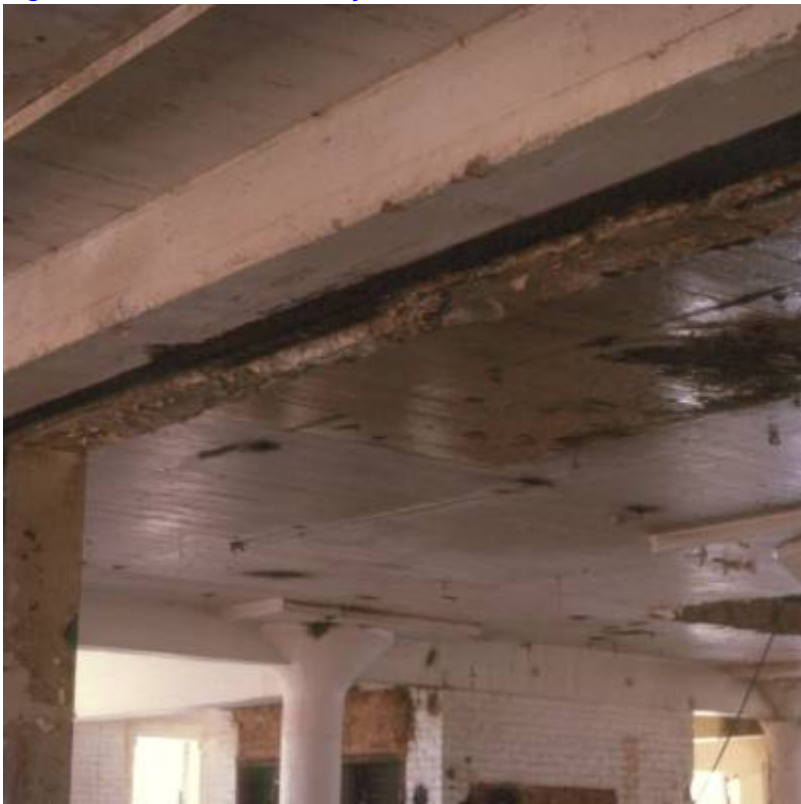
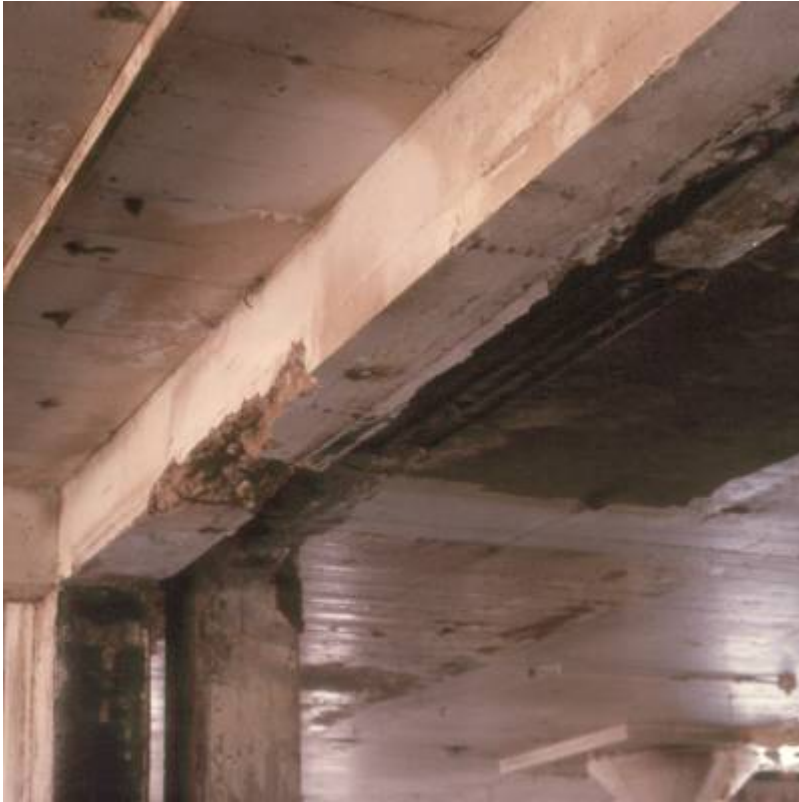
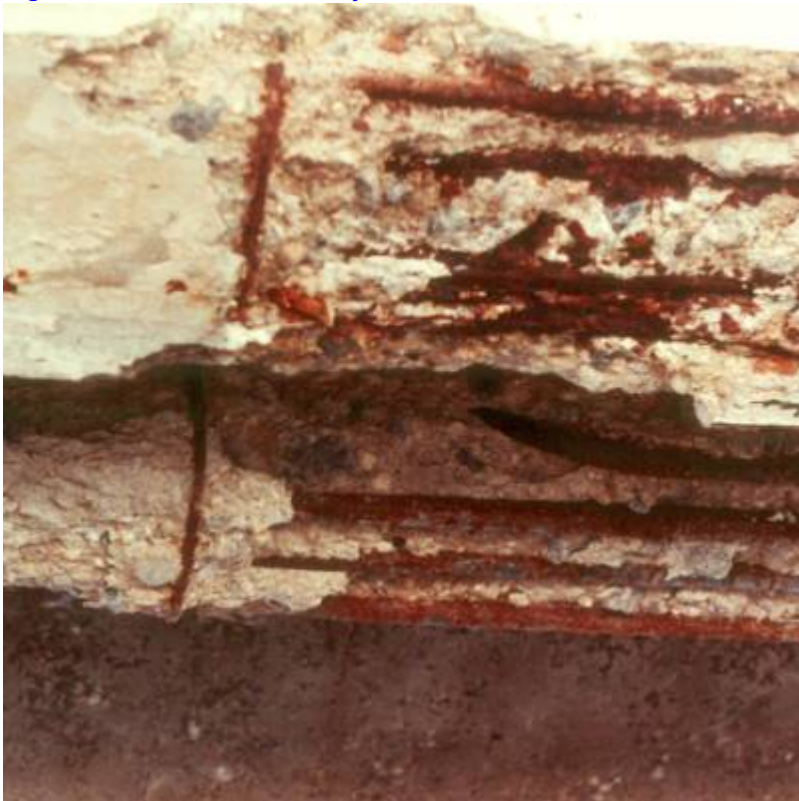
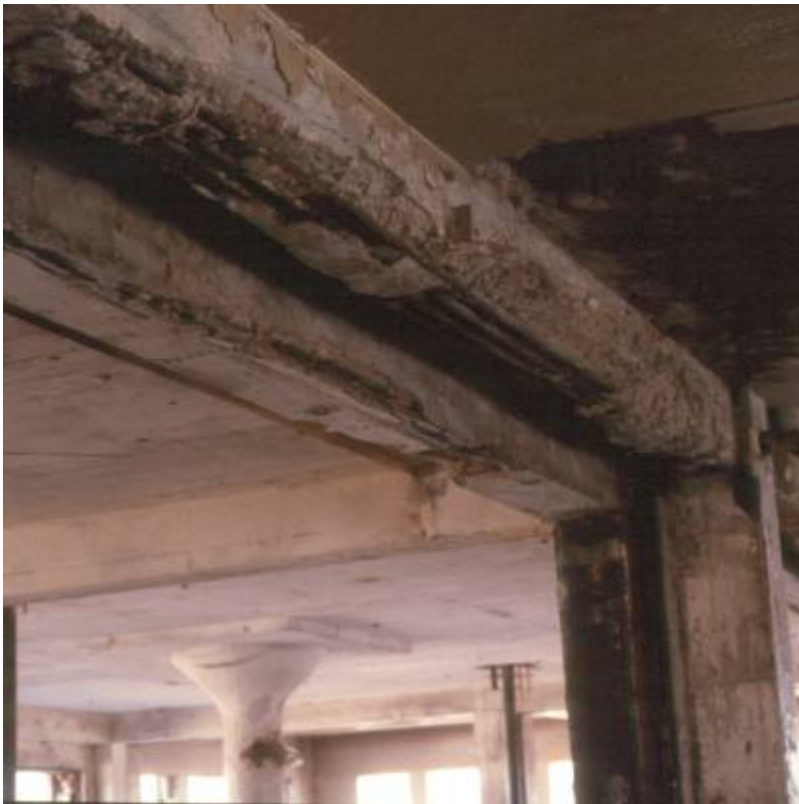
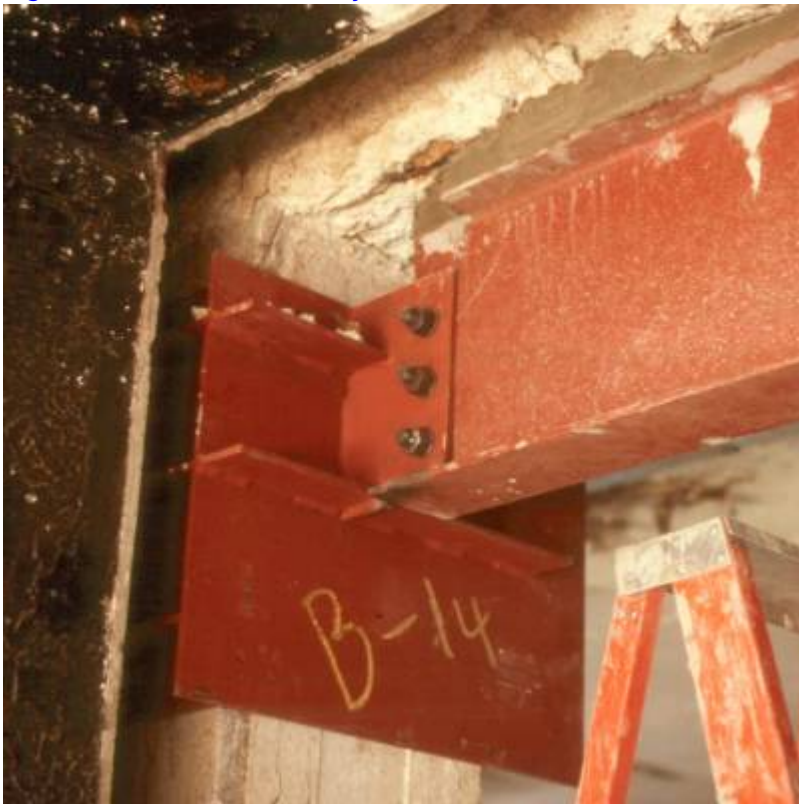
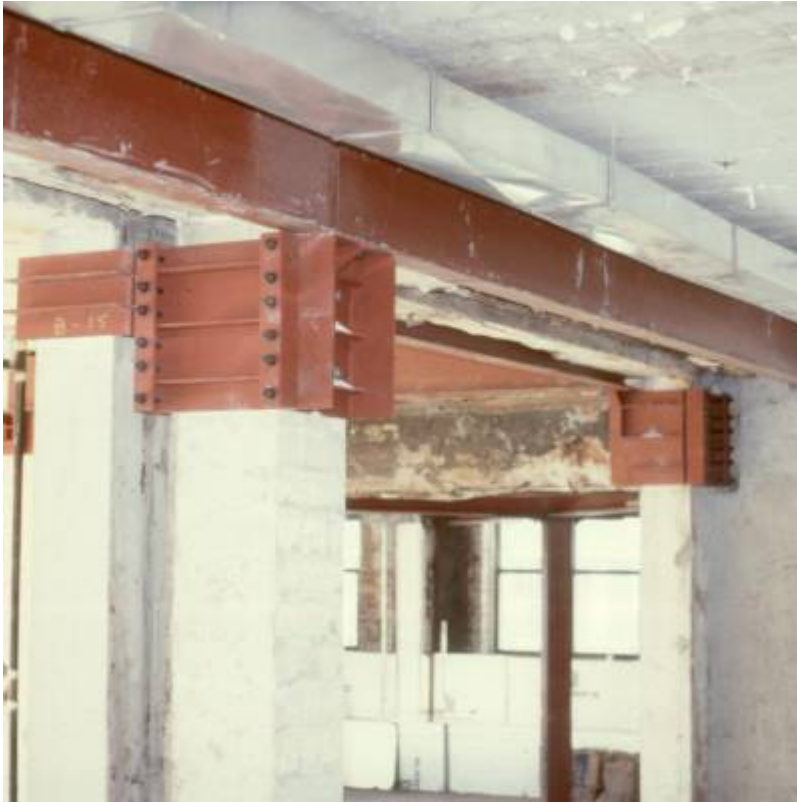
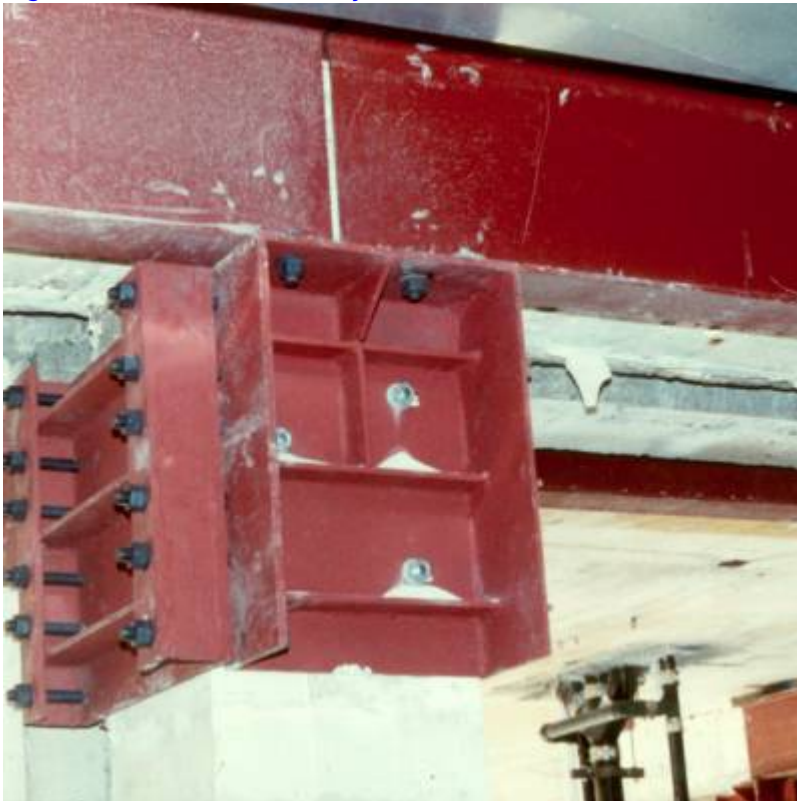
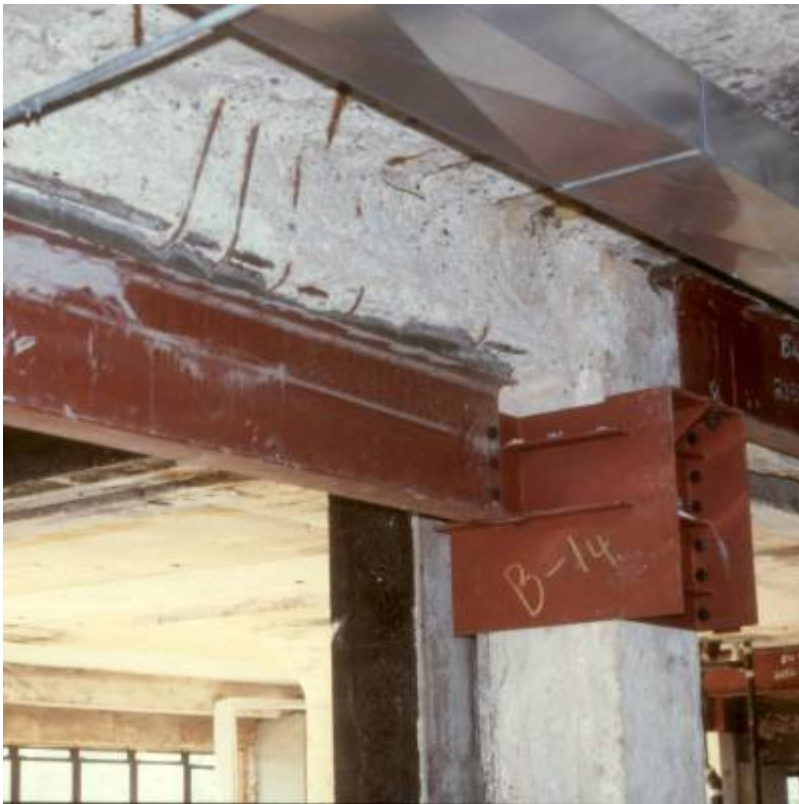
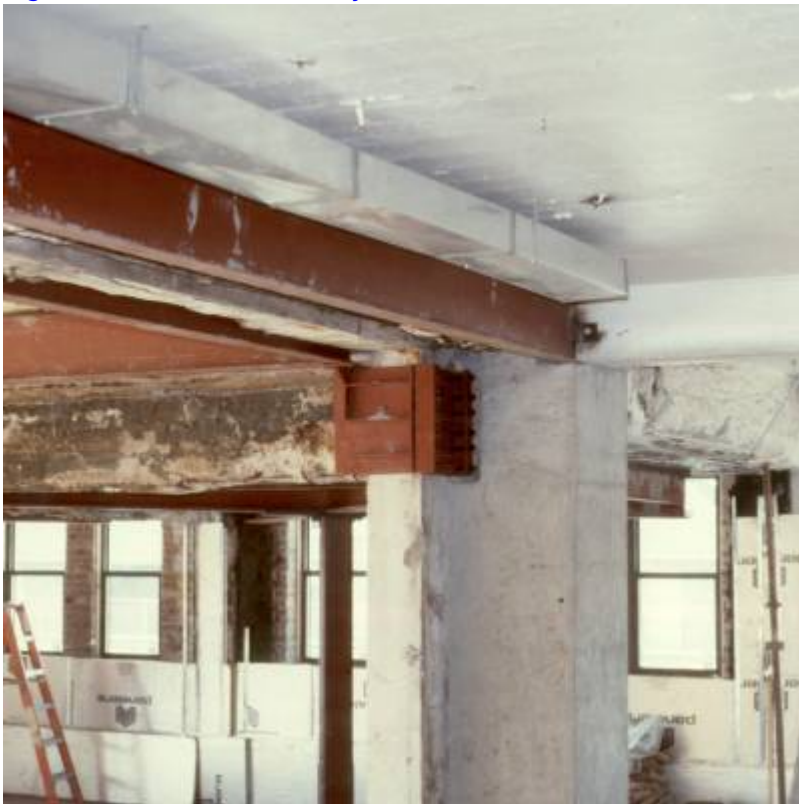
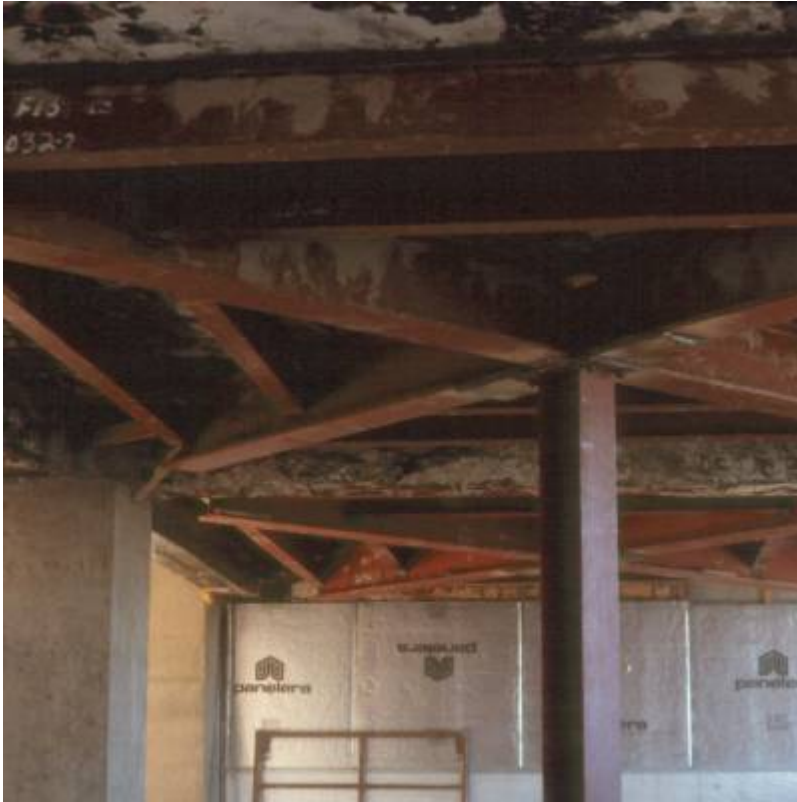
While employed with Hurst & Hendricks in Fargo, ND I had the opportunity to be involved with the restoration adaptive reuse of this historic 1923 brick industrial building now listed on the register of historic places. Many parts of this building's concrete structural frame and floor slabs had severe deterioration due to nature of the creameries' operations, a wet environment, coolers and freezers.

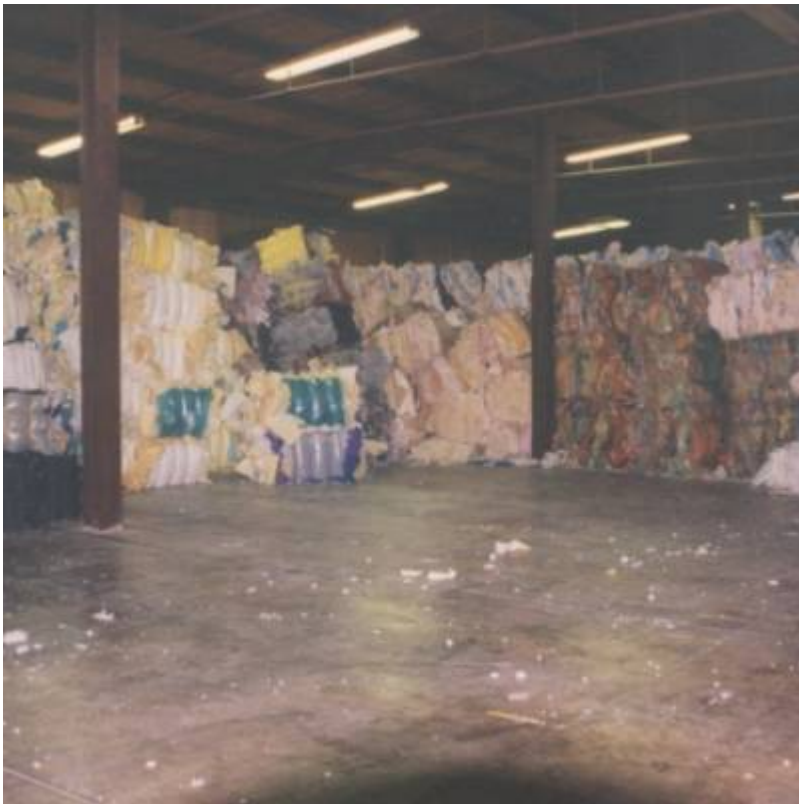
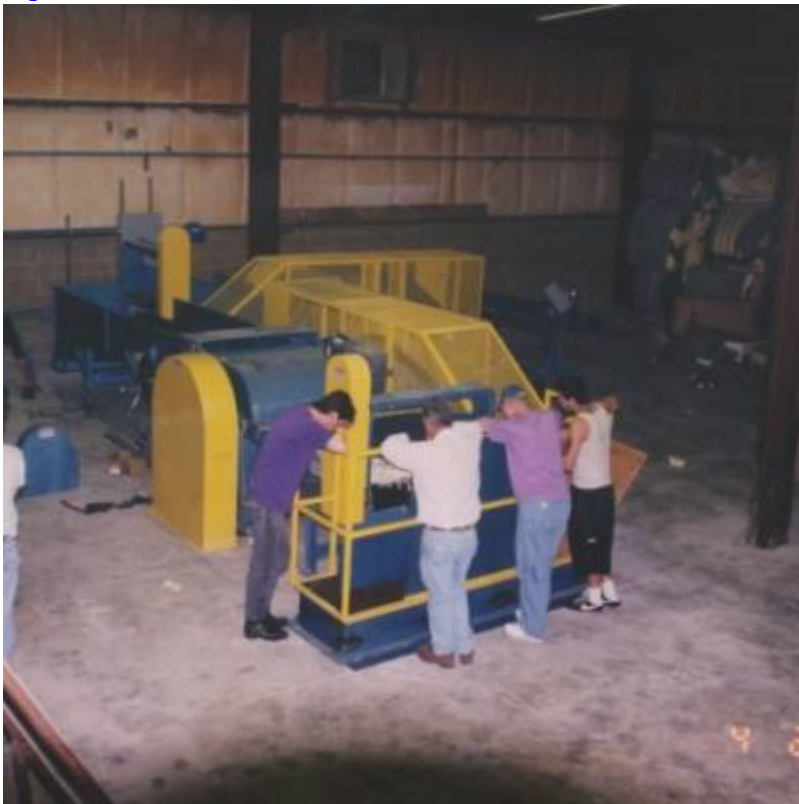
This industrial building's structural framing system was comprised of a pre-engineered steel frame and precast concrete floor slab. The owner, which recycles foam, wished to determine whether the second floor had any additional capacity for the companies operation. Well, not only did it not have any additional capacity, it's second floor beams were under-sized. As shown in Figure 4 stiffener plates were

added to these beams to bring their capacity up to the original prescribed design load of 100 psf.

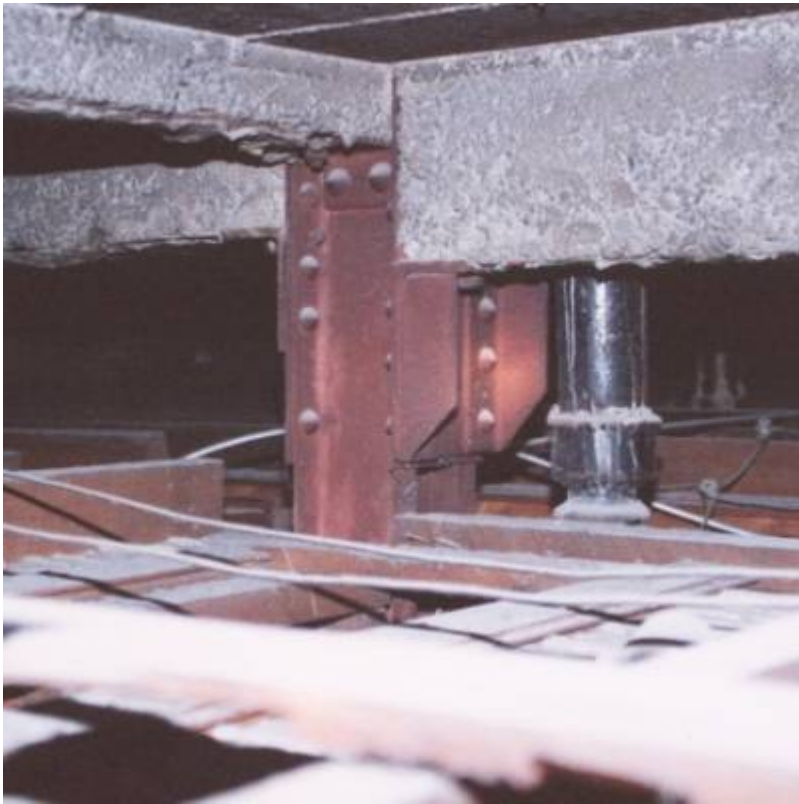
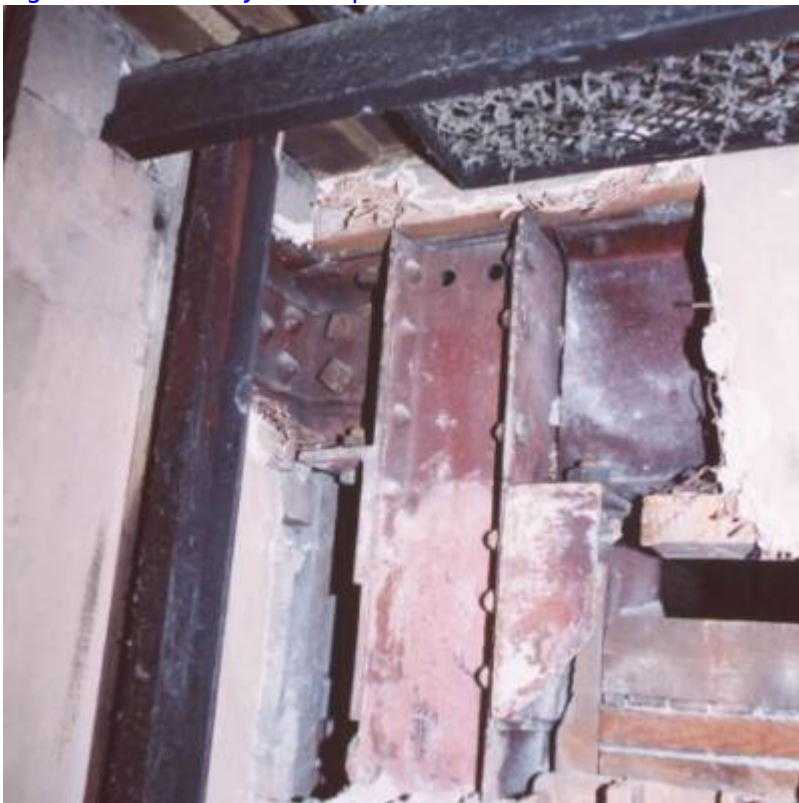
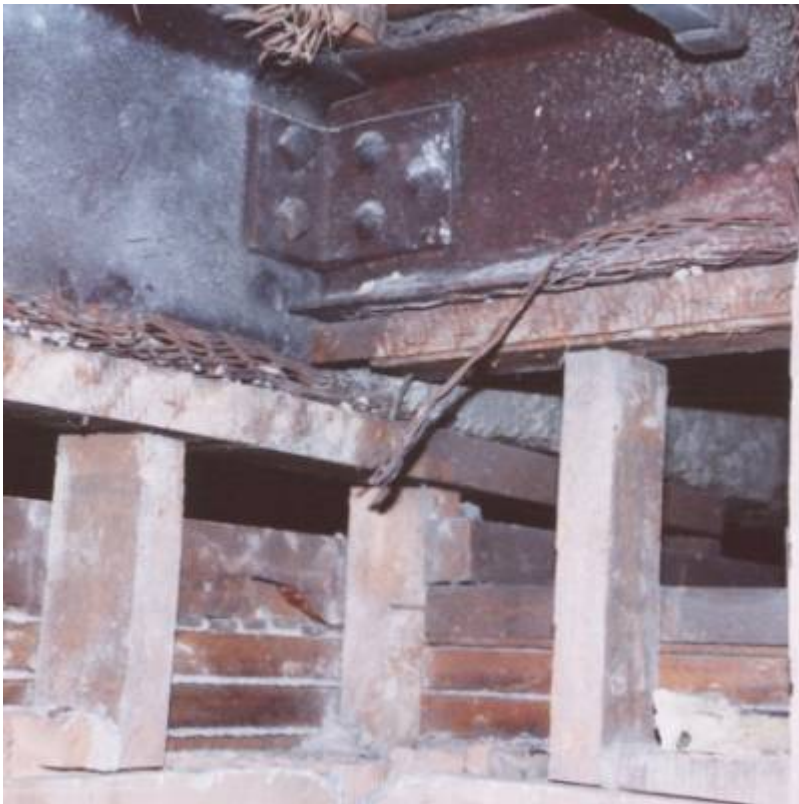
The renovation and rehabilitation of an apartment building one-hundred or more years old may involve dealing with posts made of cast iron, early iron or steel columns and beams made of an unknown steel strength, concrete floor systems of unknown capacity and most often no plans. The challenges can be numerous. This project involved the review of existing steel framing which supported an elevator that owner wished to upgrade.

During the retrofit process existing structural systems needed careful evaluation for new loading conditions and for compliance with current building codes. Material properties may need to be determined to ensure compatibility with restoration materials.

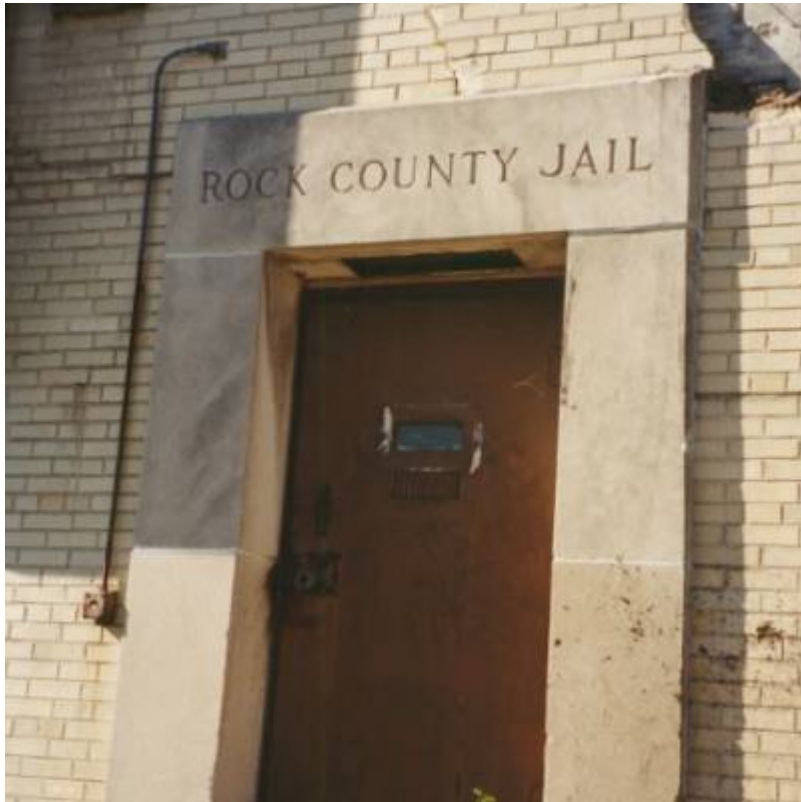
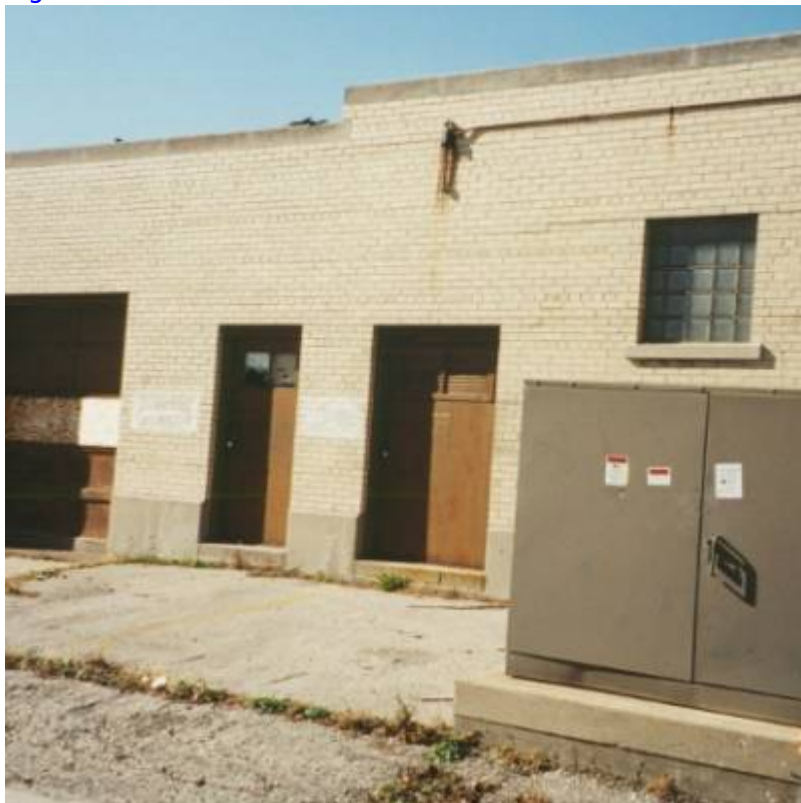
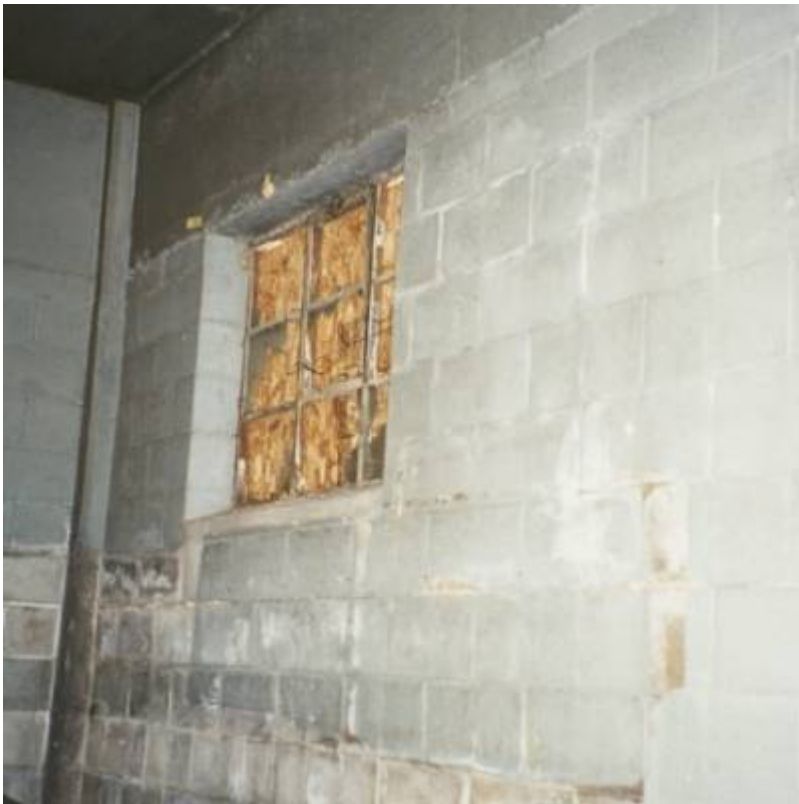
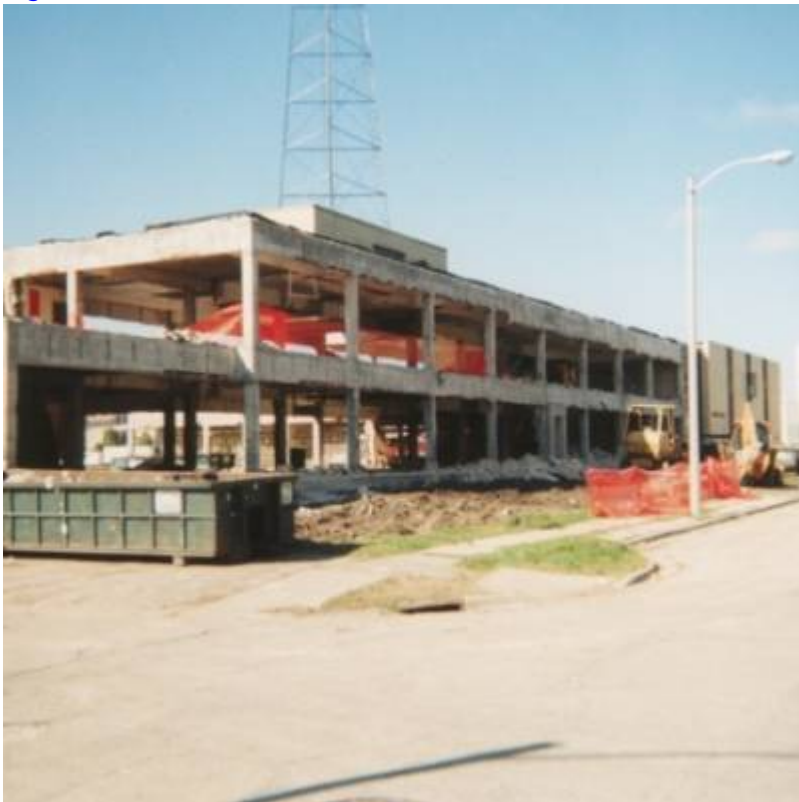
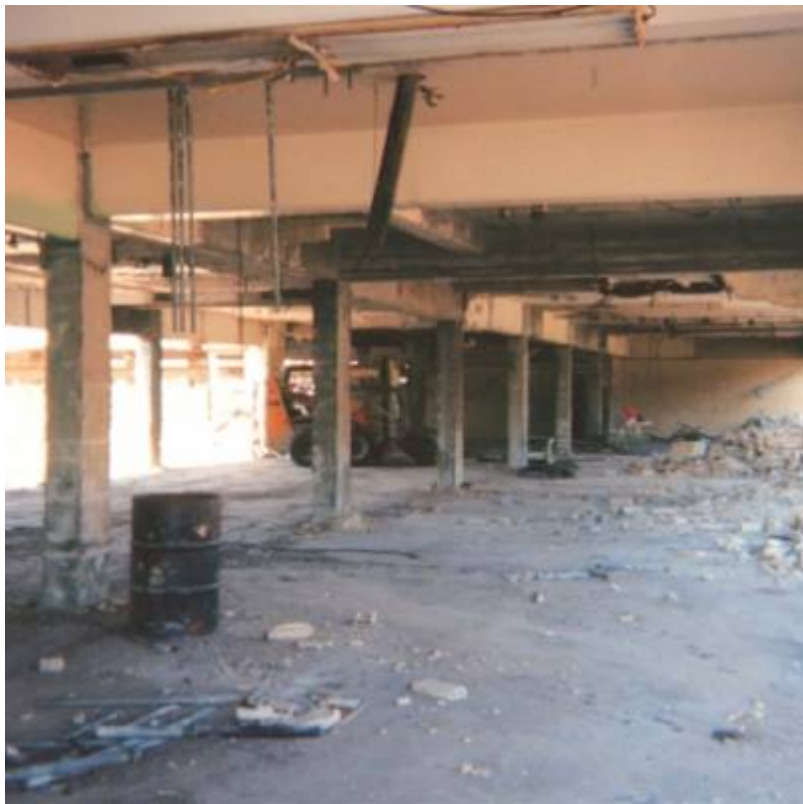
The proposed renovation of this former jail, built in 1949, posed a number of unique challenges. One challenge was to come up with a new lateral support system that would work with the architect's new cladding system. This concrete framed building was laterally supported by an infill masonry wall system. The removal of this deteriorated wall system required a replacement lateral system. A concrete shear wall system integrated with the existing concrete frame was selected. An interesting aspect of the design of this shear wall system was modeling the system so as to not axially load the new walls with existing loads yet deliver the required shear loads thru the diaphragm to the shear walls (Figures 8-11). Another challenge was to evaluate the load-carrying capacity of the existing concrete floor system due to a change in use. Fortunately existing structural plans were available which made the evaluation process considerably easier. This is not always the case when renovating an existing building.
